AQUETONG CREEK RESTORATION PROJECT

2022 RIVERINE MONITORING REPORT

SOLEBURY TOWNSHIP, BUCKS COUNTY, PENNSYLVANIA

NOVEMBER 2022

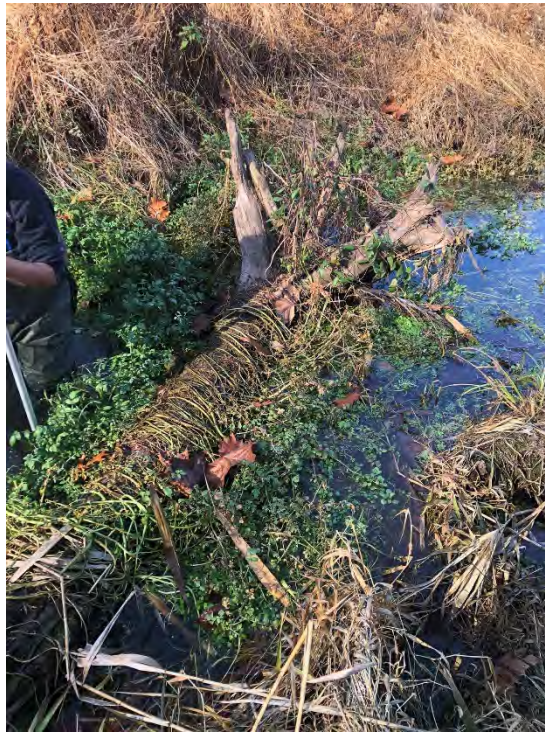
Photograph ID: 1

Structure 1 is a grade control woody debris structure located at station 15+15. Water was flowing through and under the logs of the structure, with some undercutting. However, vegetation was well established along the banks and there was no bank erosion associated with the structure.

Comments:
View from right bank of Structure 1. Note extensive watercress growth.

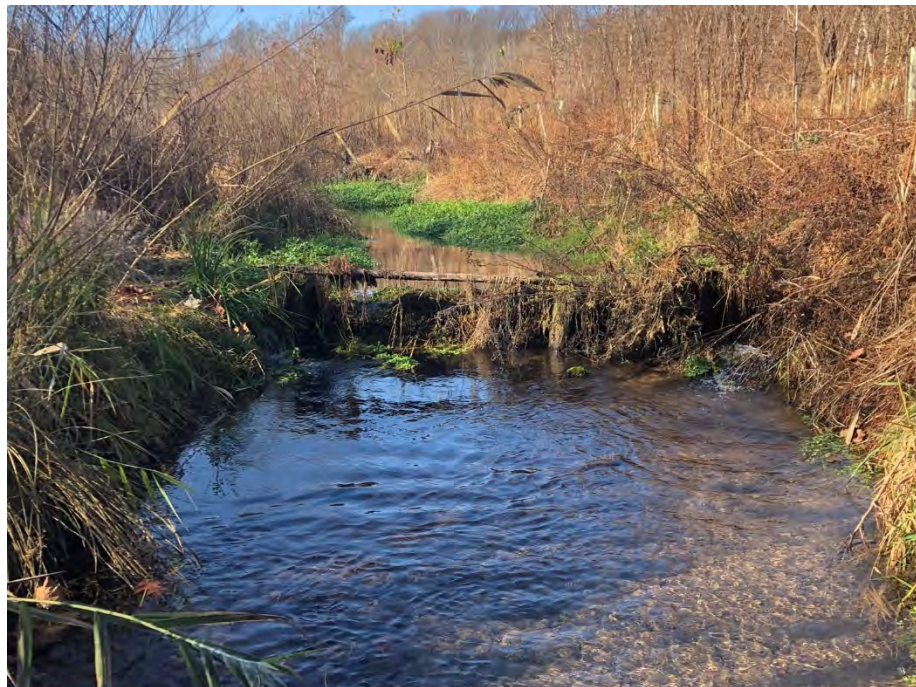
Photograph ID: 2

Structure 2 is a grade control woody debris structure located at station 14+30. This structure is composed of a single log spanning the channel perpendicular to flow. When observed in 2020 water was flowing over the log, but in 2021 the log was undercut and water was flowing under the log. In 2022, the structure was undercut on the downstream side but had a solid layer of sediment on the upstream side. Water was being diverted towards the banks, causing erosion into the banks around the ends of the structure. To divert water towards the center of the channel and stabilize the banks it is recommended that at minimum a notch be cut in the top log of the structure, and rock placed around the ends of the structure along the banks. Alternatively, the structure could be reinstalled completely to be embedded further into the bed and banks, and constructed to avoid diverting water towards the banks.

Comments:
Upstream view of Structure 2. Water is flowing around both sides of the structure.

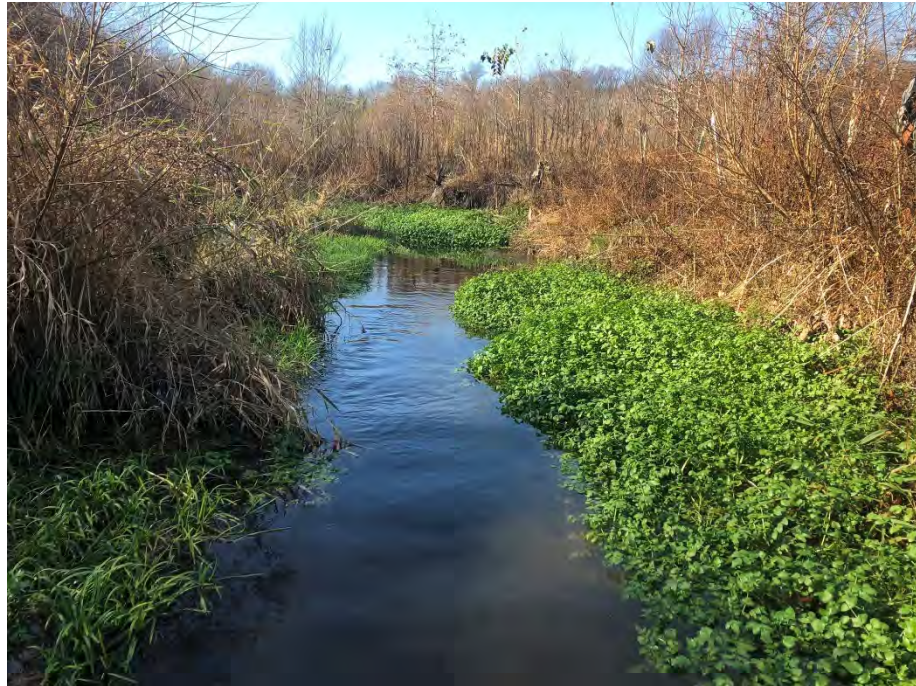
Photographic Log
Riverine Monitoring 2022**Client:** Solebury Township**Site Name:** Aquetong Spring Park Restoration Project**Project Number:** 0388.011**Site Location:** Solebury Township, PA**Photograph ID:** 3**Date:** Nov. 10, 2022**Location:**
See photo location map.**Direction:**
West**Comments:**
View upstream of Structure 2, showing extensive watercress growth in the channel.

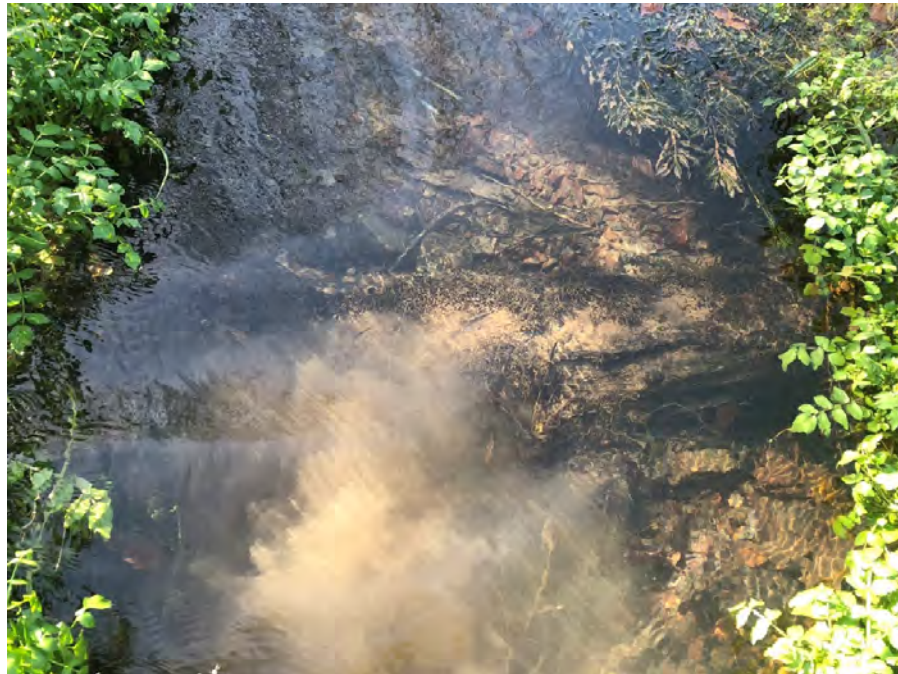
Structure 3 is a grade control woody debris structure located at station 13+50. The structure was originally composed of several cross-channel logs. However, between the 2020 and 2021 site visits, the structure had been broken up with one of the logs washed downstream and other logs rearranged, possibly due to the impact of Hurricane Ida. As of 2022, the structure was composed of a single log well embedded into the stream bed and banks. Water was no longer being diverted against the right bank, and previous erosion has been stabilized by dense vegetation growth. As with all of these stream restoration design structures they are not designed to be there forever but to allow time for the stream channel to stabilize. As such, no action is required.

**Photograph ID:** 4**Date:** Nov. 10, 2022**Location:**
See photo location map.**Direction:**
Southwest**Comments:**
Upstream view of Structure 3. This structure has been significantly altered, and consisted of a single embedded log. Bed and banks stable in the vicinity of the structure.

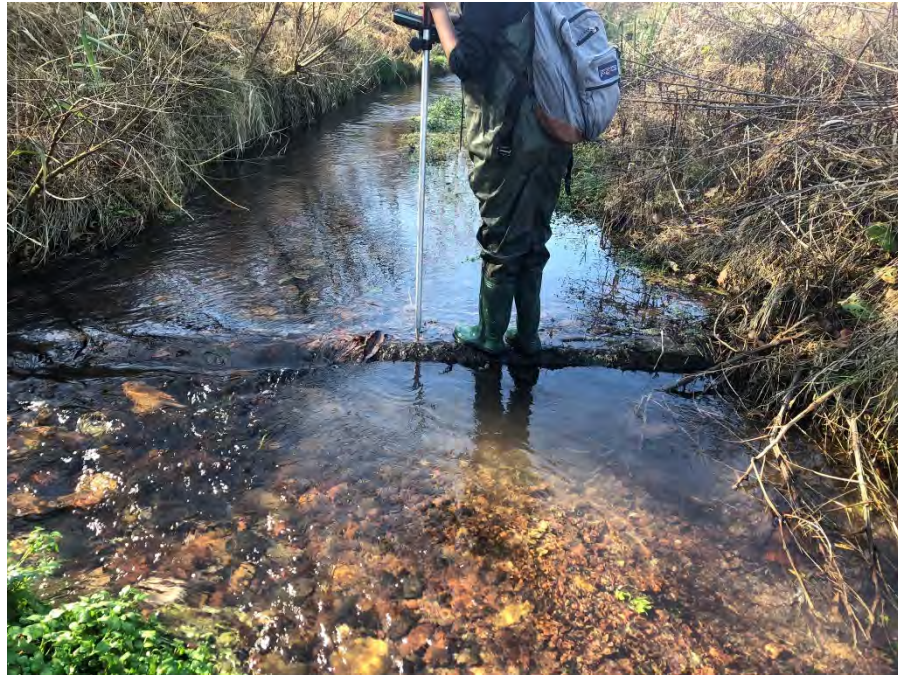
Photograph ID: 5

Structure 4 was constructed as a grade control log step-pool series from station 12+70 to 13+00. Only the most upstream log out of four could be located during the 2022 monitoring inspection. While well embedded in the stream bed, water was running around the end of the log and cutting into the right bank. To divert water towards the center of the channel and stabilize the banks it is recommended that at minimum a notch be cut in the top log of the structure, and rock placed around the ends of the structure along the banks. Alternatively, the structure could be reinstalled completely to be embedded further into the bank, and constructed to avoid diverting water towards the banks.

Comments:
Upstream view of Structure 4. Only one log of four was observed. Water was cutting around the end of the log and into the right bank.

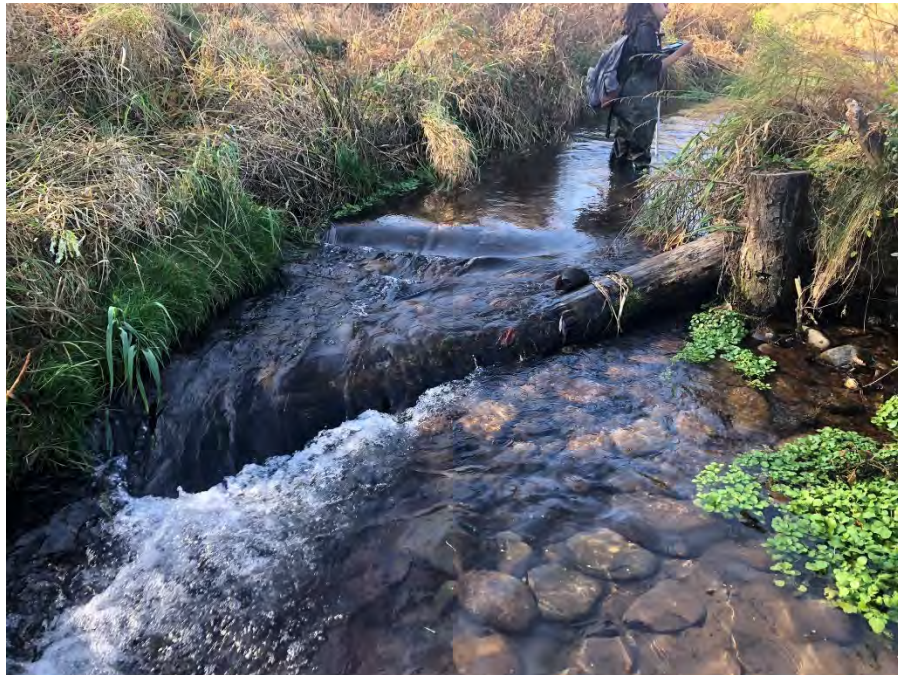
Photograph ID: 6

Structure 5 is a grade control woody debris structure located at station 12+25. This structure was in good condition, with water flowing over the logs of the structure and no undercutting. However, some water was being diverted behind the log toe structure of the right bank, bypassing the structure and causing erosion on the bank. To divert water towards the center of the channel and stabilize the banks it is recommended that at minimum a notch be

Comments:
Upstream view of Structure 5. Some water was being diverted behind the log toe structure on the right bank.

cut in the top log of the structure, and rock placed around the ends of the structure along the banks. Alternatively, the structure could be reinstalled completely to be embedded further into the bank, and constructed to avoid diverting water towards the banks.

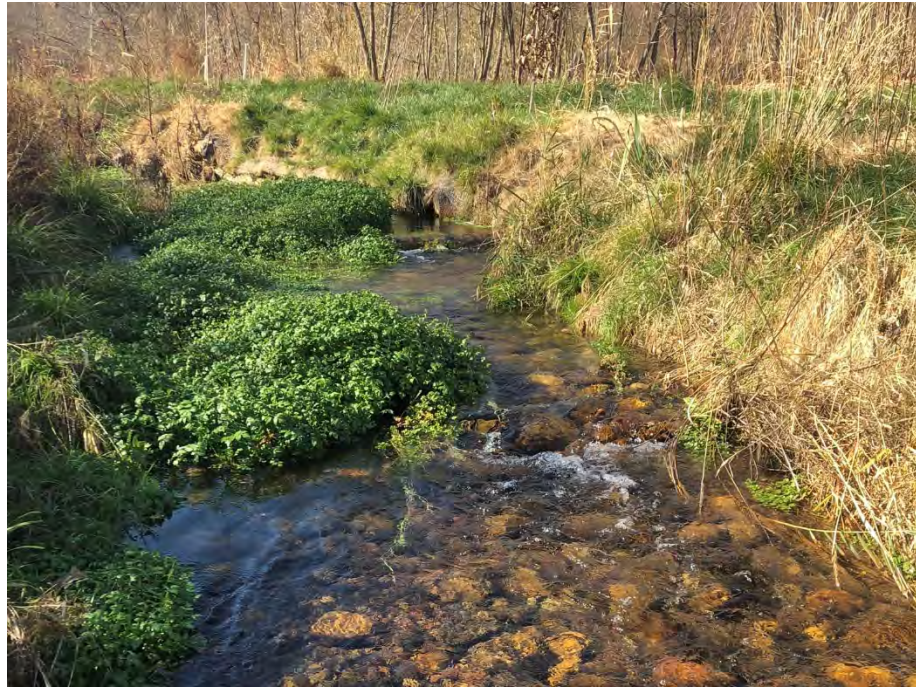
Structure 6 is a grade control log step-pool series from station 11+20 to 11+50. The bed and banks were stable through this section of the channel, with no undercutting, or bypassing of the structure observed. The downstream extent of the floodplain bench installed in 2021 was located at Structure 6.

Comments:
Upstream view of Structure 6. The structure was stable with no erosion observed.

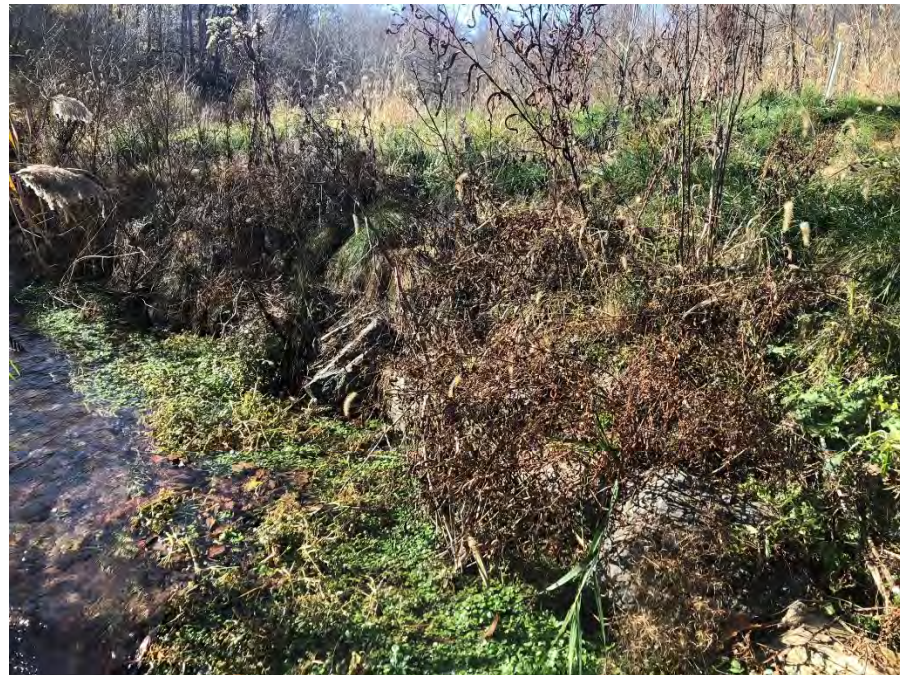
Photograph ID: 8

The floodplain bench on the main channel is located on the river left bank between station 9+50 to 11+50. The bench was installed in 2021 and is now at an elevation ranging from 129.5 to 130 feet, with a maximum width of 30 feet. It extends from the confluence with the tributary to Structure 6 at the downstream end. Construction was completed in the summer of 2021. During the 2021 monitoring site visit, it was observed that part of the bank in this area was unstable and actively eroding, with erosion control matting dislodged, likely due to the impact of Hurricane Ida before vegetation could become established post-construction. As of the 2022 monitoring site visit, vegetation has become well established and the bank appeared stable.

Comments:
View of downstream extent of floodplain bench constructed in 2021. Vegetation was well established and stabilizing bank.

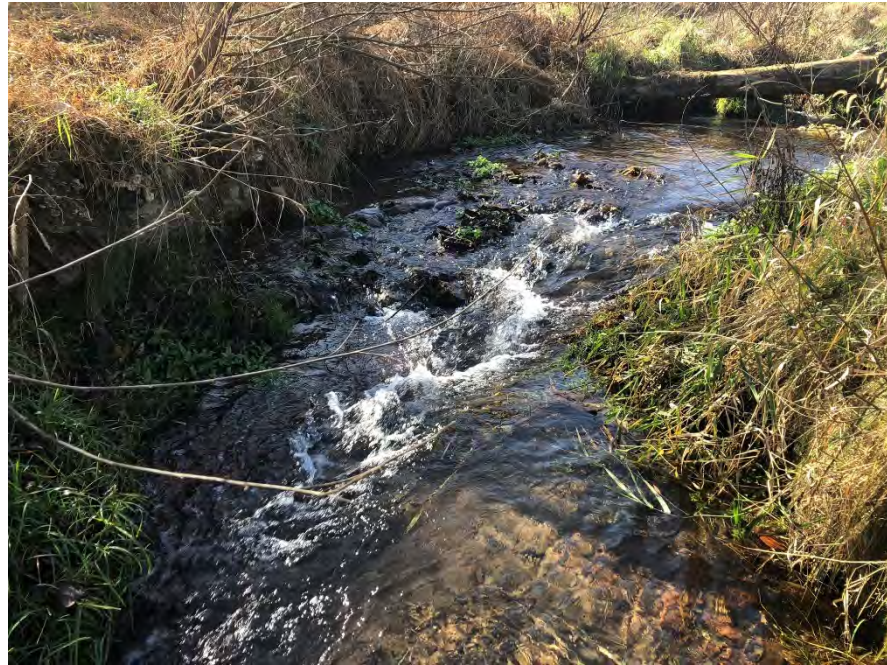
Also in this area of the channel was a headcut located at station 10+30. The headcut has migrated approximately 10 feet upstream and has become less steep than in previous years, indicating that it may self arrest. At this time continued monitoring is recommended.

Comments:
Upstream view of headcut.

The headcut downstream of Structure 7 has advanced upstream since October of 2020 but has become less steep. At this time, it is recommended that it remain under observation with no immediate action required.

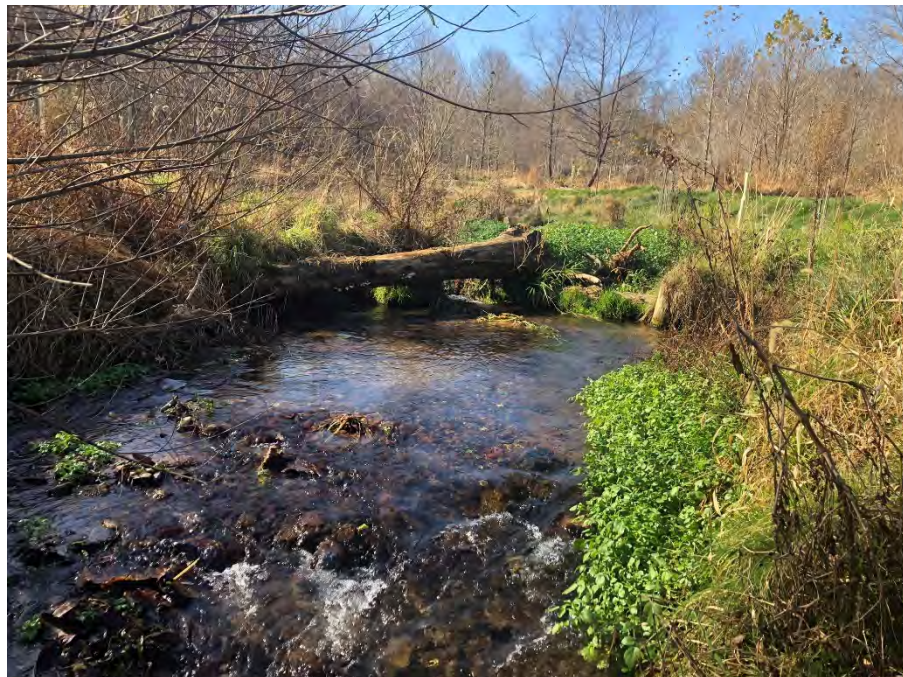
Photograph ID: 10

Structure 7 is a grade control woody debris structure located at station 10+10. The structure has become undermined, with the top log completely out of the water and water flowing under the other logs. Additionally, the structure is being bypassed by flow to both banks, cutting around the ends of the logs and causing erosion in the banks. To divert water towards the center of the channel and stabilize the banks it is recommended that at minimum a notch be cut in the top log of the structure, and rock placed around the ends of the structure along the banks. Alternatively, the structure could be reinstalled completely to be embedded further into the banks, and constructed such that water will not be diverted towards the banks.

Comments:
Upstream view of Structure 7. Water was cutting around the structure into both banks.

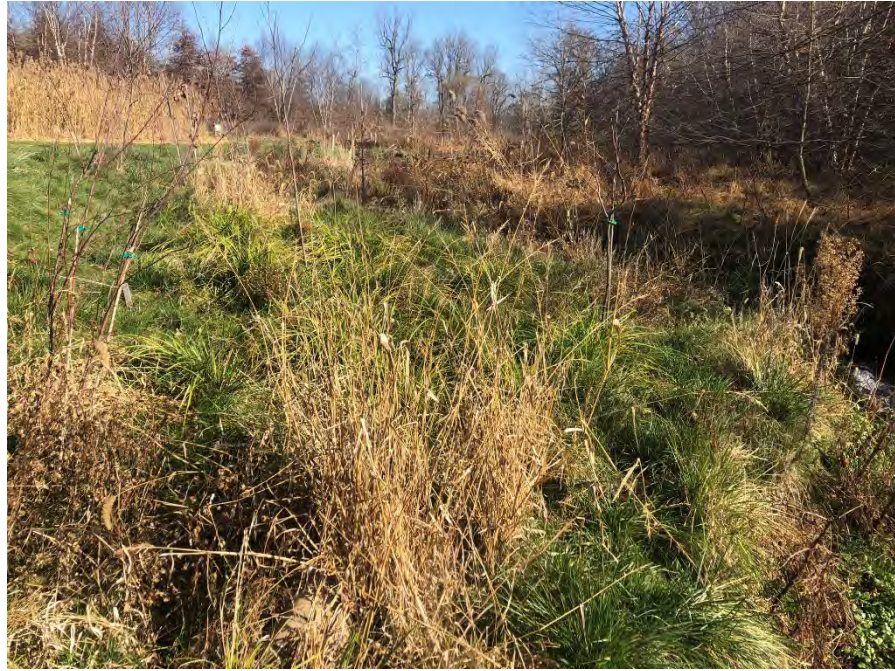
Comments:
Downstream view of floodplain bench constructed in 2021. Vegetation is well established.

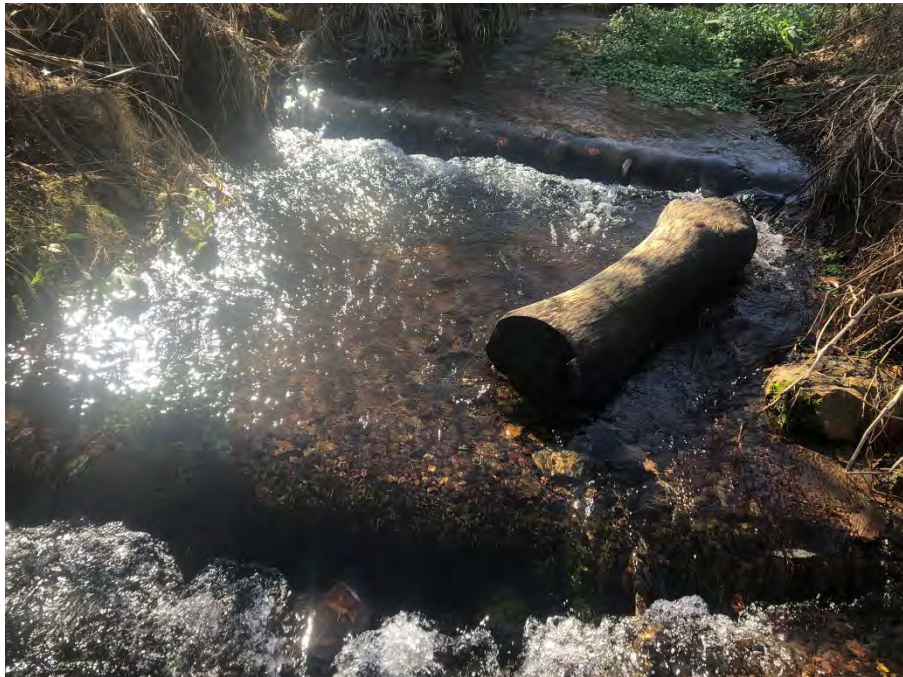
Photograph ID: 12

Structure 8 is a grade control log step-pool series from station 9+00 to 9+50. The bed and banks were stable through this section of the channel, with no bypassing of the structure observed. Minor undercutting of the bank along the outside bend was observed; however, vegetation was dense and the bank appeared stable. A point bar has formed directly downstream of Structure 8 at the inside bend of the channel.

Comments:
Upstream view of Structure 8. The structure was stable with minor undercutting of the right bank along an outside bend.

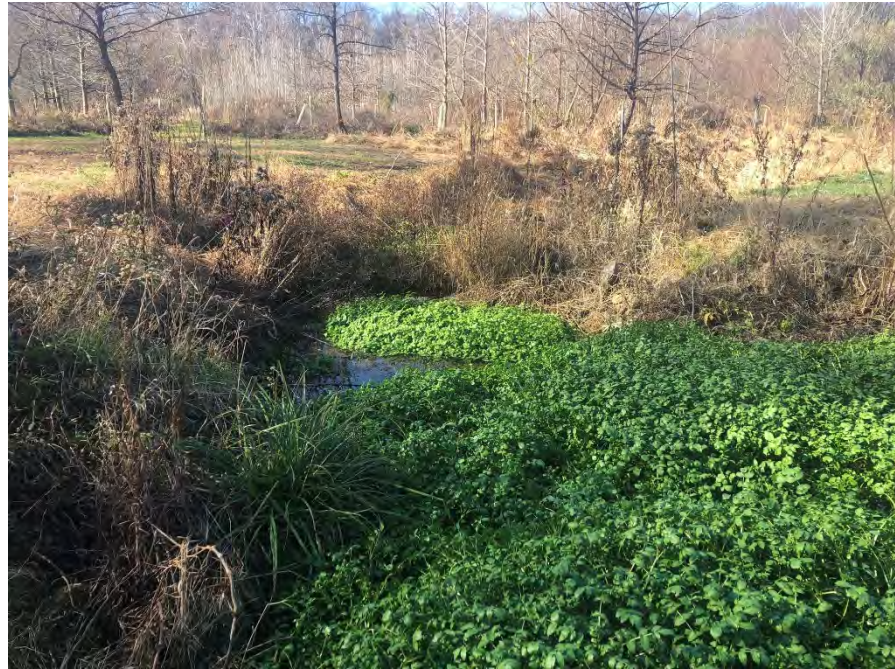
Comments:
Upstream view of the stormwater tributary at the confluence of the stormwater tributary with the main channel. Note extensive watercress growth.

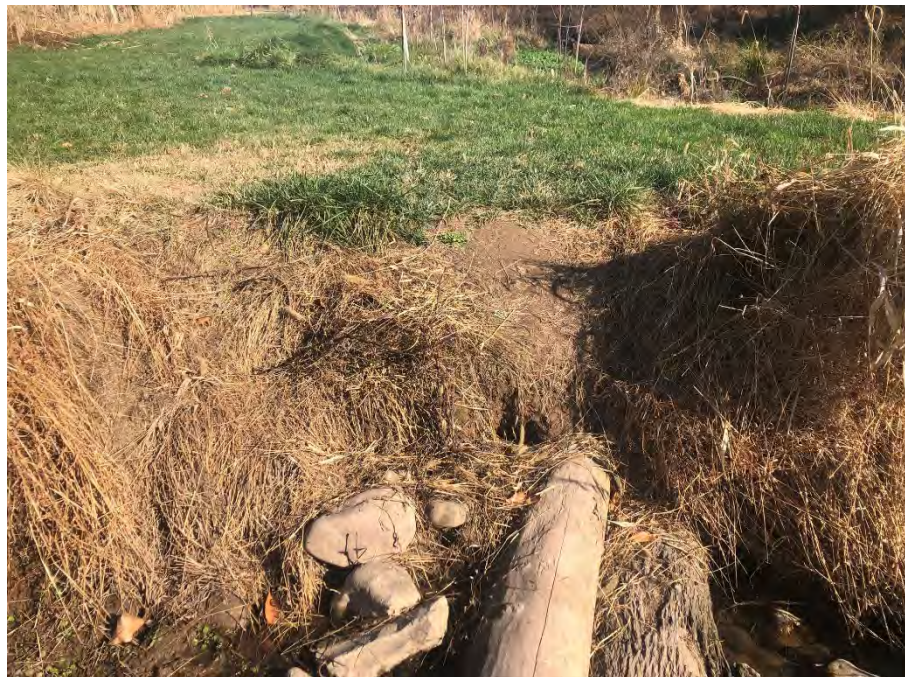
Photograph ID: 14

Comments:
View of informal trail causing erosion on left bank of stormwater tributary.

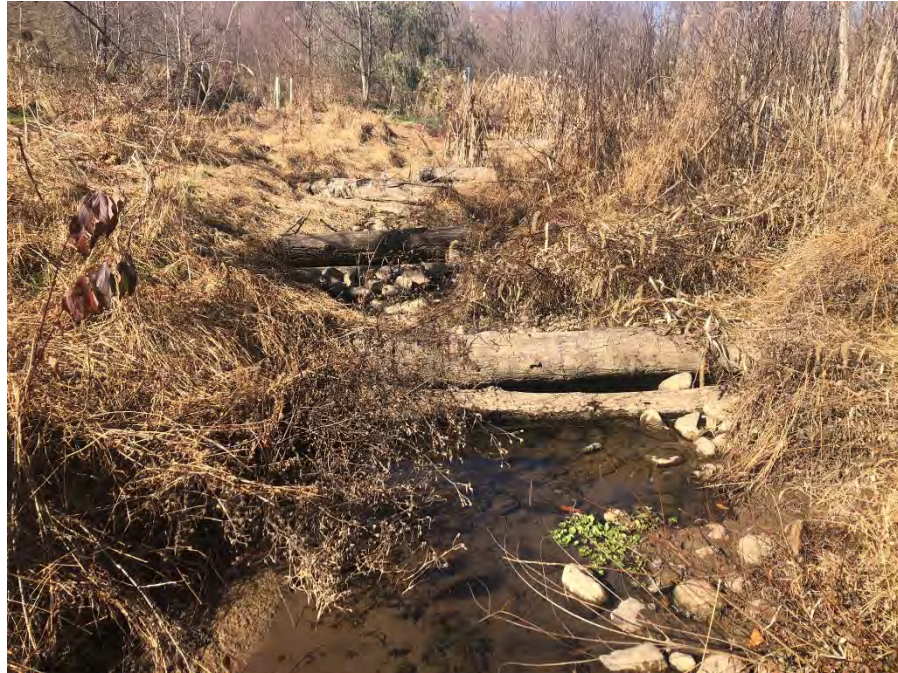
Structure 9 is a log step-pool series on the stormwater tributary from station 5+00 to 6+55. These steps were installed above the design elevation, and three steps at the downstream end were lowered in 2021. As observed in 2022, the bed and banks were stable through this section of the channel, with no undercutting, or bypassing of the structure observed. An informal path had been created through this section that may contribute to erosion in the future. It is recommended that rock be placed on the bank in the area of the informal path to avoid further erosion.

Comments:
Upstream view of Structure 9.

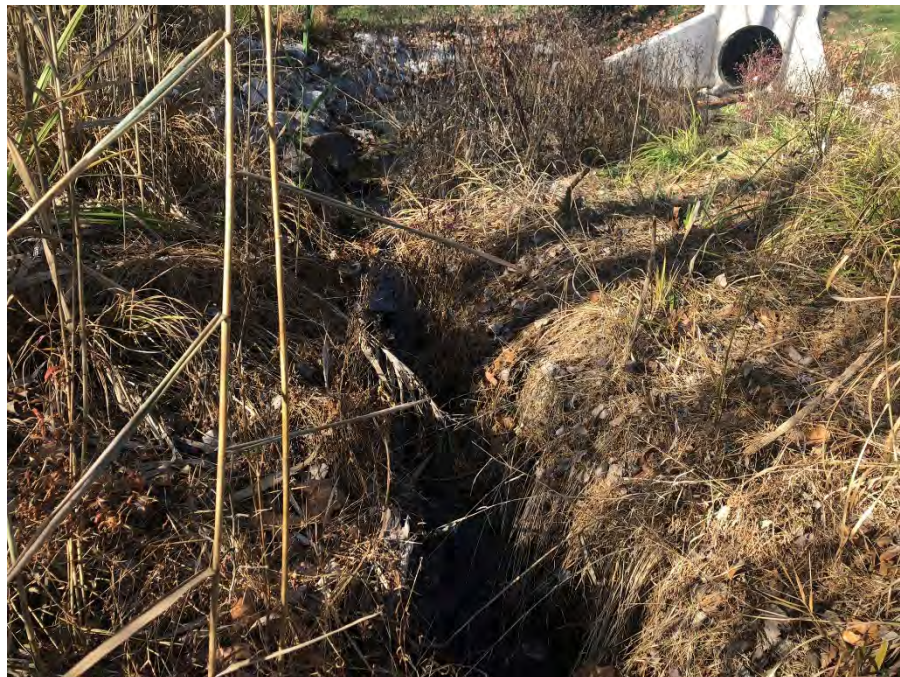
Photograph ID: 16

A small floodplain bench was constructed on river left at the upstream end of the stormwater tributary, with live stakes added. Additionally, as part of a separate project, the stormwater pipe under Route 202 was replaced, and a path and associated stormwater management features were added nearby. Overall, the bank stabilization structures in this reach were stable and in good condition. No actions are recommended at this time.

Comments:
Upstream view of upper end of stormwater tributary and stormwater outlet installed in 2021. Vegetation was well established along the channel.
