Aquetong Spring Park: Aquetong Creek Restoration Project

Solebury Township, Bucks County, PA

December 2017

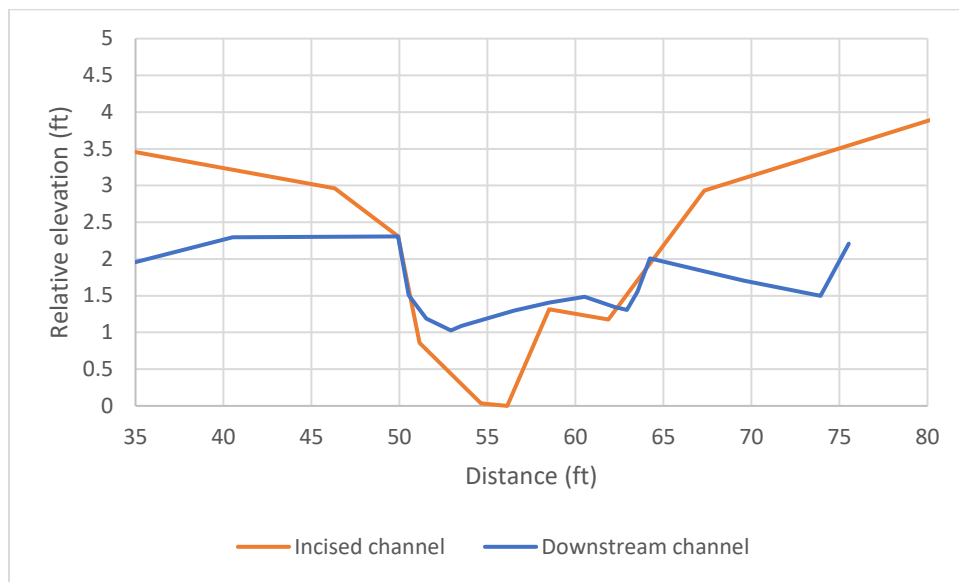
Substantial accumulations of formerly impounded sediment remain in the mainstem of Aquetong Creek in the lower reach of the former lake. The first evidence of this occurs at a headcut approximately 3 feet in height, approximately 100 feet upstream of the former dam. Extending an additional 700 linear feet upstream, typical depths of 1.5-2 feet of erodible sediment remain below the existing channel invert. The channel cross-section in this reach is incised and entrenched, particularly relative to the reference reach identified downstream of the dam (Figure 1). In contrast, the upper reach of Aquetong Creek, approximately 1,000 feet upstream of the dam, and approximately 100 feet upstream of the unnamed tributary, contains lesser accumulations of erodible sediment with an average depth of 0.7 feet. Reduced sediment depth in this reach is consistent with this portion of the creek being a nearly constant inflow thus precluding sediment deposition, that is in addition, primarily spring-fed and thus carrying minimal sediment. As is typical, the greatest proportion of finer sediment particles have deposited in the lower portion of the lake due to the longer settling times.

Figure 1. Comparison between the channel cross-section downstream of the dam and the incised channel upstream of the dam.

Main stem channel excavation dimensions will be modeled from the dimensions of the stable channel below the dam, with a width of approximately 14.5 feet and a depth of 1 foot. To avoid entrenchment, the excavated floodplain bench shall be approximately two times the channel width, with a stable 3H:1V slope to meet the surrounding grade. Approximately 770 feet of the channel will be targeted for restoration. We propose a similar approach to the tributary channel alterations, with the channel excavated for a length of approximately 450 feet to be approximately 0.6 feet deep and 7 feet wide with a floodplain bench 14 feet wide. These dimensions are based on published hydraulic geometry curves applicable to the site and developed for the encompassing physiographic regions of the northeast (Bent 2006; Johnson and Fecko 2008). It appears based on preliminary estimates that the proposed excavation may generate an estimated 6,000 cubic yards of earthen material; however, a more detailed cut/fill analysis will be required during the final design to confirm this estimate and to ensure a balance between the planned excavation and the space available for onsite placement of this excavated material. This is a small volume of material relative to the total volume of formerly impounded sediment, that can be re-distributed on-site thus avoiding the cost for its off-site transportation. There are multiple options for placing sediment onsite, such as spreading it thinly across the hillslope area of the former lake bed, creating elevated landscape features for viewpoints (e.g. knolls), circular berms for outdoor classroom seating, or filling the former raceway located downstream of the dam.
