Aquetong Spring Park Strategic Master Plan

Aquatic Habitat Restoration
November 2018

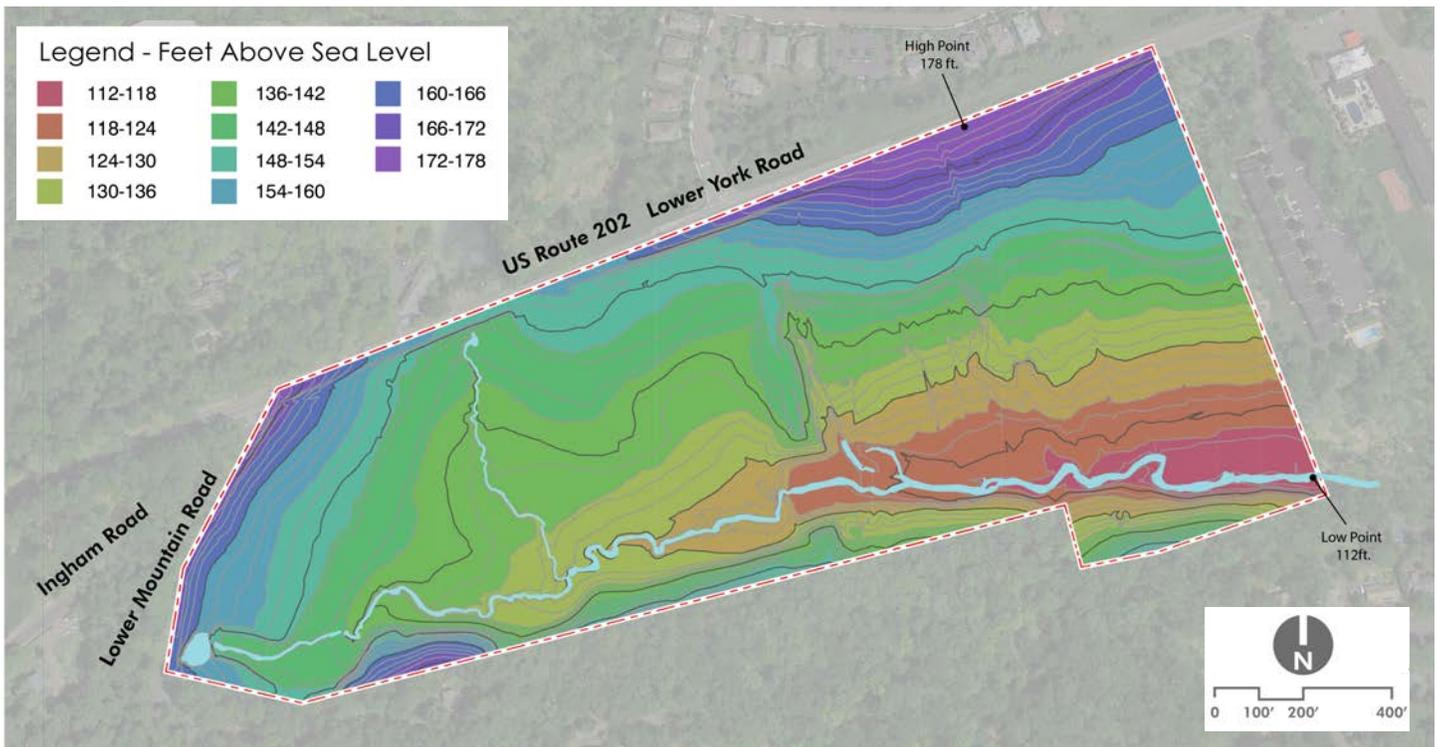
Elevation Map

There are areas of steep slopes on the site that are important when considering soil erosion, storm water management, and slope stabilization. Most steep slopes of 25%+ are along the south side of Aquetong Spring Park. Steep slopes are also found along the creek edge, former millrace, and the dam remains. Slopes of 8-15%

are found on the northeastern side of the property. Areas of flatter topography lie where the lake once existed and surrounding the Bond (Judy) House.

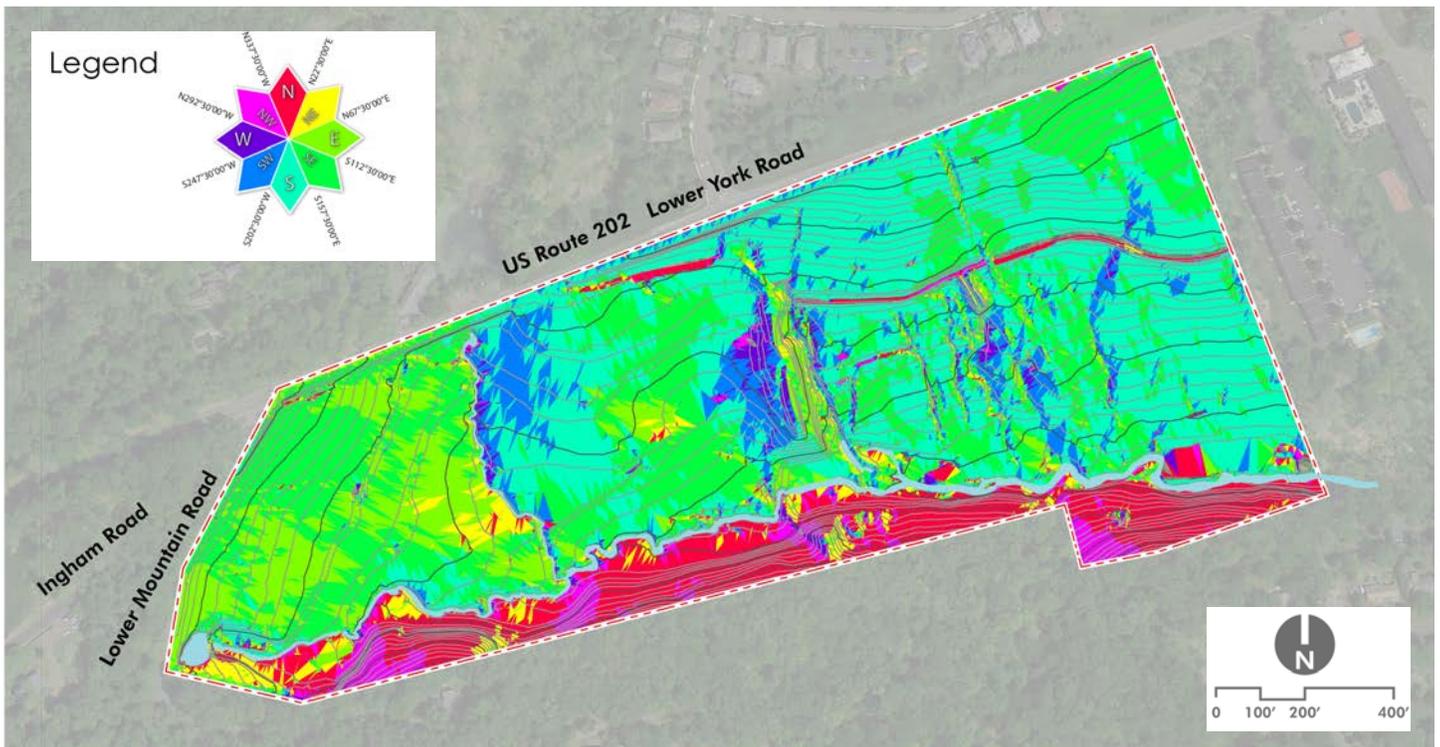
Slope "Aspect" Map

The direction a slope faces, or slope "aspect", impacts the sun exposure and micro ecology of the site. South of the creek, the slope faces north, and this hillside receives the most shade throughout the seasons. Areas of full tree canopy on the south side help provide some of the most effective shade to the waterway. North of the creek, the slope's predominant faces of south and southeast aspects foster different microclimates that broaden biodiversity on site.

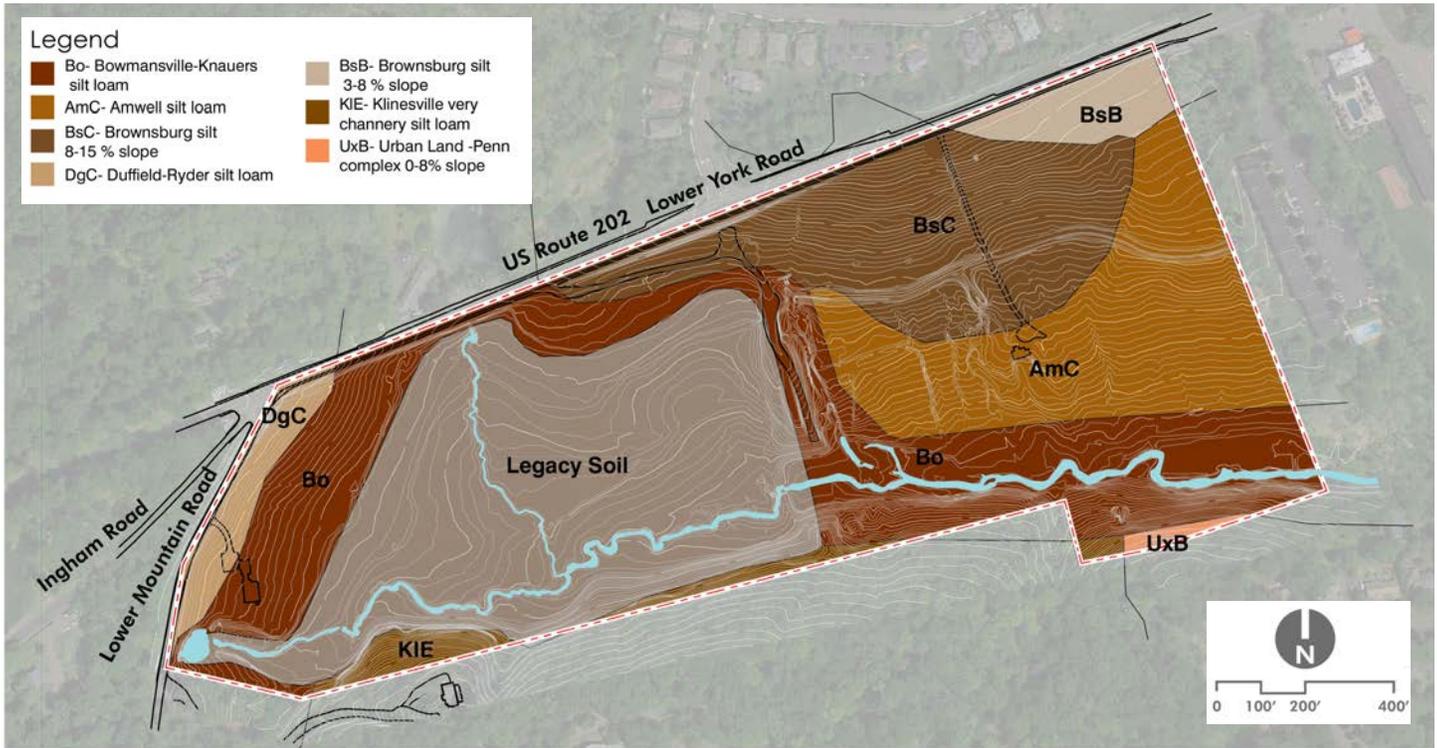
Soils Map

A variety of soils is found on site, with the majority of the site covered in Bowmansville-Knauers (Bo) silt loam, Amwell (AmC) silt loam, Brownsburg (BsC) 8-15% slope silt loam, and legacy soils where the lake once existed. Additionally, some Duffield-Ryder (DgC) silt loam, Klinesville (KIE) very channery silt loam, Brownsburg (BsB) 3-8% slope silt loams, and Urban land-Penn complex (UxB) are found around the edges of the site. The following descriptions of these soils are taken from United States Department of Agriculture's web soil survey.

(Bo) Bowmansville-Knauers silt loam makes up approximately 25% of the soil on site. This soil lies within 0-3% slope range and is considered poorly drained. It is 72-99 inches to bedrock and about 0 inches to the water table. This soil is found around where the lake once existed and along the stream.

considered somewhat poorly drained with high runoff. It is 40-99 inches to bedrock and 12-30 inches to the water table. This soil is found on the east side of the site.

(BsC) Brownsburg silt on 8-15% slope makes up about 17% of the site. It is considered to be well drained soil with medium runoff. It is 40-60 inches to bedrock and more than 80 inches to the water table. This soil is found on the north side of the property.

(KIE) Klinesville - a very channery silt loam, makes up about 1% of the site and is found on the hillsides on the southside. It lies on 25-45% slope and is considered to be somewhat excessively drained with high runoff. It is 10-20 inches to bedrock and more than 80 inches to the water table.

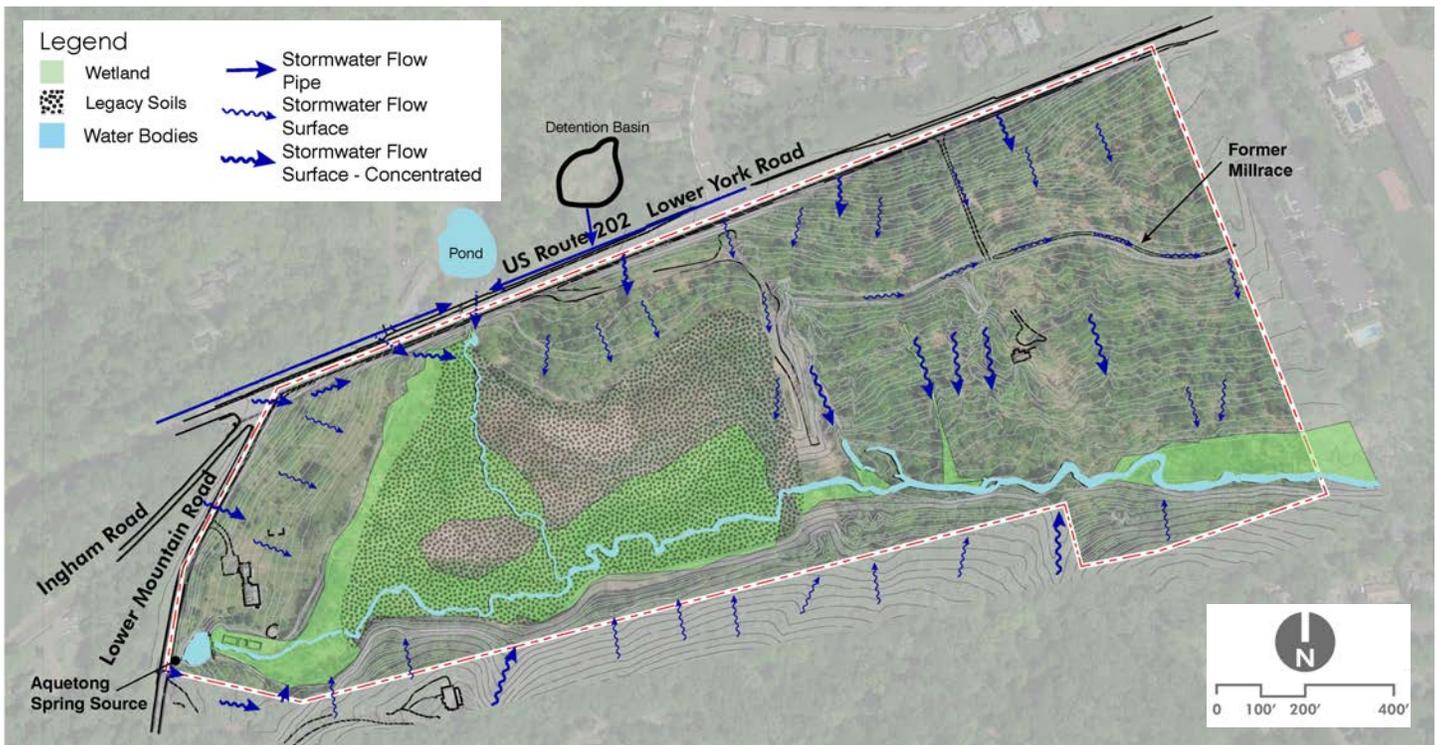
Hydrology Analysis Map

winding watercourse has formed through the empty lake bed, flowing from the spring source at the western side of the park eastward to the confluence of Aquetong Creek and the Delaware River. The creek within the park site is fed primarily by the Aquetong Spring at a steady flow rate of approximately 2,000 gallons per minute. A small tributary beginning north of Route 202 also feeds into Aquetong Creek within the site. The tributary under Route 202 receives water from a relatively small sub-watershed to the north of the site and runoff from the Route 202 corridor. The section of tributary formerly above the lake pool level shows signs of erosion from periodic concentrations of high water velocity from stormwater above the park, and this branch serves as a direct source for pollutants to enter into the Aquetong Creek mainstem within the Park.

Stormwater runoff emanating from on-site areas has created several types of conditions. The former lake bed, the Route 202 tributary, and the emerging mainstem creek are all subject to erosion from on-site stormwater sources. The former millrace also acts as an interceptor channel for stormwater flowing down the north slope in the area from below the former dam to the eastern park property line. Areas of channelized water flows are evident from the obvious rill erosion primarily along steep grades. In areas of lesser grade, rain water tends to run off more slowly and "sheet flow" across the site.

breached and has been re-investigated for the purpose of Phase 1 park restoration elements. A large portion of wetlands found on site exist where the lake once was. Other wetland areas are found along the main stem and tributary courses.

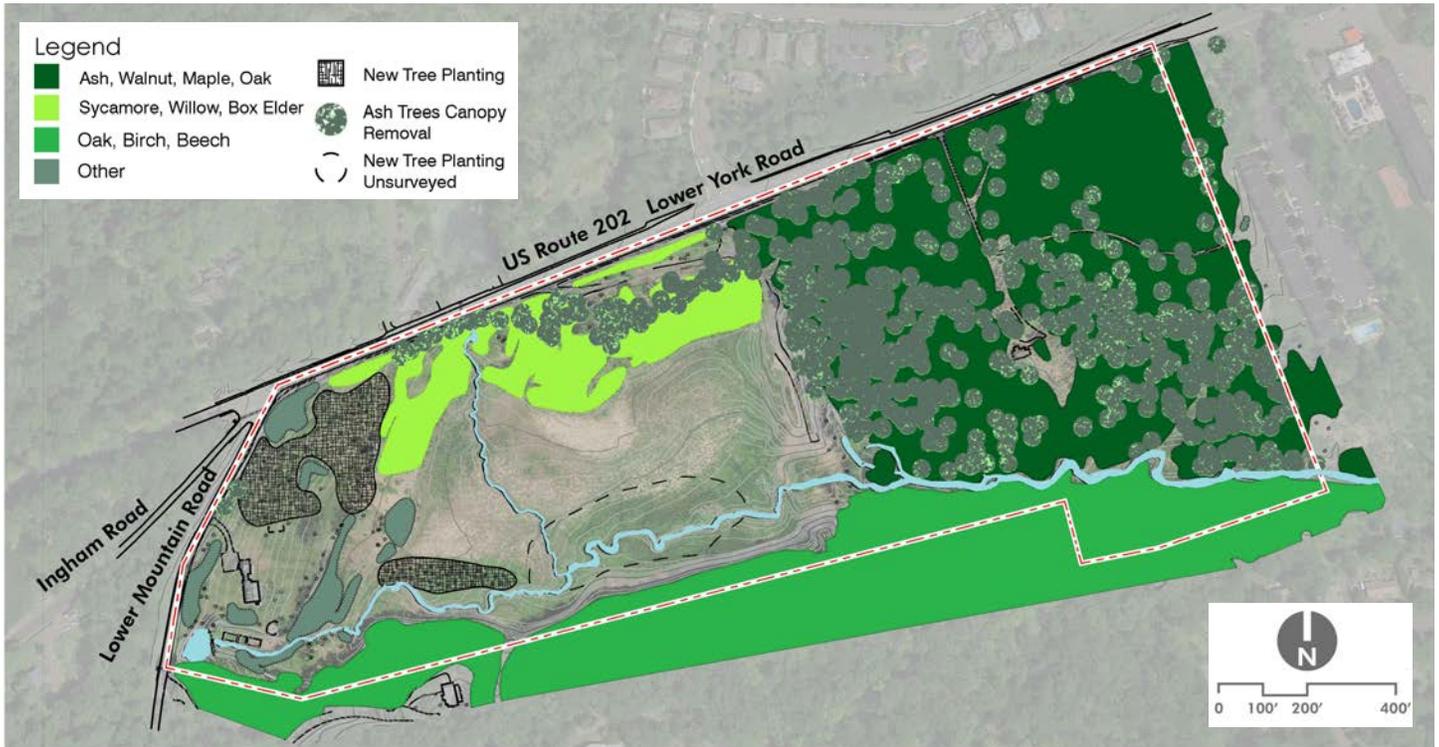
Tree Canopy Analysis Map

Canopy tree infestation is an ongoing issue within the area. Emerald Ash Borer is no stranger to the area has already decimated large stands of Ash trees throughout the region. More recently, Thousand Cankers Disease has been identified in Bucks County, and its effects on Black Walnut trees is equally as destructive. The disease is caused by a fungus carried by Walnut Twig Beetles. A professional forestry report commissioned by Solebury Township determined that all ash and black walnut species on site must be removed due to incurable invasive insects and disease issues. Approximately 1,100 trees will be lost across the Park site, especially concentrated on the steep north slopes below the former dam. The resulting loss of the existing tree canopy will increase the susceptibility of the heavily deer-browsed woodland floor to invasive plants and erosion. The Forest Canopy map shows about 690 trees of the nearly 1100 that are marked to be removed and provides an idea of the extensive canopy loss due to the necessary removal of these trees.

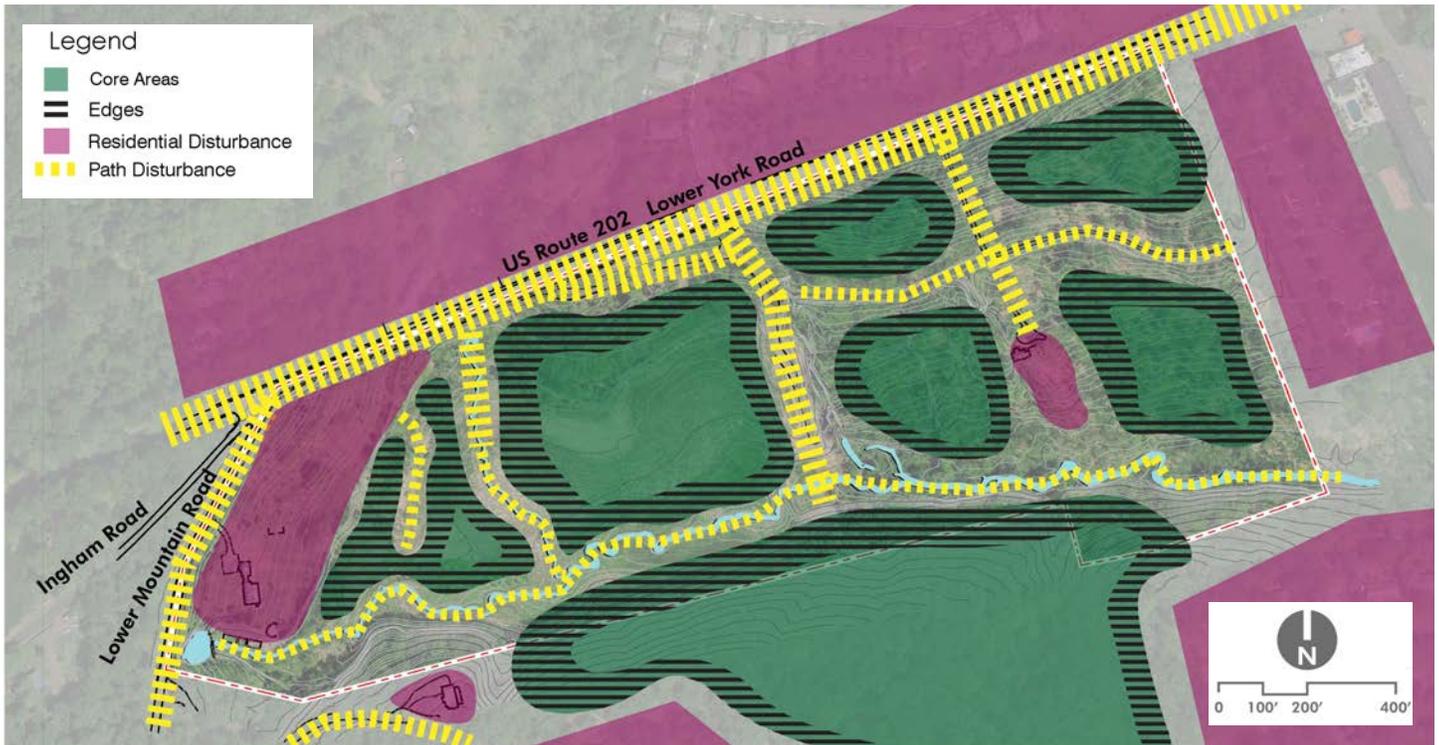
Disturbance and Existing Habitat Core Analysis Map

In an analysis of habitat area, locations of key disturbances were identified and differentiated by residential or path. Residential disturbances occur from areas of development, removing areas of natural habitat. Pathways cause disturbance by fragmenting larger areas of habitat. The creek and tributary watercourses are considered “disturbances” since they are still downcutting through the former lake bed and creating paths of repose. Other large disturbances, such as loss

of tree canopy are occurring within the site. All these disturbances conspire to divide vegetation ecology into small “core” habitat areas. Small areas of core habitat decrease the resilience of the ecosystems to the impacts of disturbances by reducing areas of sustainable biodiversity and viable populations to survive and thrive as they can in larger core habitat areas. This core habitat fragmentation also allows for “edge communities” to become established with portals for opportunistic invasive plants and animals to invade protected habitats. Without interventions, disturbances ultimately alter the essential environmental conditions for healthy, native core habitats.

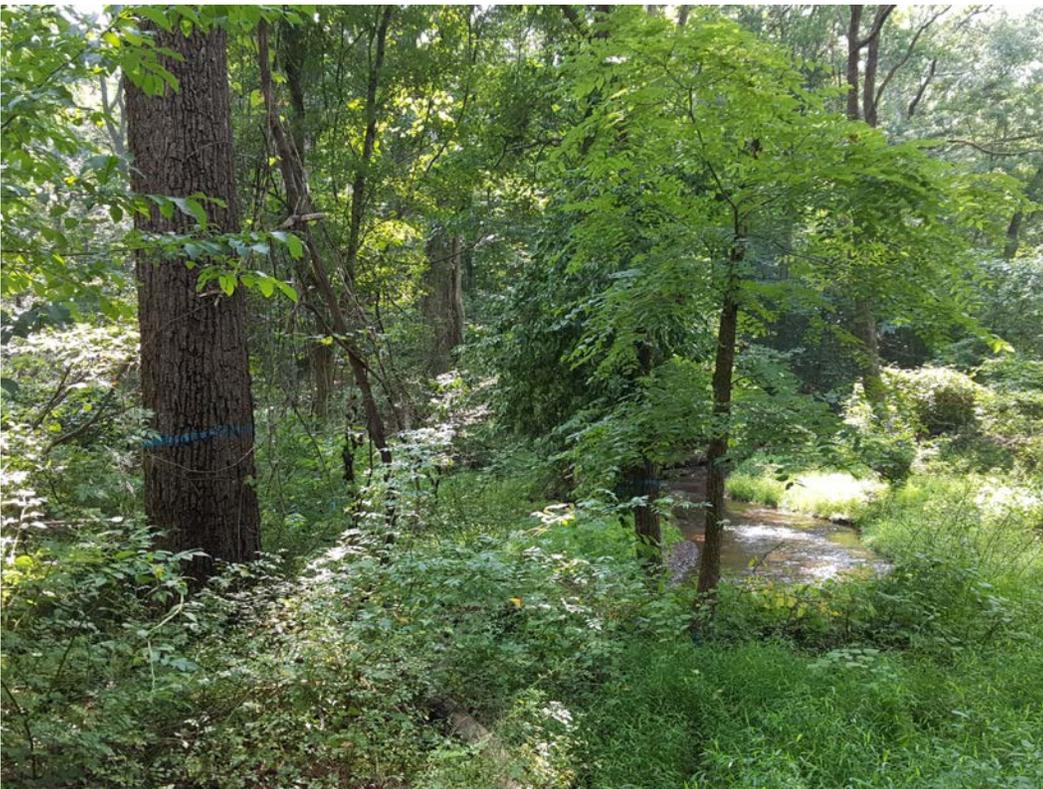
Existing woodland landscape below the former dam. Trees are marked blue that are to be removed.

Element 5 – Forestry Management/Tree Removal – Solebury Township invested in a tree survey and professional forester assessment of the conditions of the mature forest canopy in Aquetong Spring Park. Shultz Forest Management & Consulting completed a report that recommended removal of over 1000 trees

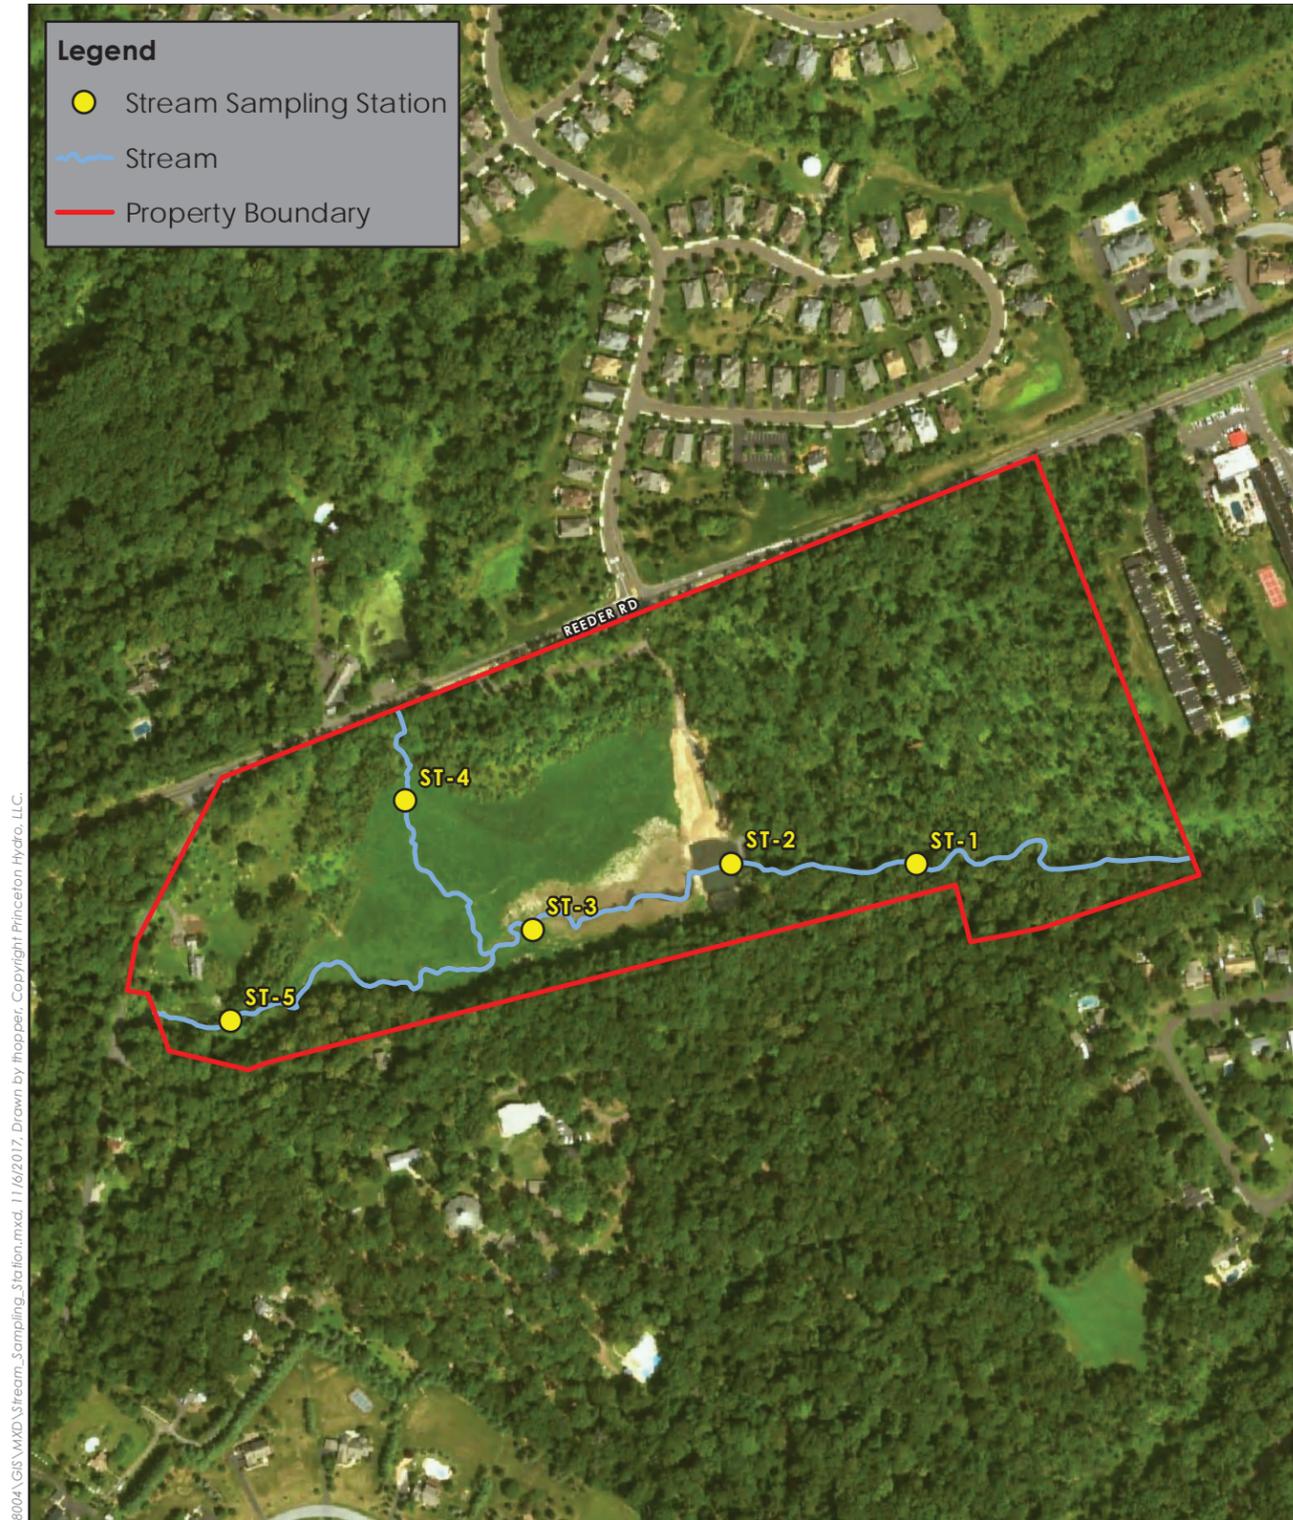
**STREAM SAMPLING
STATION MAP**
 AQUETONG SPRING PARK
 SOLEBURY TOWNSHIP
 BUCKS COUNTY, PENNSYLVANIA

NOTES:
 1. Stream sampling station locations are approximate.
 2. 2015 orthomagey obtained from the United States Department of Agriculture's (USDA), National Agriculture Imagery Program (NAIP).
 0 200 400 Feet
 Map Projection: NAD 1983 StatePlane Pennsylvania South FIPS 3702 Feet

- Scientific monitoring of the legacy alluvial soils of the lake bed, as the new stream channel establishes itself;
- Professional water quality monitoring (benthic, pH, temperature) at five stations on site;
- Removal of invasive plant species in former lake bed alluvial soils, and site monitoring of conditions;
- Mitigation planting of canopy trees in the former lake bed areas;
- Professional tree survey of the ASP site, and strategy for over 1000 afflicted walnut and ash species to be removed.

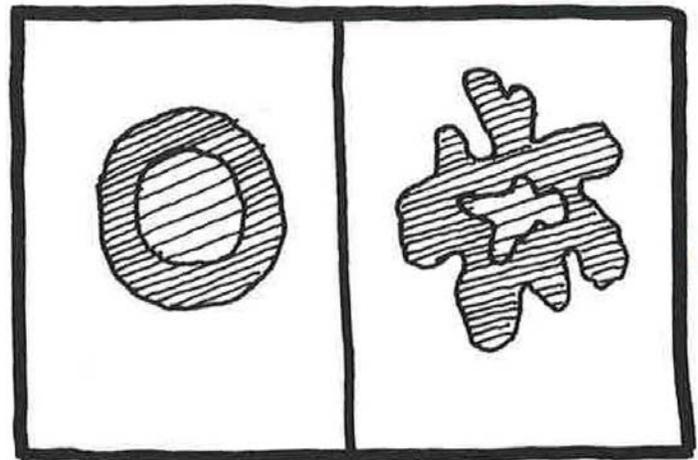
Figure A. Edge and interior - Reduced edges increase beneficial interior spaces for specialized species.

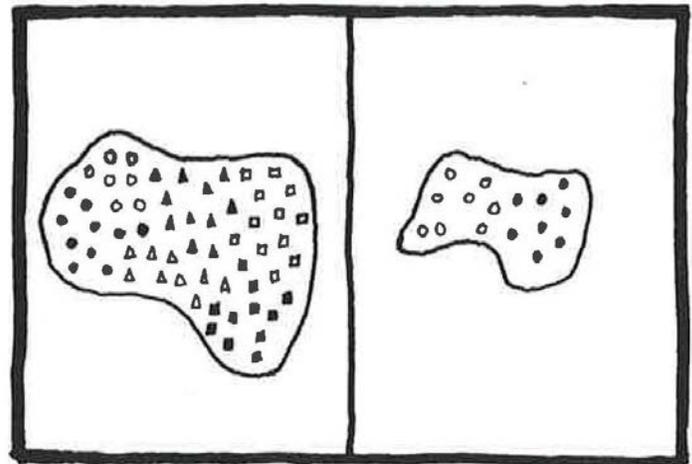
Figure B. Habitat diversity - Larger patches of habitat supports more diversity, creating a more resilient ecosystem.

- Habitat Diversity – A large patch of habitat is more likely to contain a greater number of species with greater population, therefore creating a more healthy and resilient ecosystem. (Figure B)

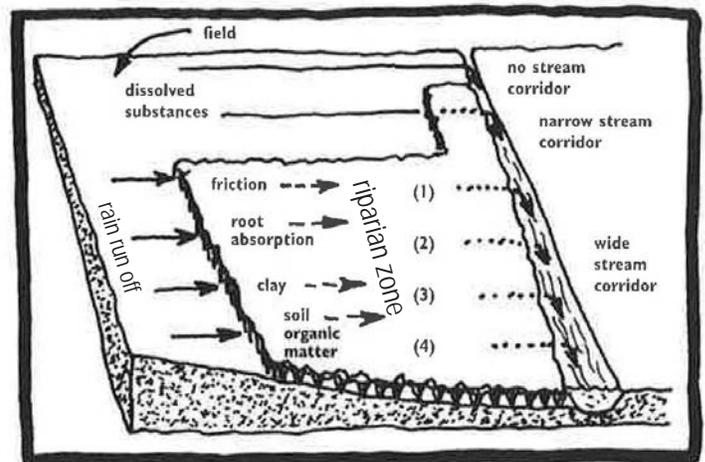
Figure C. Stream corridor and dissolved substances

organic matter, clay, and root systems absorb or hold dissolved substances, such as nitrogen, phosphorus, and toxin, and inhibit such substance from entering the stream and negatively affecting water quality. Healthy riparian vegetation will also slow water velocity and help minimize soil erosion. Reducing vegetative gaps within the riparian ecosystem is essential to support optimum aquatic habitat conditions such as preferred water temperature and oxygen content. (Figure C)

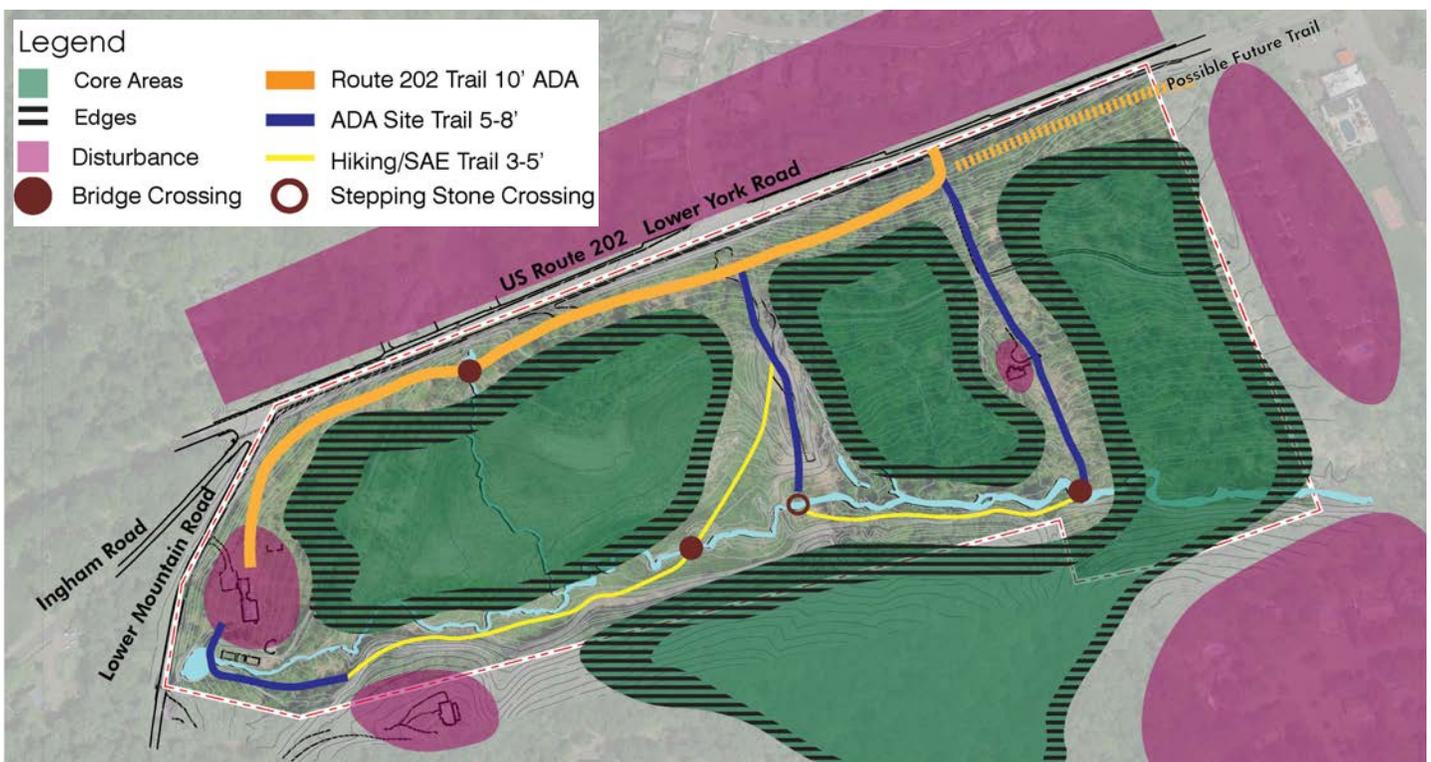
Concept plan proposed in 08/2018 showing increased areas of Core Habitat.

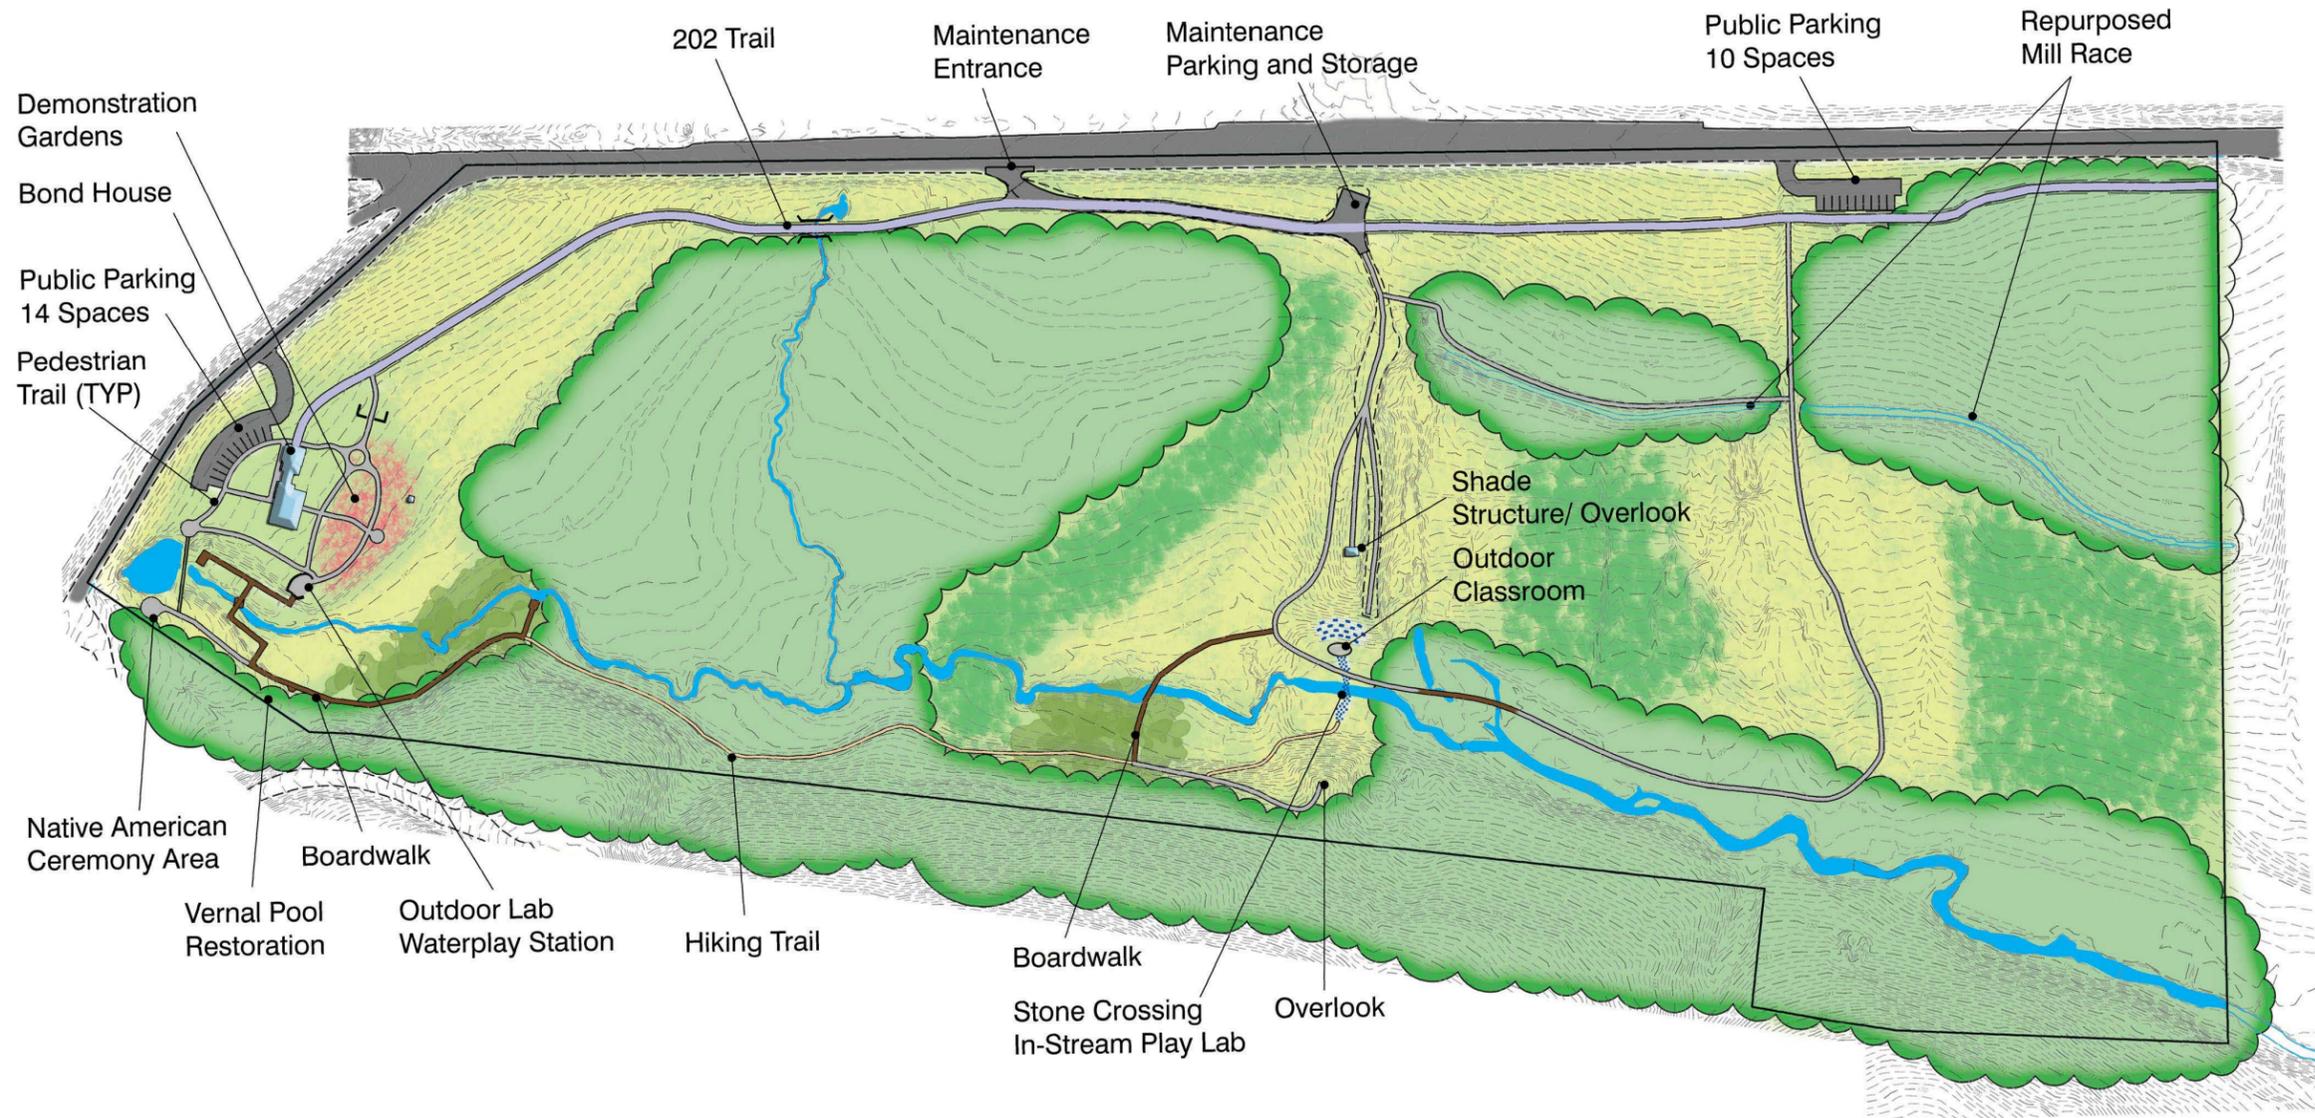
AQUETONG SPRING PARK CONCEPT SITE PLAN

The concept site plan for the Aquetong Spring Park reflects the general locations of Phase 1 as a guide for designing future Park improvements. This concept is described through the 3 strategic zones. Zone 1 – Heritage Landscape - includes parking and trailhead services. The Bond (Judy) House is identified as a

ADA-accessible paths from Zone 1 into Zone 2 will enable access to key locations to observe views into the large former lakebed habitat core area and restored stream in Zone 2. A "loop" walking trail network is suggested through Zone 2 to link to walking trails in Zone 3. The former dam area is recommended to provide programming opportunities, including an outdoor classroom, interpretive overlook, and a "stepping stone" crossing of Aquetong Creek that may also serve as an in-stream play lab. The multi-modal Route 202 trail will run along US Route 202 through all three zones and be the only trail within the ASP site to serve bicycle use. Possible future parking and a Route 202 trail extension eastward to the property line is proposed in zone 3.

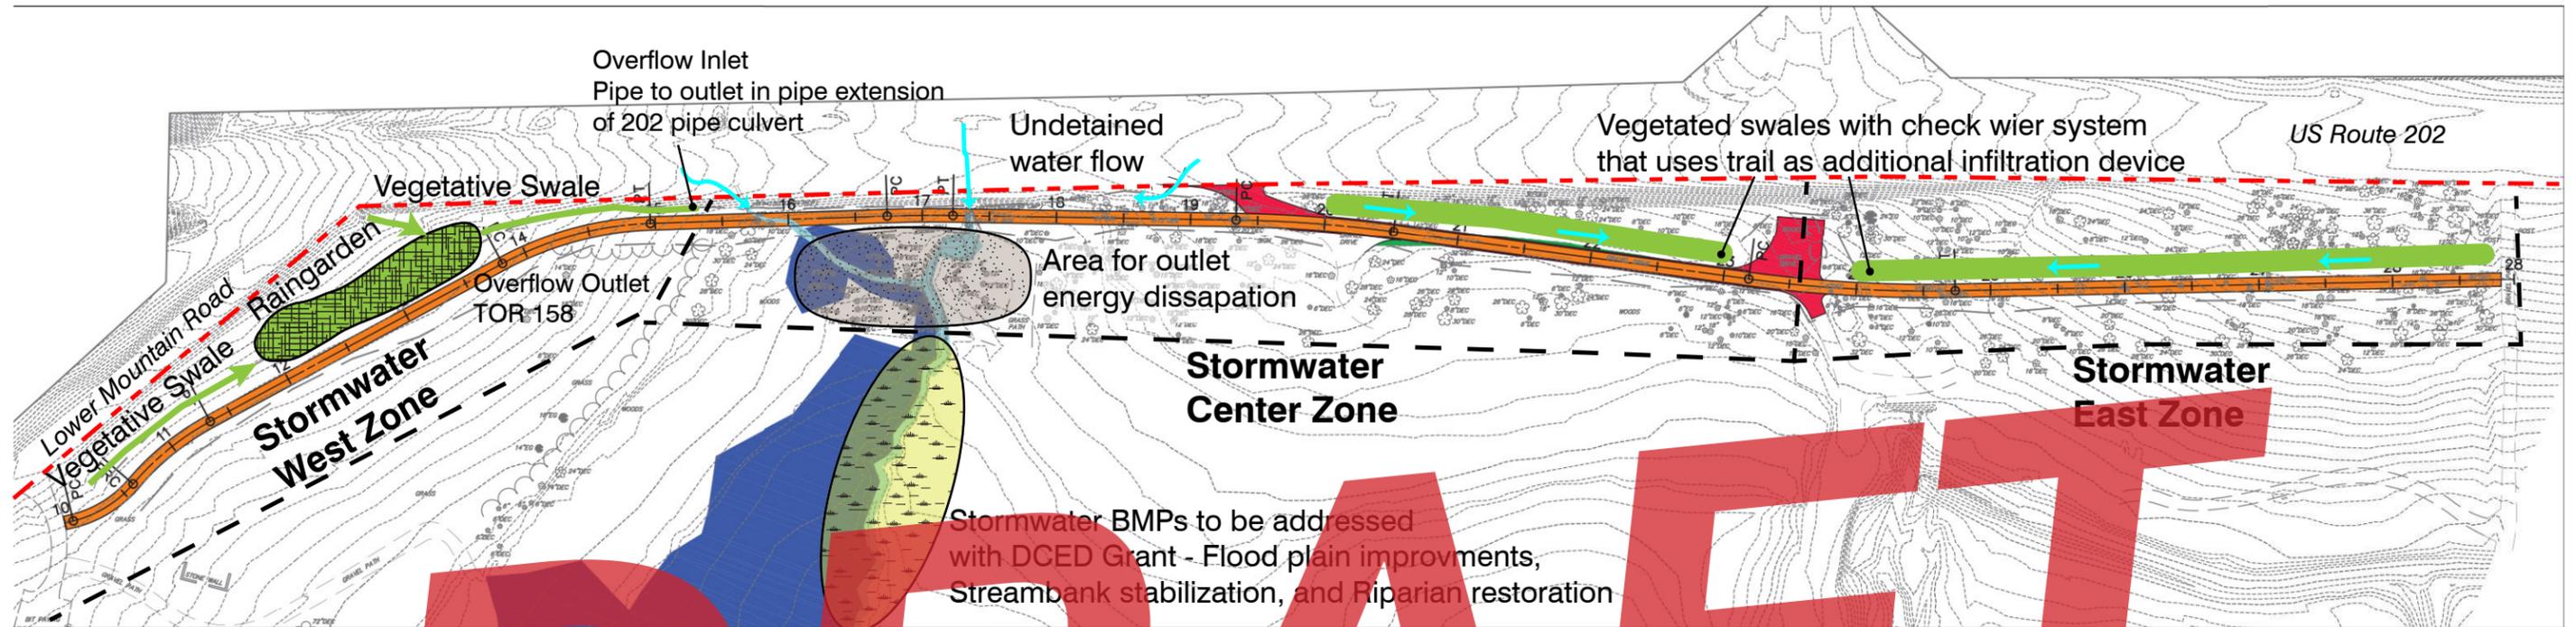
- 10' MULTI-USE TRAIL
- PAVED TRAIL SHOULDER/DRIVEWAY AREA
- EXISTING GRAVEL DRIVEWAY TO BE REMOVED
- SURVEYED WETLAND AREA
- SURVEYED STREAM AREA
- APPROXIMATE LIMIT OF DISTURBANCE

Element 2 – Route 202, 9/11 National Memorial Trail Segment – PennDOT and Delaware Valley Regional Planning Commission selected the 2017 Solebury application for Federal Highway Administration “Transportation Alternatives” (TA) funds, and both agencies will administer the \$1M grant to construct a section of the Route 202 Cross-County Trail along the perimeter of the ASP site. Following Solebury Supervisor’s endorsement to join the 9/11 National Memorial Trail program, building this segment grows Solebury Township’s link to the envisioned 1,300 mile regional memorial trail. The design of the trail segment within the Park will include stormwater management facilities to intercept and treat runoff from Route 202.
