AQUETONG CREEK RESTORATION PROJECT 2023 MONITORING REPORT

SOLEBURY TOWNSHIP, BUCKS COUNTY, PENNSYLVANIA

NOVEMBER 2023

PRINCETON HYDRO, LLC
35 CLARK STREET
P.O. BOX 3689
TRENTON, NEW JERSEY 08611
908-237-5660

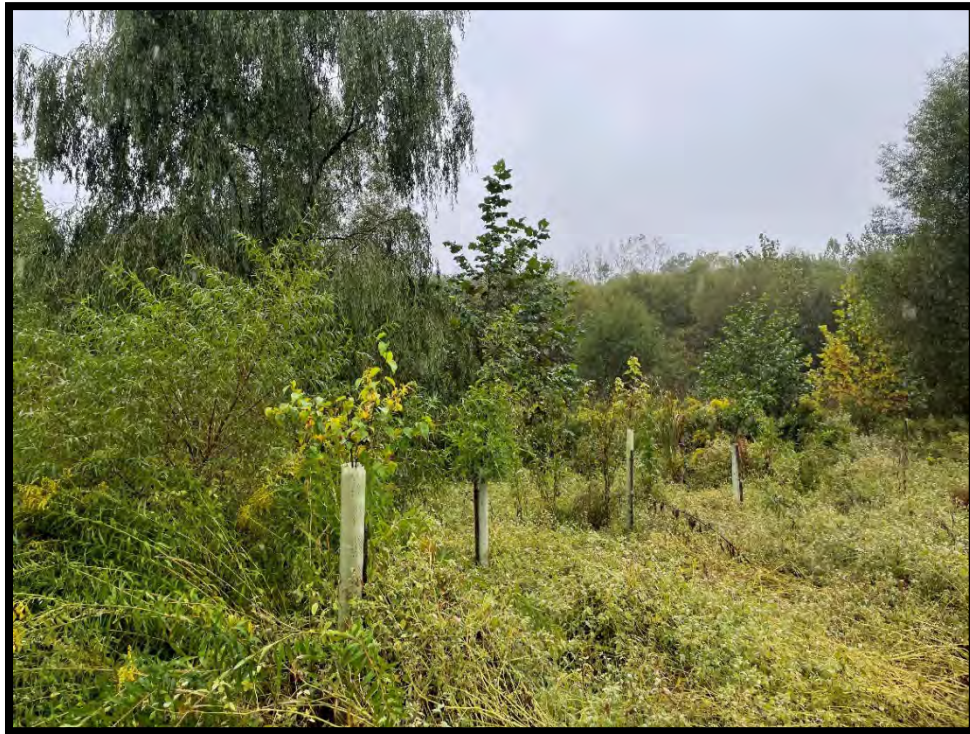
Figure 3. View of healthy installed woody species amidst a robust herbaceous stratum within the wetland enhancement area.

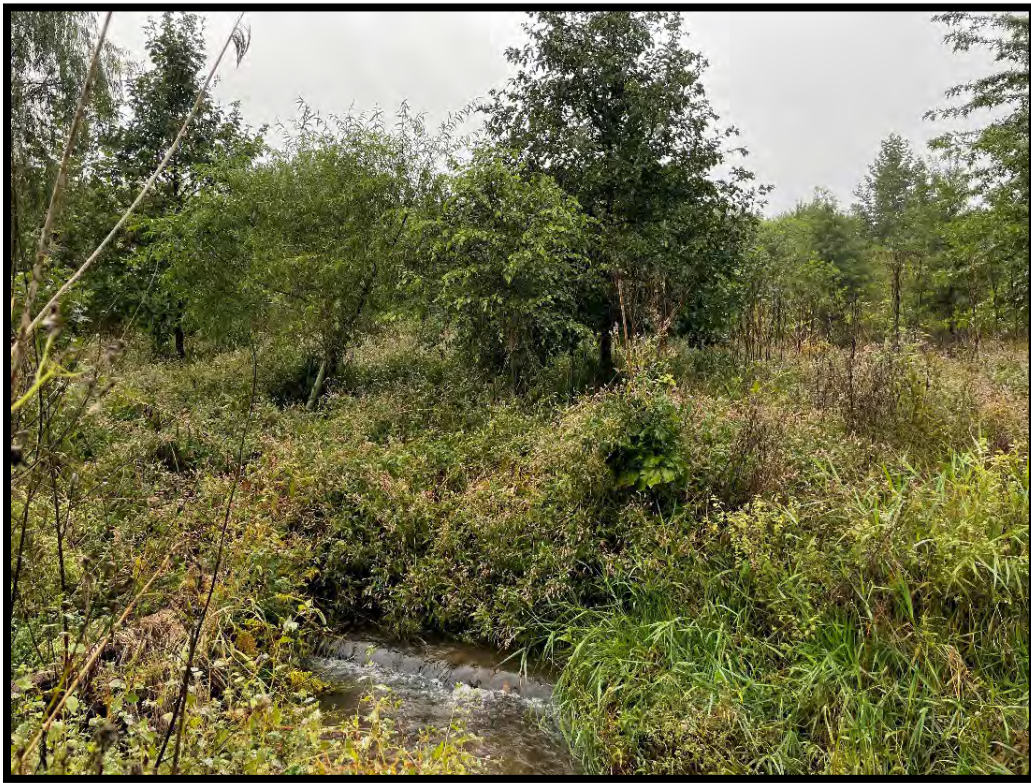
Figure 4. View of Aquetong Creek's banks that support well-established hydrophytic vegetation.

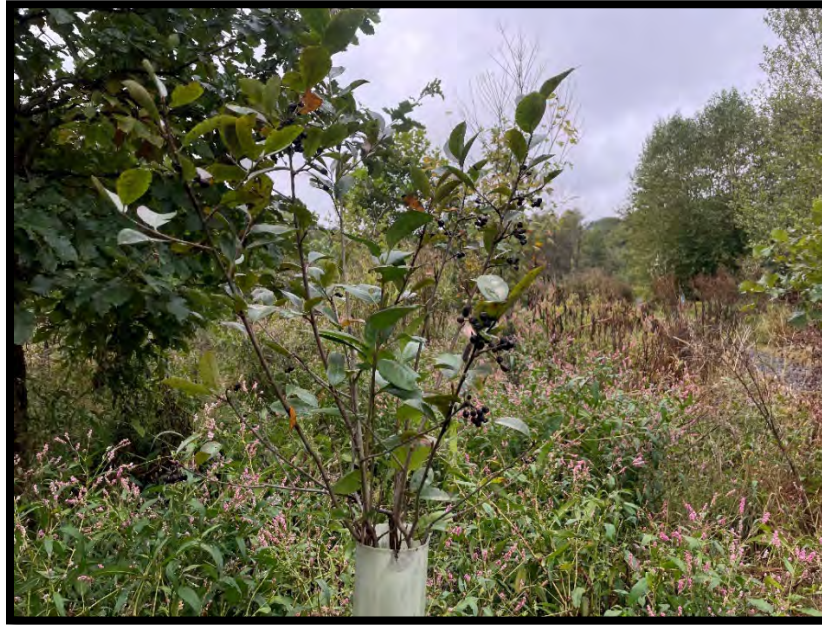
Figure 5. A healthy installed red chokecherry (*Aronia arbutifolia*, FACW).

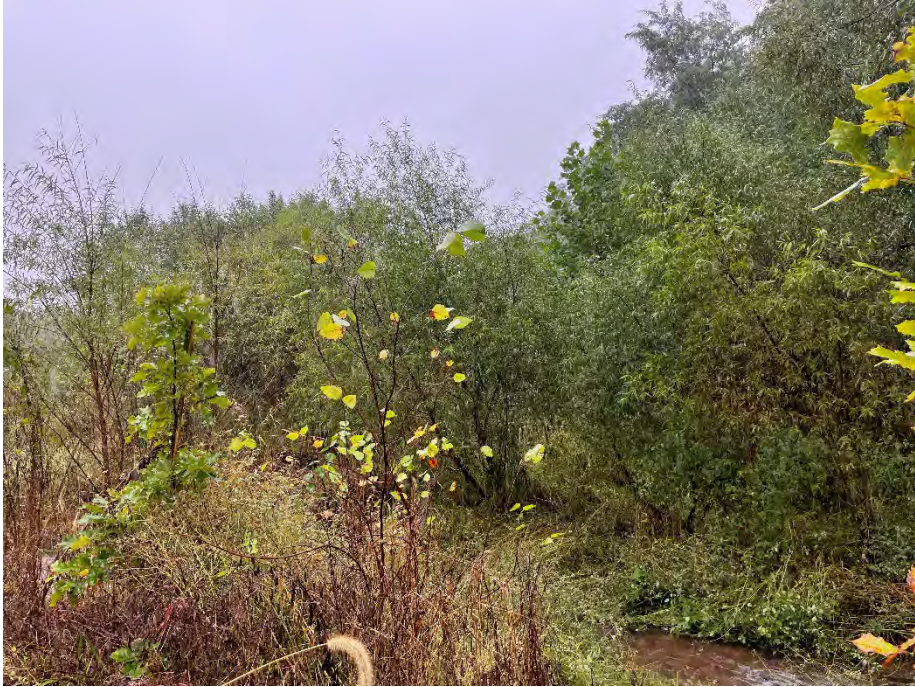
<p>Client: Solebury Township Site Name: Aquetong Spring Park Restoration Project</p>		<p>Project Number: 0388.011 Site Location: Solebury Township, PA</p>	
<p>Photograph ID: 3</p>

<p>Date: Sept. 29, 2023</p>			
<p>Location: See photo location map.</p>			
<p>Direction: East</p>			
<p>Comments: View of the wetland enhancement area along the north bank of Aquetong Creek featuring well-established installed woody species including river birch, black willow, and swamp white oak (<i>Quercus palustris</i>).</p>			
<p>Photograph ID: 4</p>	 		
<p>Date: Sept. 29, 2023</p>			
<p>Location: See photo location map.</p>			
<p>Direction: East</p>			
<p>Comments: View of Aquetong Creek flowing through the wetland creation area featuring a robust herbaceous stratum and healthy installed woody species such as swamp white oak (left) and black willow (right).</p>

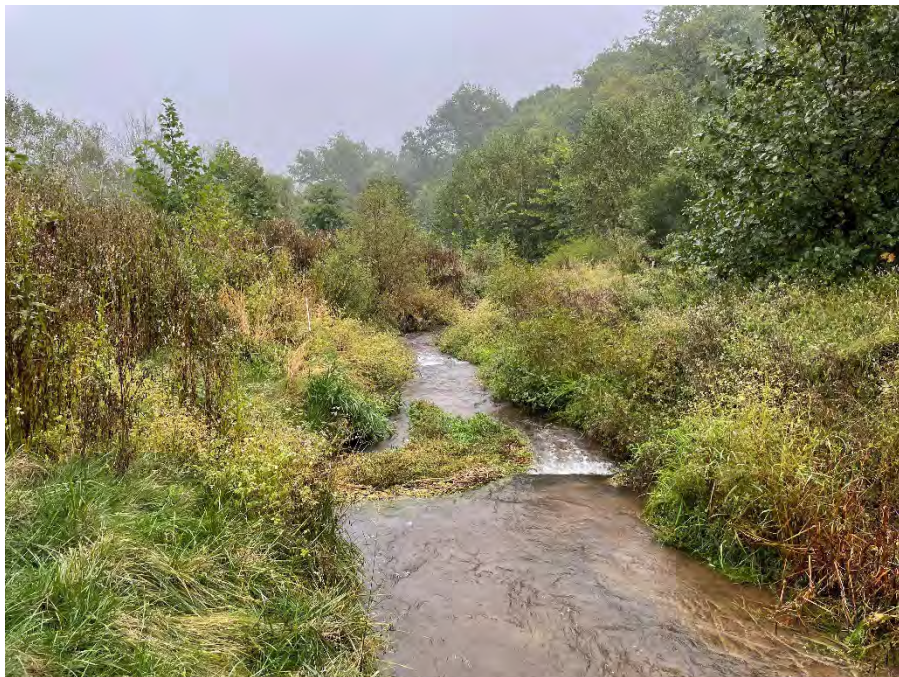
<p>Date: Sept. 29, 2023</p>	
<p>Location: See photo location map.</p>	
<p>Direction: East</p>	
<p>Comments: Typical view of Aquetong Creek and its banks that are well-established with a robust herbaceous plant community.</p>

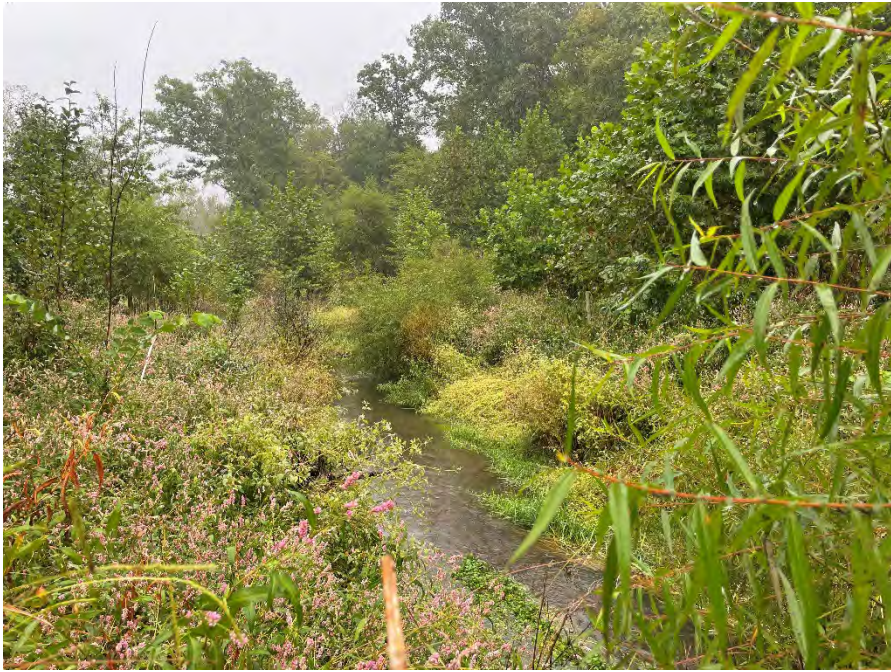
<p>Client: Solebury Township Site Name: Aquetong Spring Park Restoration Project</p>		<p>Project Number: 0388.011 Site Location: Solebury Township, PA</p>	
<p>Photograph ID: 11</p>

<p>Date: Sept. 29, 2023</p>			
<p>Location: See photo location map.</p>			
<p>Direction: East</p>			
<p>Comments: General view of the diverse and well-established herbaceous layer within the wetland enhancement area along Aquetong Creek featuring a black willow live stake (right).</p>			
<p>Photograph ID: 12</p>

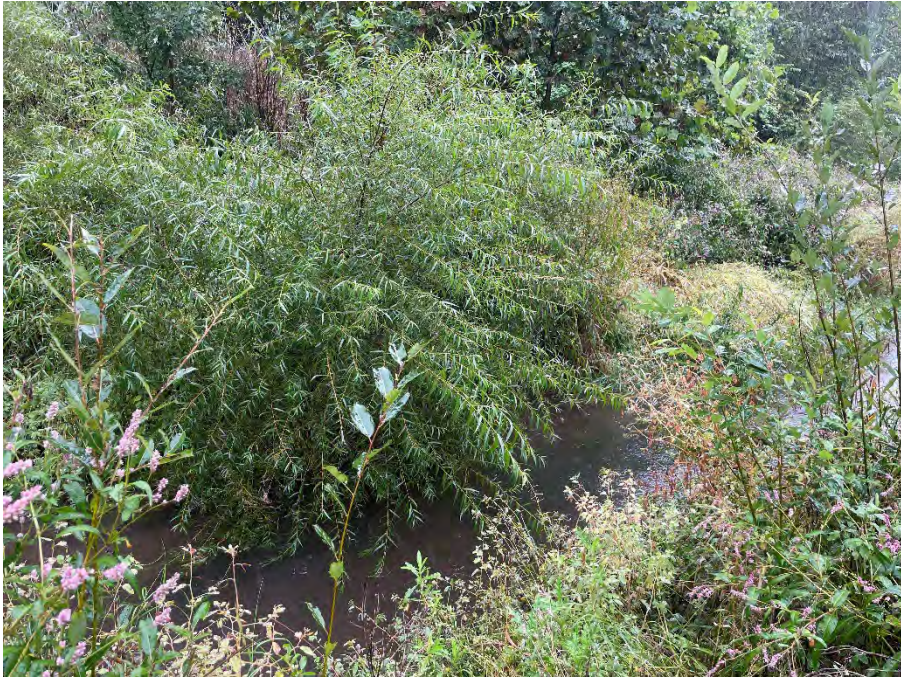
<p>Date: Sept. 29, 2023</p>			
<p>Location: See photo location map.</p>			
<p>Direction: South</p>			
<p>Comments: View of the live stakes that have established well along the banks of Aquetong Creek including pussy willow (<i>Salix discolor</i>) and black willow.</p>

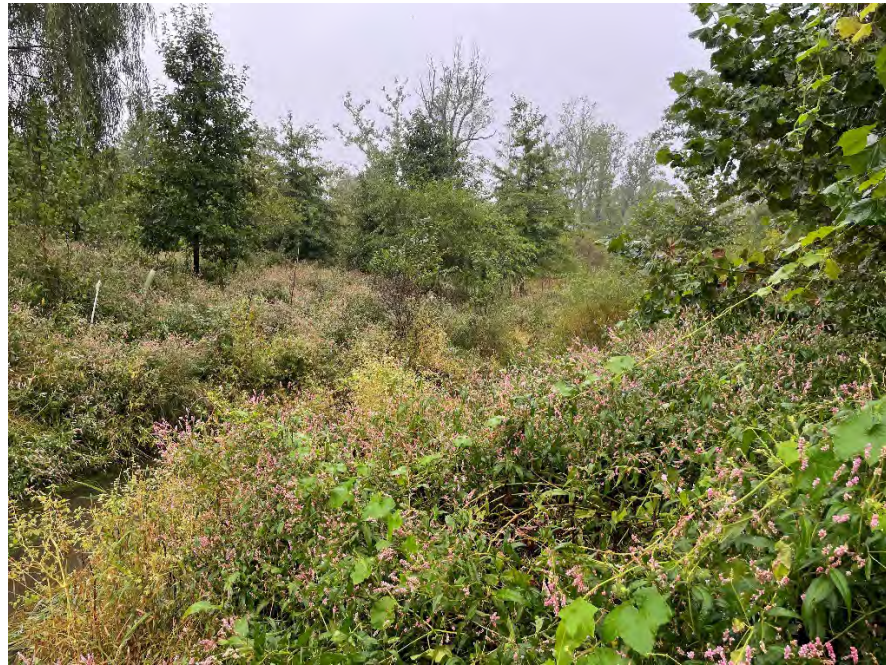
Photograph ID: 13
Date: Sept. 29, 2023
Location: See photo location map.
Direction: Northeast

Comments: Typical view of the well-established herbaceous layer within the wetland enhancement area along the south bank of Aquetong Creek.

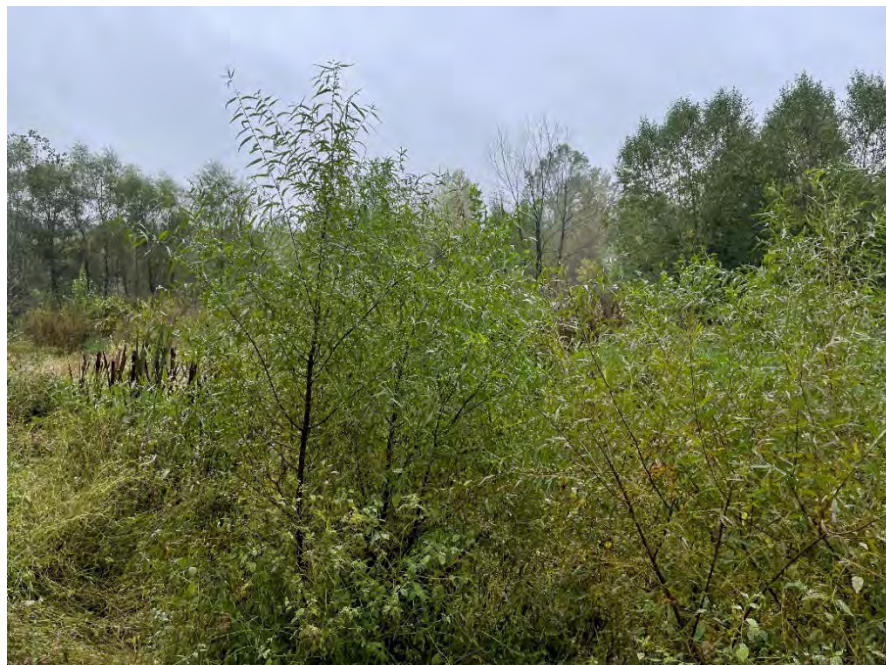
Photograph ID: 14
Date: Sept. 29, 2023
Location: See photo location map.
Direction: Northwest

Comments: General view of several healthy black willow live stakes along the south bank of Aquetong Creek.

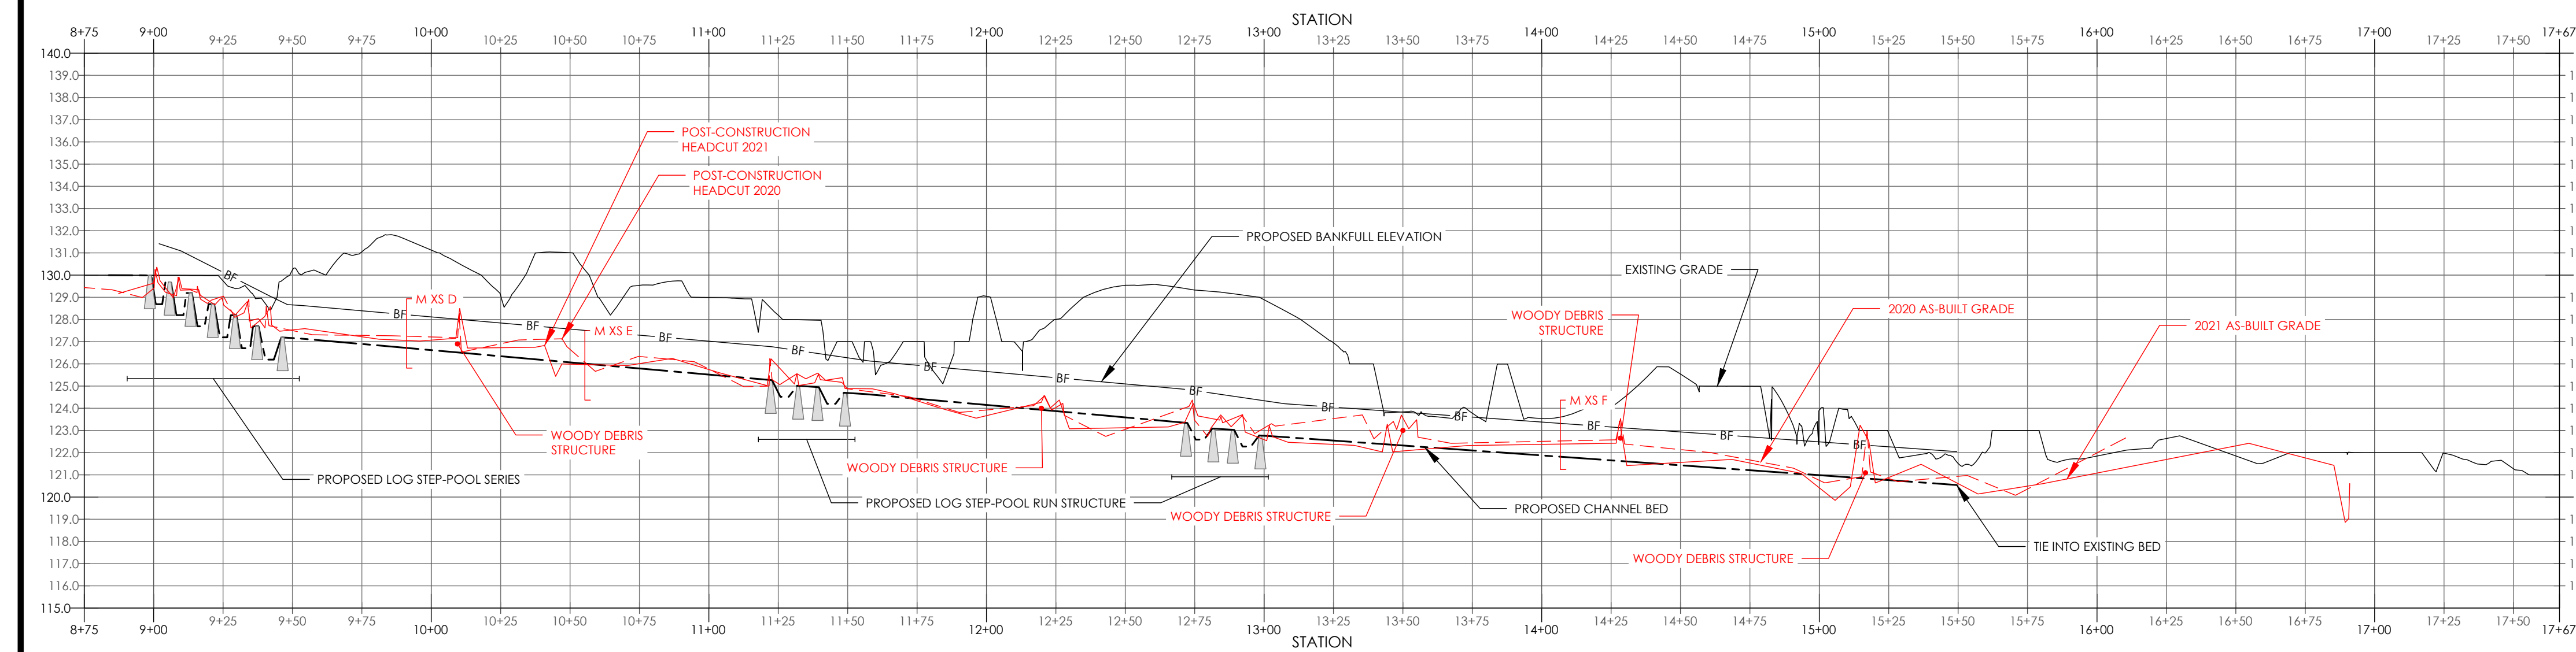
B PROPOSED PROFILE - MAIN CHANNEL - DOWNSTREAM
HORIZONTAL SCALE: 1" = 40'
VERTICAL SCALE: 1" = 5' (8X VERT. EX.)

- NOTES:
- ACTIVE EROSION IS OCCURRING THROUGHOUT THE REACH OF AQUETONG CREEK UPSTREAM OF STATION 08+75, HOWEVER NO TREATMENT OR ACTIVE RESTORATION IS CURRENTLY PROPOSED. IF TREATMENT IS NEEDED IN THE FUTURE, IT SHALL BE COMPLETED UNDER SEPARATE COVER.
 - THE DRAINAGE SWALE SHALL BE STABILIZED USING STEP POOLS CONSTRUCTED FROM EXCESS LOGS AND ROCKS. THESE STEP POOLS SHALL BE FIELD FIT BASED ON THE FIELD CONDITIONS AT THE TIME OF CONSTRUCTION AND AS DIRECTED BY ONSITE ENGINEER. THE STEP POOLS SHALL BE CONSTRUCTED IN ACCORDANCE WITH DETAIL A ON SHEET 7 OF 15.
 - THE TWO CULVERTS UNDER ROUTE 202 DRAINING INTO THE 202 STORMWATER TRIBUTARY SHALL BE STABILIZED UNDER A SEPARATE CONTRACT.
