AQUETONG CREEK RESTORATION PROJECT

2025 MONITORING REPORT

SOLEBURY TOWNSHIP, BUCKS COUNTY, PENNSYLVANIA

NOVEMBER 2025

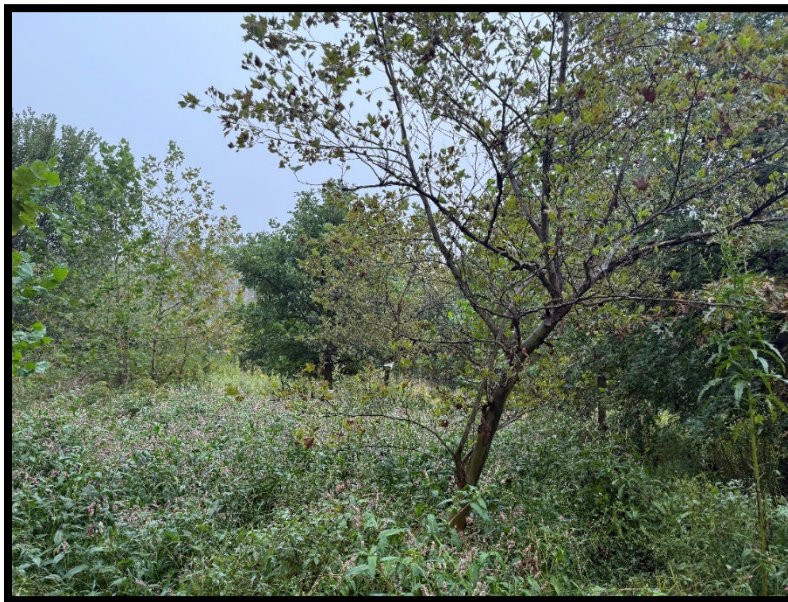
Figure 3. View of healthy installed woody species amidst a robust herbaceous stratum within the wetland enhancement area.

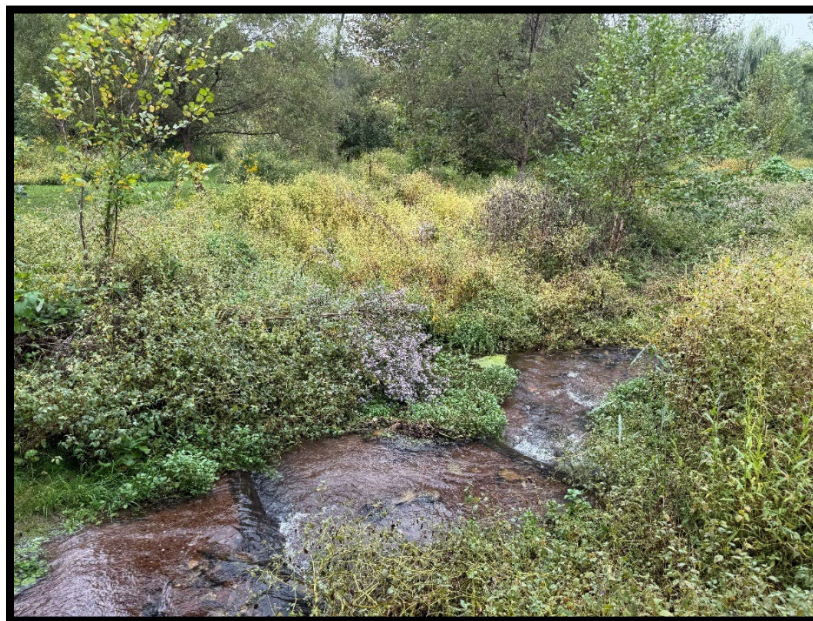
Figure 4. View of Aquetong Creek's banks that support well-established hydrophytic vegetation.

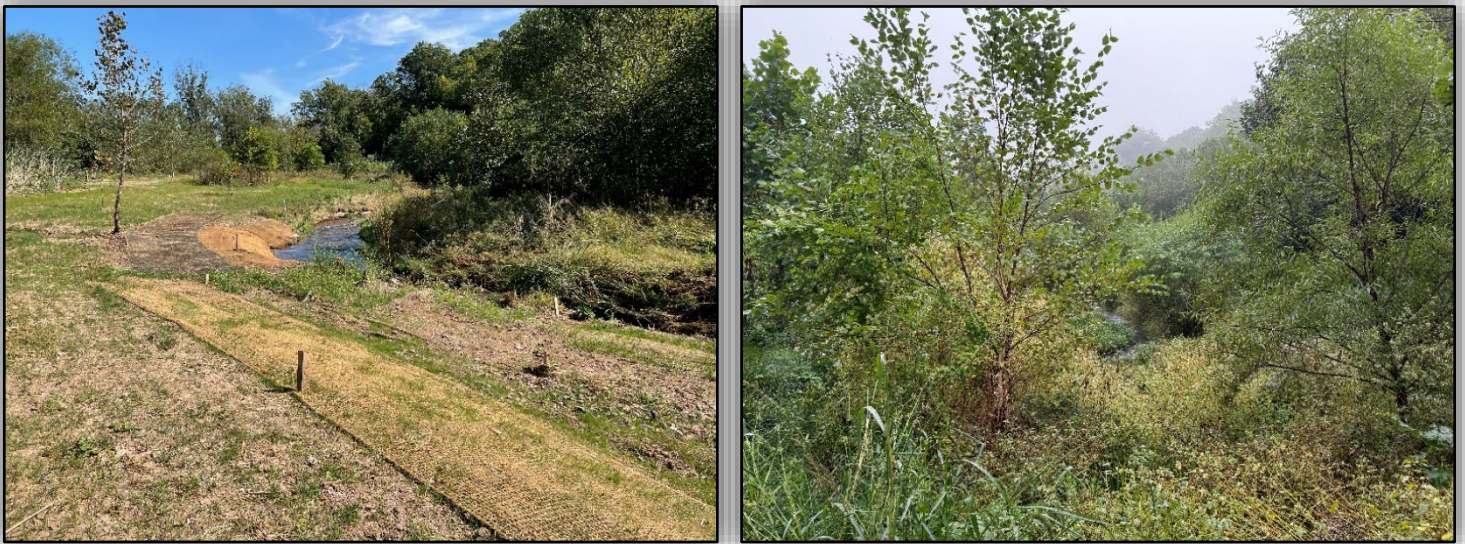
Four (4) quadrats were established in representative locations throughout the wetland creation area. **As shown in Table 5, the results of the 2025 monitoring inspection indicate that the wetland creation area possessed 100% mean vegetative cover, which exceeds the 85% vegetative cover threshold stipulated by the PADEP. The total vegetative cover was estimated to be 155.3%, which illustrates that a complex heterogeneous community has been established within the wetland creation area.** The high total percent cover observed in 2025 supports the position that the Restoration Project continues on a positive developmental trajectory while also developing increased structural heterogeneity, as depicted between Fall 2021 (left) and Fall 2025 (right).

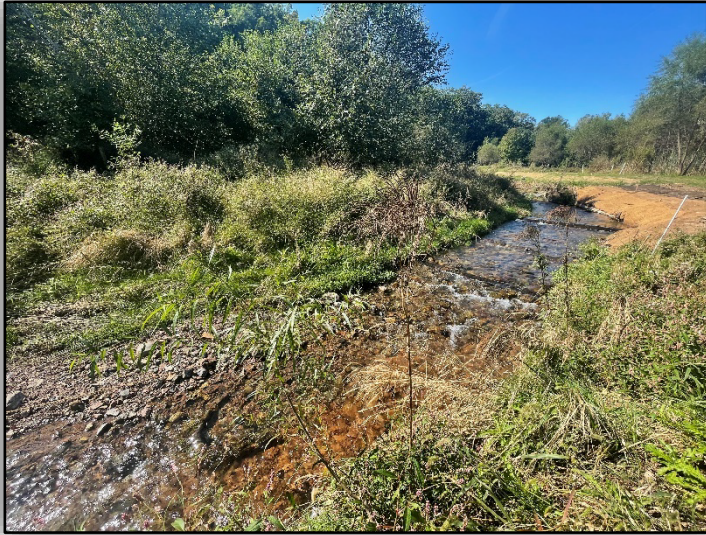
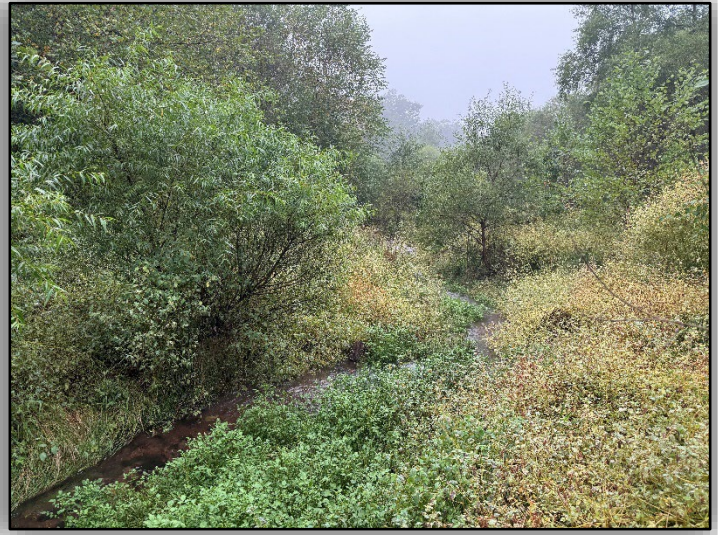
No barren ground was observed, and all plots were well-established with a diverse native herbaceous plant community. The species richness decreased slightly in 2025 ($n = 16$) from 2024 ($n = 17$). Although the total number of plant species (n) slightly decreased in 2025, non-native species, such as common reed, which was present in prior years, were absent from the monitoring plots within the wetland enhancement area. As compared to Fall 2021 (left), the native herbaceous and woody species proliferated within the wetland enhancement areas by Fall 2025 (right).

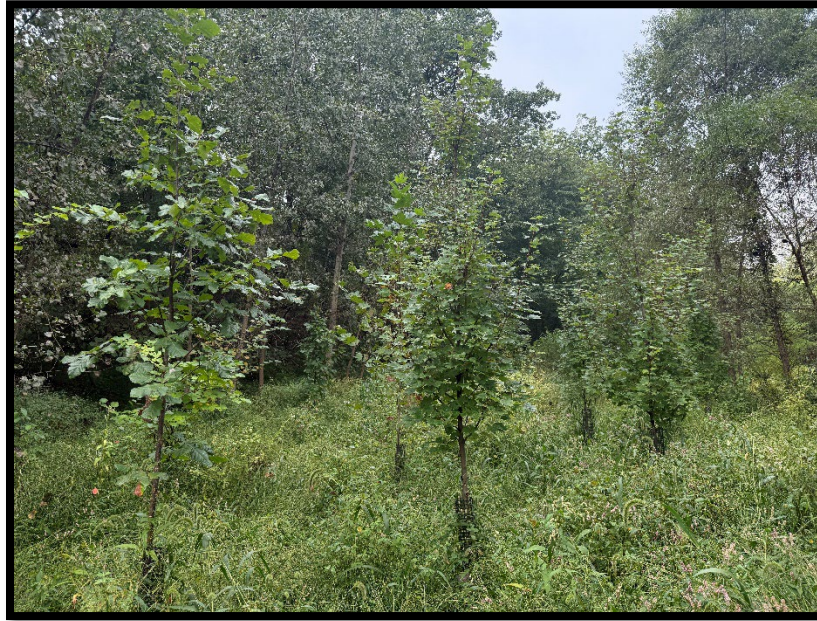
Figure 5. General view of the newly installed healthy native trees within the wetland restoration areas on-site.

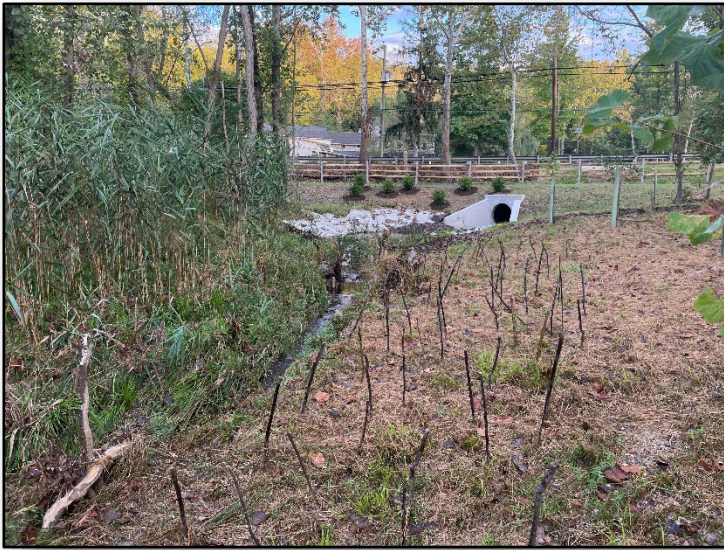
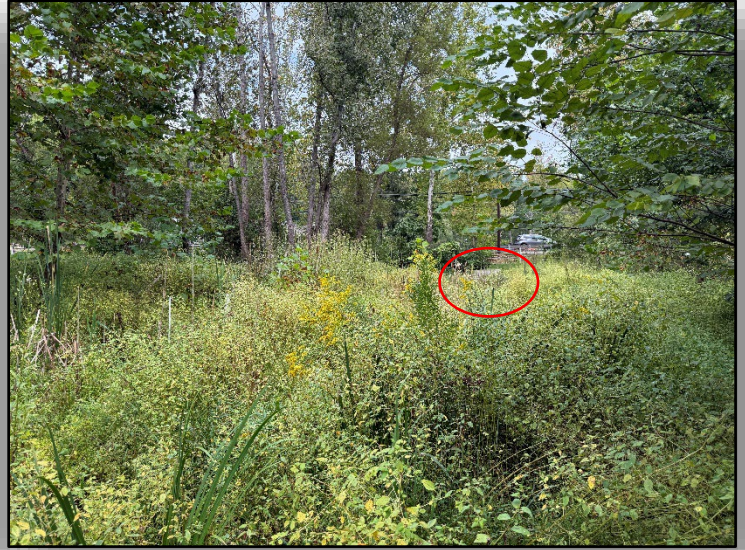
In 2025, portions of the Restoration Project possessed undesirable non-native species such as common reed, Nepalese browntop, Japanese bristlegrass, charlock mustard, Canada thistle, and purple loosestrife; however, the extent of undesirable and non-native plant species has reduced significantly compared to 2021. For example, a common reed monoculture that was predominantly located outside of the wetland restoration area encroached into portions of the enhancement areas along the tributary to Aquetong Creek (left). After numerous treatments and colonization of desirable native hydrophytic plant species, the common reed had diminished completely within this wetland restoration area by Fall 2025 (culvert circled in red; right). Other patches of common reed that were located outside of the monitoring plots, but within the Restoration Project, have decreased significantly in areal cover and, where remaining, possessed signs of stress, including stunted growth.

To address the presence of undesirable non-native species, Princeton Hydro targeted these species with an herbicide application on October 7th, 2025. Additionally, as the installed woody material continues to mature, it is anticipated that the presence of undesirable non-native species will concomitantly reduce in areal coverage as they generally require full sun exposure to proliferate.

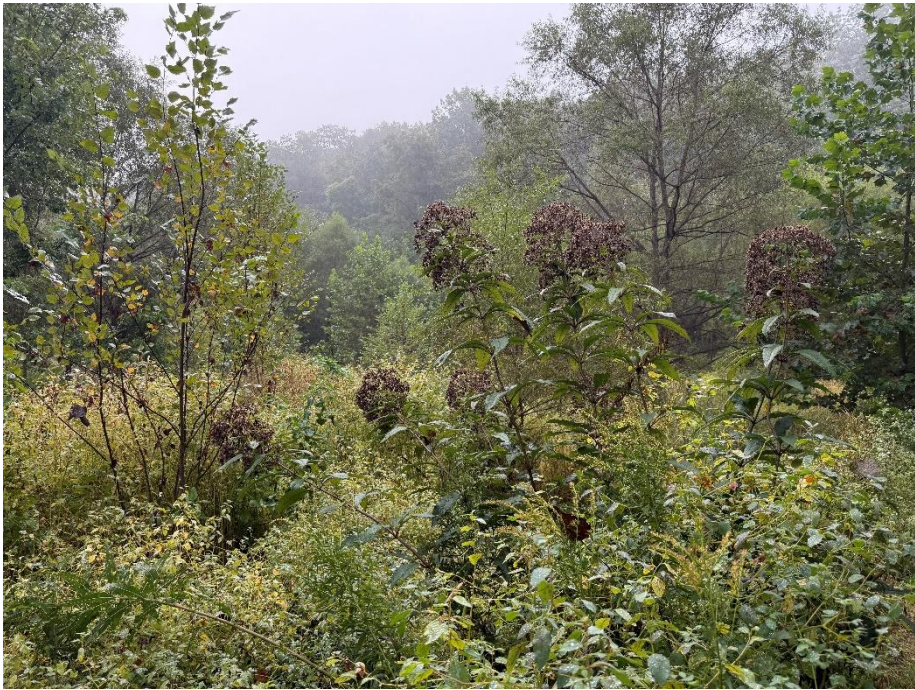
<p>Client: Solebury Township Site Name: Aquetong Spring Park Restoration Project</p>		<p>Project Number: 0388.011 Site Location: Solebury Township, PA</p>	
<p>Photograph ID: 3</p>

<p>Date: Sept. 24, 2025</p>			
<p>Location: See photo location map.</p>			
<p>Direction: East</p>			
<p>Comments: General view of the diverse and well-established herbaceous layer along the banks of the tributary to Aquetong Creek, including sweet-scented joe-pye-weed (<i>Eutrochium purpureum</i>).</p>			
<p>Photograph ID: 4</p>	 		
<p>Date: Sept. 24, 2025</p>			
<p>Location: See photo location map.</p>			
<p>Direction: Southeast</p>			
<p>Comments: General view of healthy and thriving (>5 ft.) installed woody species within the wetland creation area, including river birch (<i>Betula nigra</i>).</p>

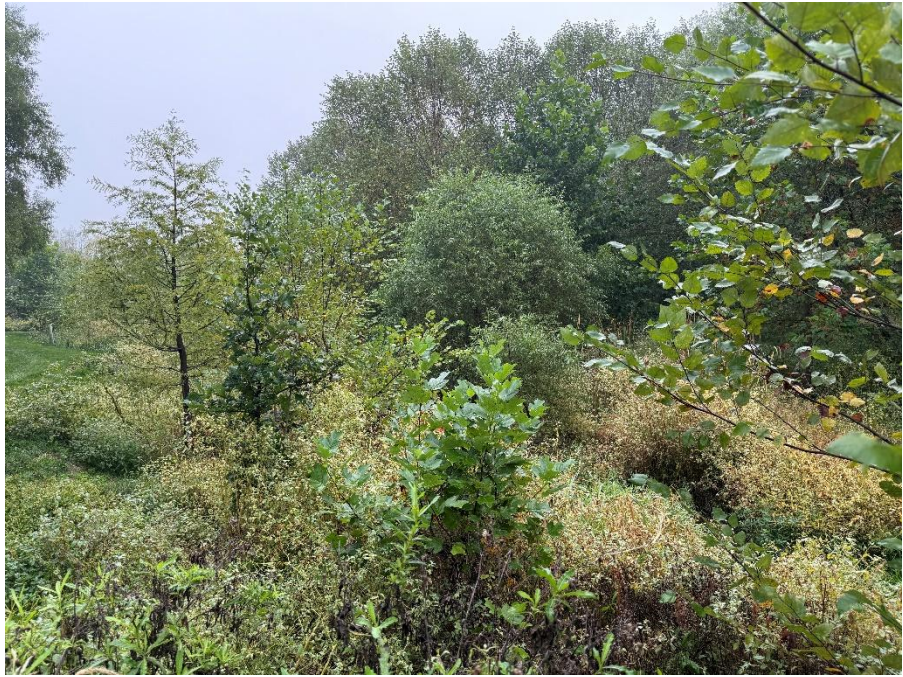
<p>Client: Solebury Township Site Name: Aquetong Spring Park Restoration Project Project Number: 0388.011 Site Location: Solebury Township, PA</p>	
<p>Photograph ID: 5</p>

<p>Date: Sept. 24, 2025</p>	
<p>Location: See photo location map.</p>	
<p>Direction: East</p>	
<p>Comments: General view of healthy and thriving (>5 ft.) installed woody species, including river birch (<i>Betula nigra</i>) within the wetland creation area along Aquetong Creek.</p>	
<p>Photograph ID: 6</p>

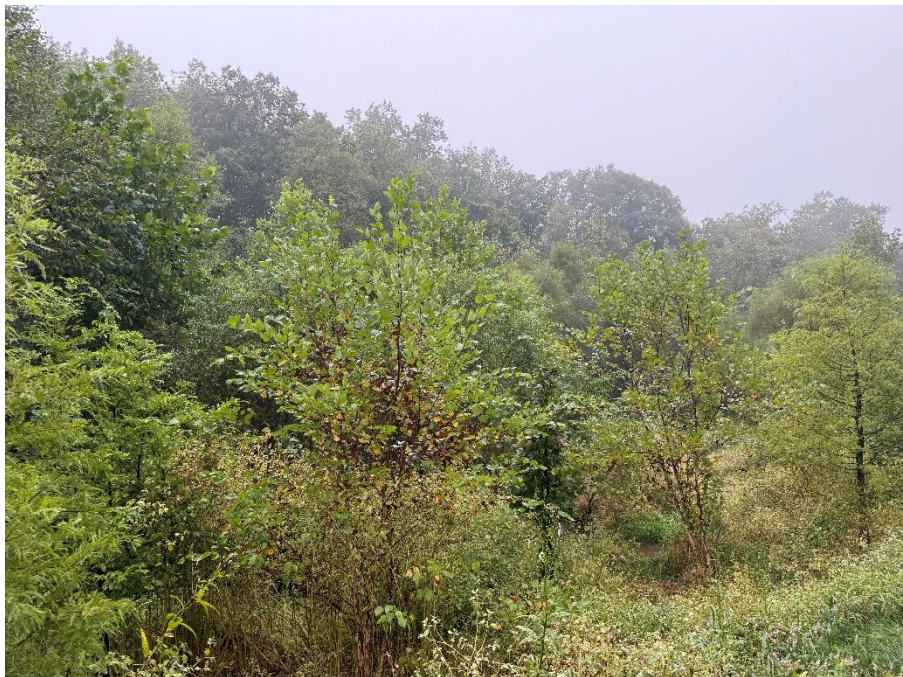
<p>Date: Sept. 24, 2025</p>	
<p>Location: See photo location map.</p>	
<p>Direction: West</p>	
<p>Comments: General view of the diverse and well-established woody and herbaceous layer within the wetland creation area along the north bank of Aquetong Creek.</p>

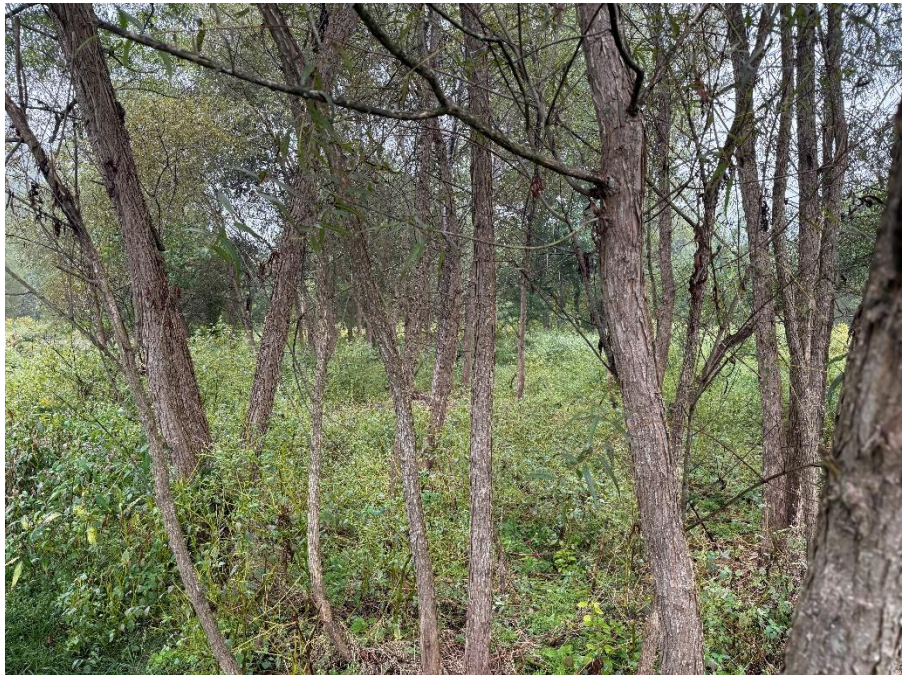
<p>Date: Sept. 24, 2025</p>	
<p>Location: See photo location map.</p>	
<p>Direction: West</p>	
<p>Comments: View of thriving black willows within the wetland enhancement area on the northern bank of Aquetong Creek.</p>

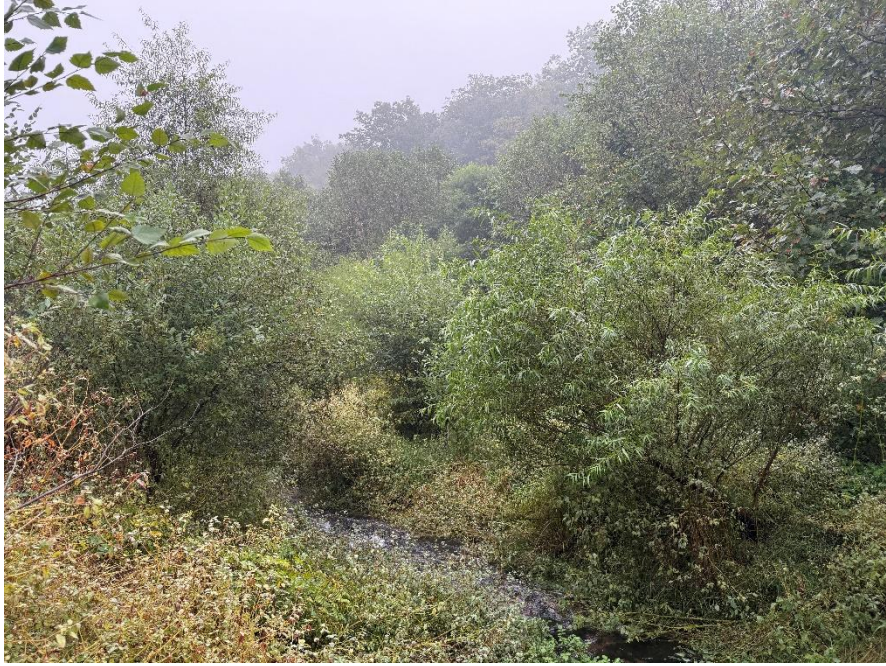
<p>Client: Solebury Township Site Name: Aquetong Spring Park Restoration Project</p>		<p>Project Number: 0388.011 Site Location: Solebury Township, PA</p>	
<p>Photograph ID: 9</p>

<p>Date: Sept. 24, 2025</p>			
<p>Location: See photo location map.</p>			
<p>Direction: East</p>			
<p>Comments: View of the wetland enhancement area featuring a robust herbaceous stratum and healthy woody species.</p>			
<p>Photograph ID: 10</p>	 		
<p>Date: Sept. 24, 2025</p>			
<p>Location: See photo location map.</p>			
<p>Direction: East</p>			
<p>Comments: General view of the diverse and well-established vegetation within the wetland enhancement area along Aquetong Creek.</p>

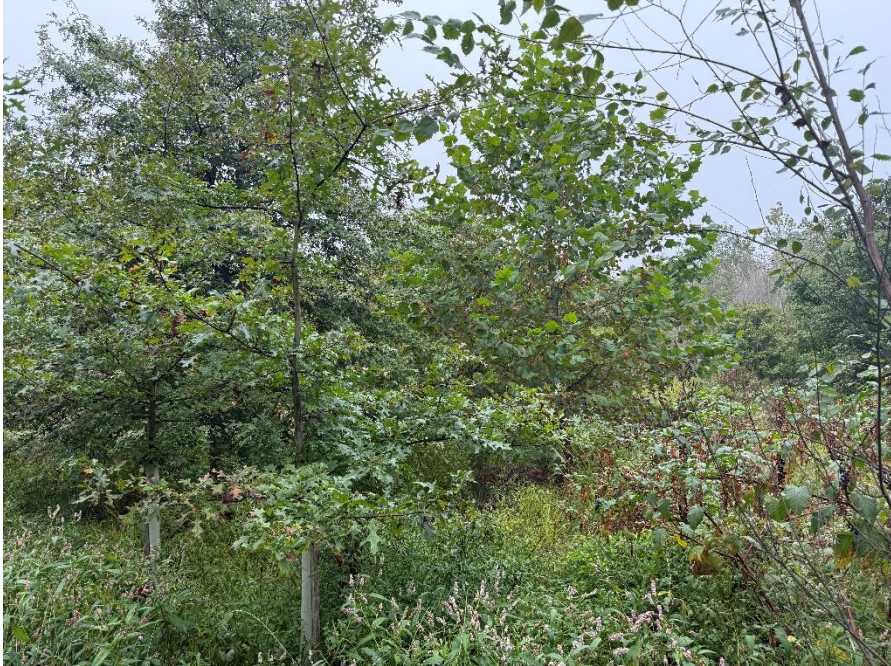
<p>Client: Solebury Township Site Name: Aquetong Spring Park Restoration Project</p>		<p>Project Number: 0388.011 Site Location: Solebury Township, PA</p>	
<p>Photograph ID: 11</p>

<p>Date: Sept. 24, 2025</p>			
<p>Location: See photo location map.</p>			
<p>Direction: East</p>			
<p>Comments: General view of the diverse and well-established vegetation within the wetland enhancement area along Aquetong Creek.</p>			
<p>Photograph ID: 12</p>	 		
<p>Date: Sept. 24, 2025</p>			
<p>Location: See photo location map.</p>			
<p>Direction: East</p>			
<p>Comments: Typical view of Aquetong Creek and its banks that are well-established with a robust herbaceous plant community and healthy and thriving woody plant material.</p>

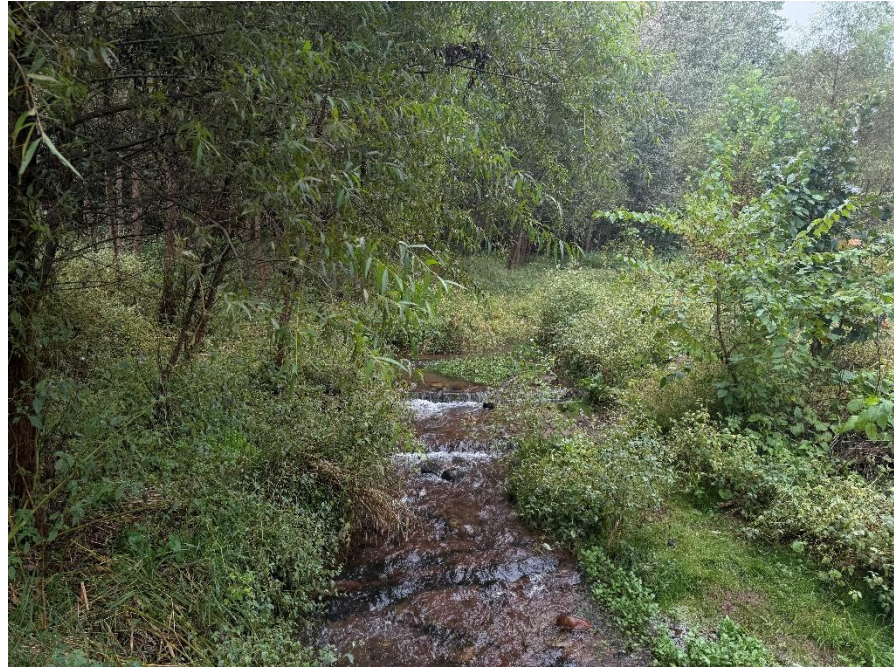
Comments: Typical view of Aquetong Creek and its banks that are well-established with a robust herbaceous plant community and healthy and thriving woody plant material.

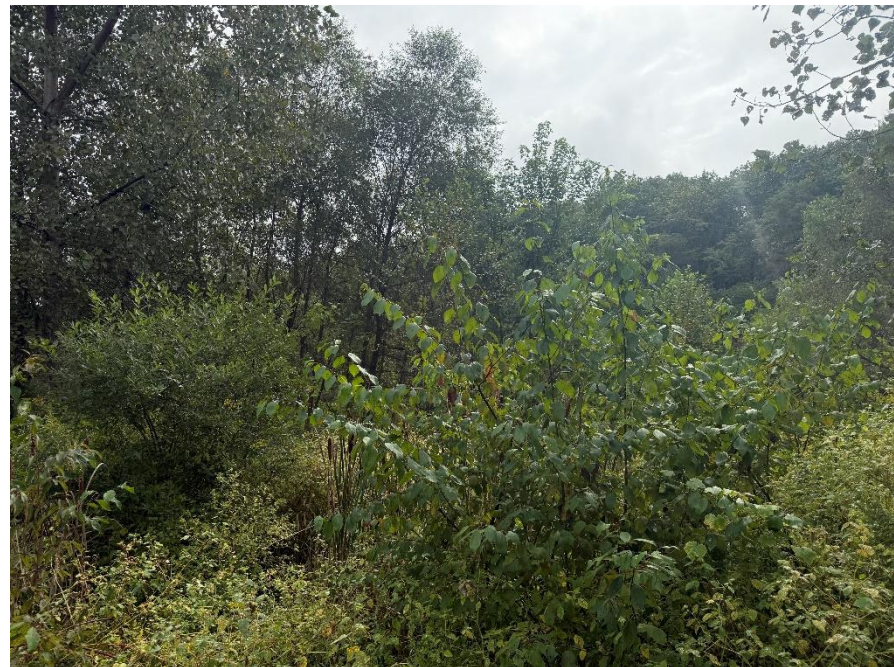
Photograph ID: 14

Comments: View of the well-established hydrophytic herbaceous and woody plants along the banks of the tributary to Aquetong Creek, including silky dogwood and black willow.

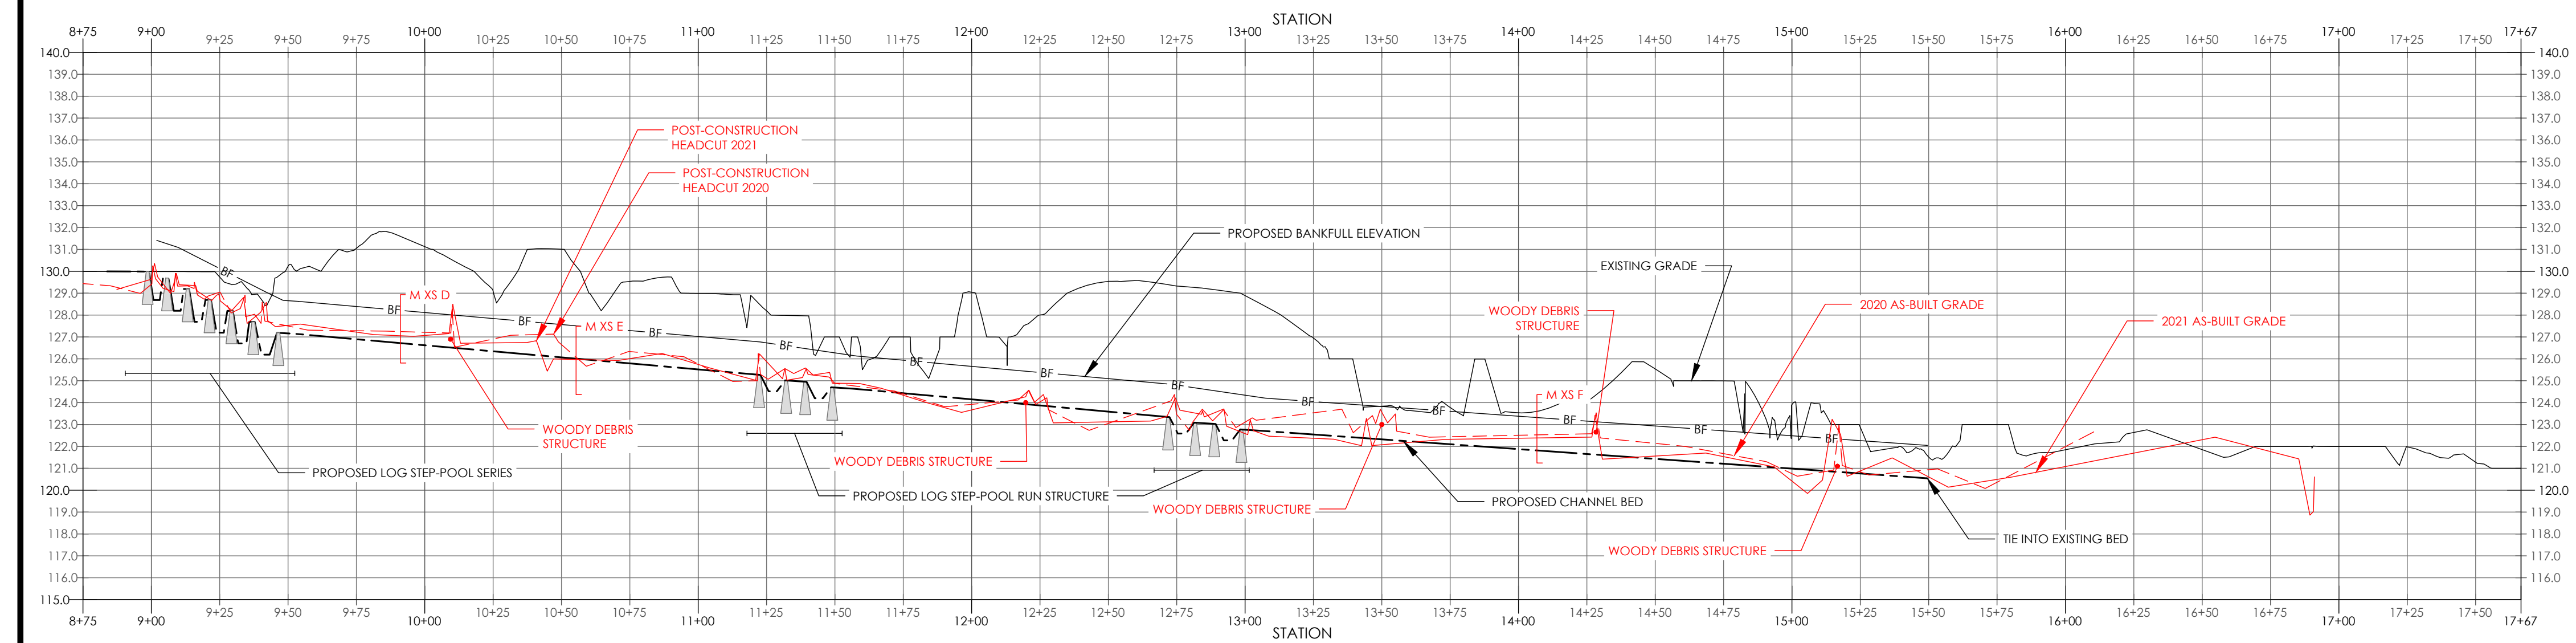
B PROPOSED PROFILE - MAIN CHANNEL - DOWNSTREAM
HORIZONTAL SCALE: 1" = 40'
VERTICAL SCALE: 1" = 5' (8X VERT. EX.)

- NOTES:
- ACTIVE EROSION IS OCCURRING THROUGHOUT THE REACH OF AQUETONG CREEK UPSTREAM OF STATION 08+75, HOWEVER NO TREATMENT OR ACTIVE RESTORATION IS CURRENTLY PROPOSED. IF TREATMENT IS NEEDED IN THE FUTURE, IT SHALL BE COMPLETED UNDER SEPARATE COVER.
 - THE DRAINAGE SWALE SHALL BE STABILIZED USING STEP POOLS CONSTRUCTED FROM EXCESS LOGS AND ROCKS. THESE STEP POOLS SHALL BE FIELD FIT BASED ON THE FIELD CONDITIONS AT THE TIME OF CONSTRUCTION AND AS DIRECTED BY ONSITE ENGINEER. THE STEP POOLS SHALL BE CONSTRUCTED IN ACCORDANCE WITH DETAIL A ON SHEET 7 OF 15.
 - THE TWO CULVERTS UNDER ROUTE 202 DRAINING INTO THE 202 STORMWATER TRIBUTARY SHALL BE STABILIZED UNDER A SEPARATE CONTRACT.

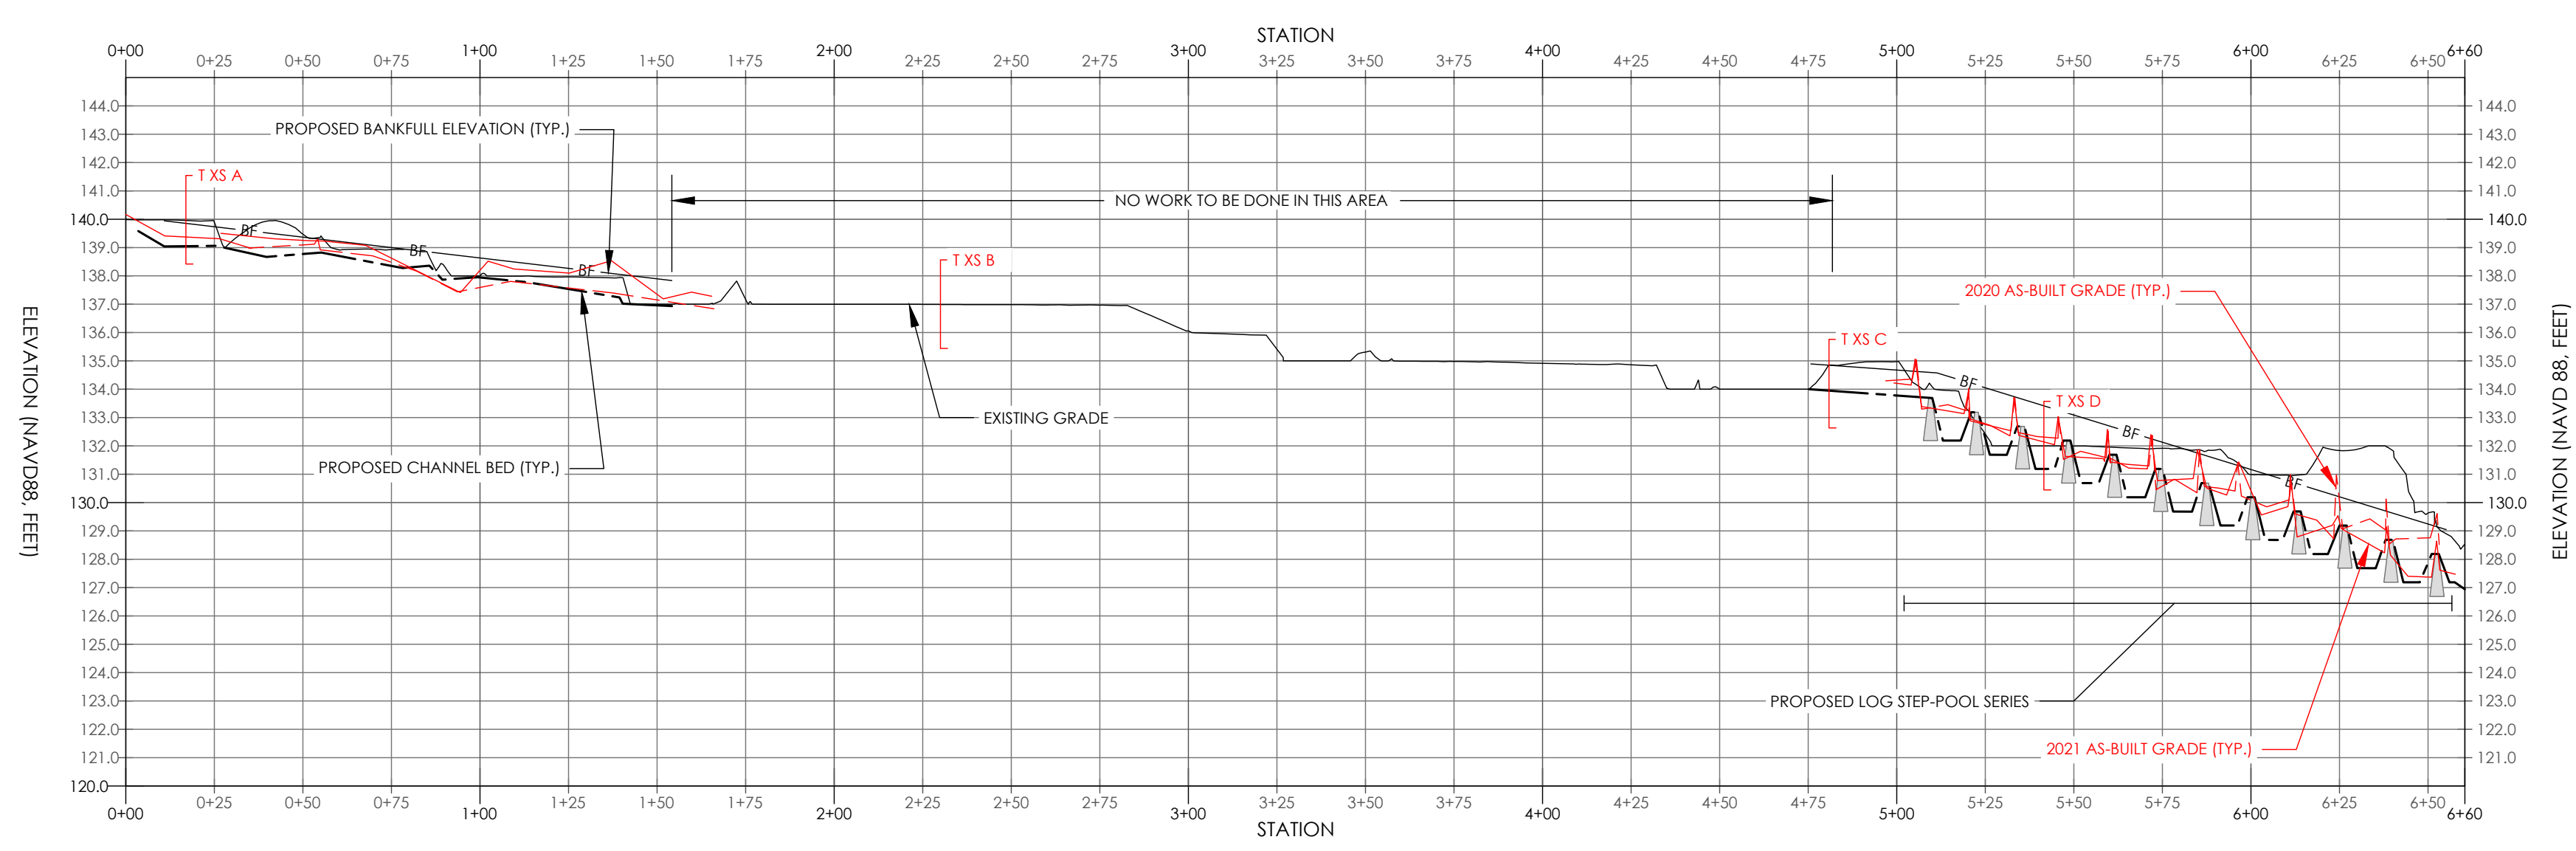
B PROPOSED PROFILE - STORMWATER TRIBUTARY
 HORIZONTAL SCALE: 1" = 40'
 VERTICAL SCALE: 1" = 5' (8X VERT. EX.)

- NOTES:**
1. ACTIVE EROSION IS OCCURRING THROUGHOUT THE REACH OF AQUETONG CREEK UPSTREAM OF STATION 08+75, HOWEVER NO TREATMENT OR ACTIVE RESTORATION IS CURRENTLY PROPOSED. IF TREATMENT IS NEEDED IN THE FUTURE, IT SHALL BE COMPLETED UNDER SEPARATE COVER.
 2. THE DRAINAGE SWALE SHALL BE STABILIZED USING STEP POOLS CONSTRUCTED FROM EXCESS LOGS AND ROCKS. THESE STEP POOLS SHALL BE FIELD FIT BASED ON THE FIELD CONDITIONS AT THE TIME OF CONSTRUCTION AND AS DIRECTED BY ONSITE ENGINEER. THE STEP POOLS SHALL BE CONSTRUCTED IN ACCORDANCE WITH DETAIL A ON SHEET 7 OF 15.
 3. THE TWO CULVERTS UNDER ROUTE 202 DRAINING INTO THE 202 STORMWATER TRIBUTARY SHALL BE STABILIZED UNDER A SEPARATE CONTRACT.
