AQUETONG CREEK RESTORATION PROJECT 2022 MONITORING REPORT

SOLEBURY TOWNSHIP, BUCKS COUNTY, PENNSYLVANIA

NOVEMBER 2022

PRINCETON HYDRO, LLC
35 CLARK STREET
P.O. BOX 3689
TRENTON, NEW JERSEY 08611
908-237-5660

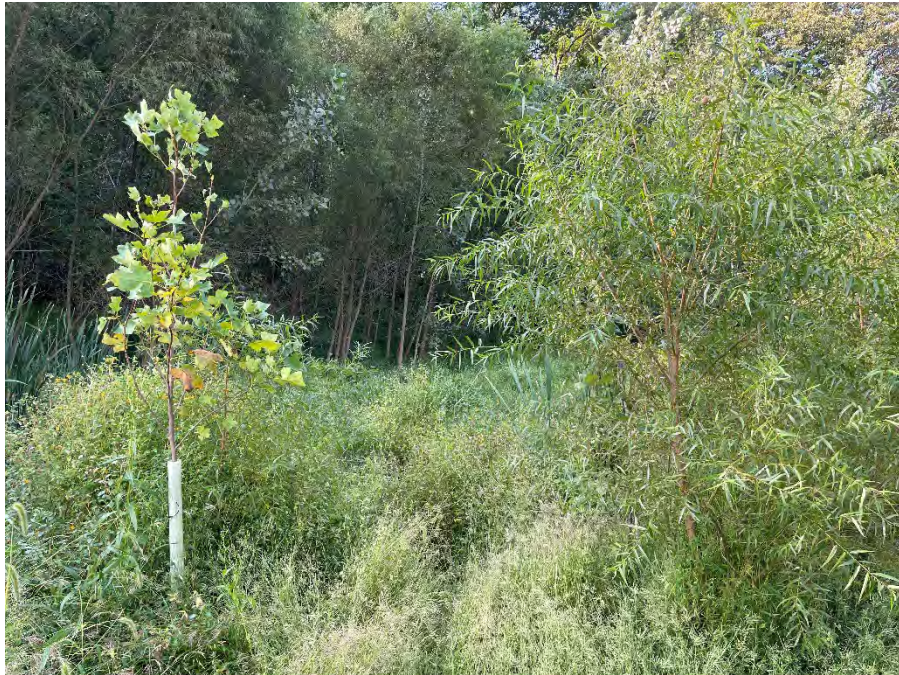
Date: Sept. 15, 2022	
Location: See photo location map.	
Direction: Northeast	
Comments: View of the wetland creation area along the northern bank of Aquetong Creek featuring tulip tree (<i>Liriodendron tulipifera</i>) and river birch (<i>Betula nigra</i>).	
Photograph ID: 4

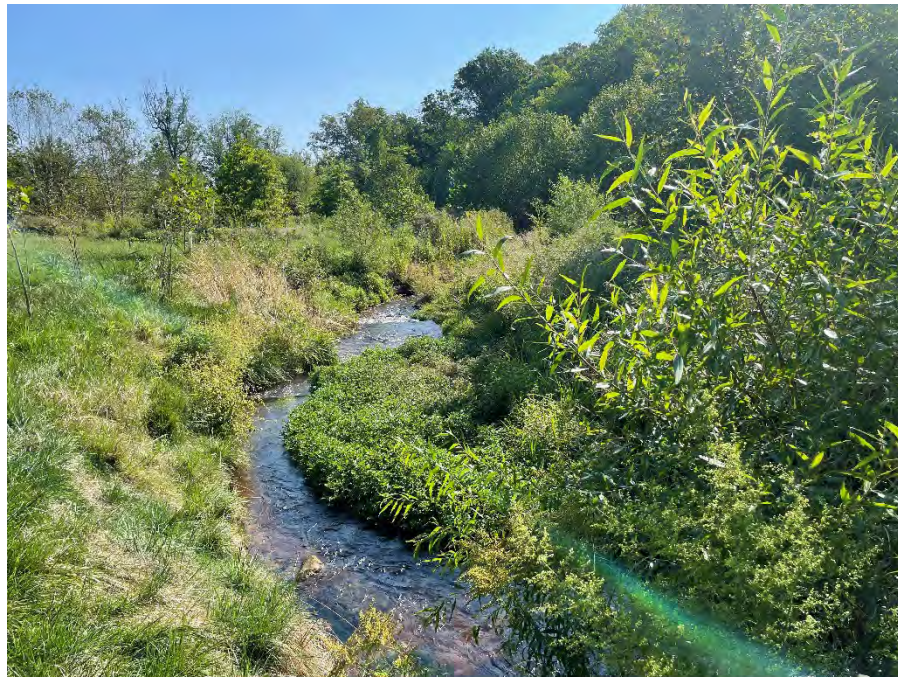
Date: Sept. 27, 2021	
Location: See photo location map.	
Direction: South	
Comments: View of the wetland enhancement area featuring the healthy (>5 ft.) installed woody species such as tulip poplar (left) and black willow (right).

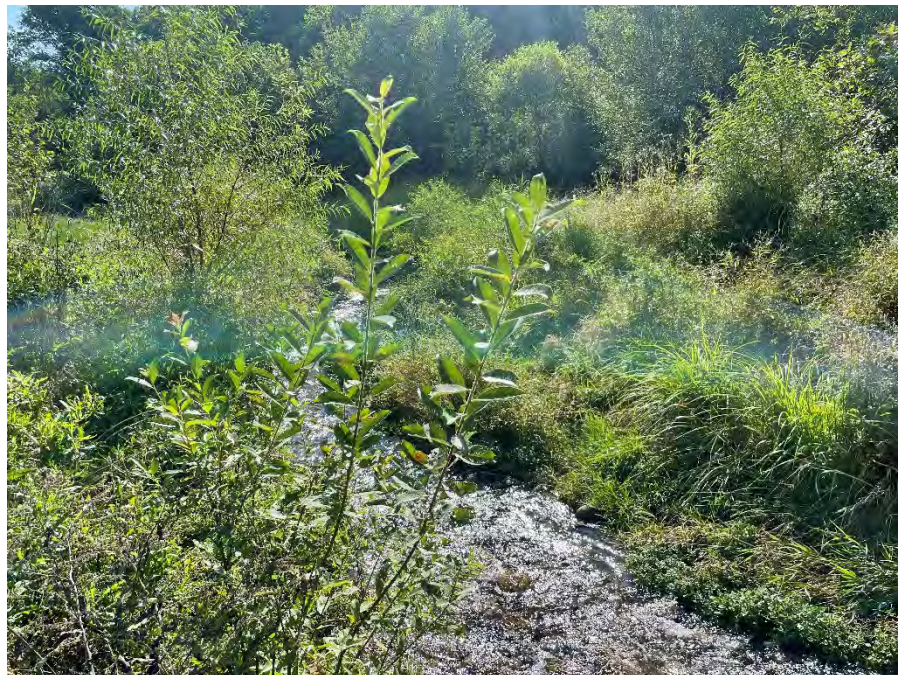
Comments:
View of the well-established herbaceous and woody vegetation within the wetland enhancement area along Aquetong Creek.

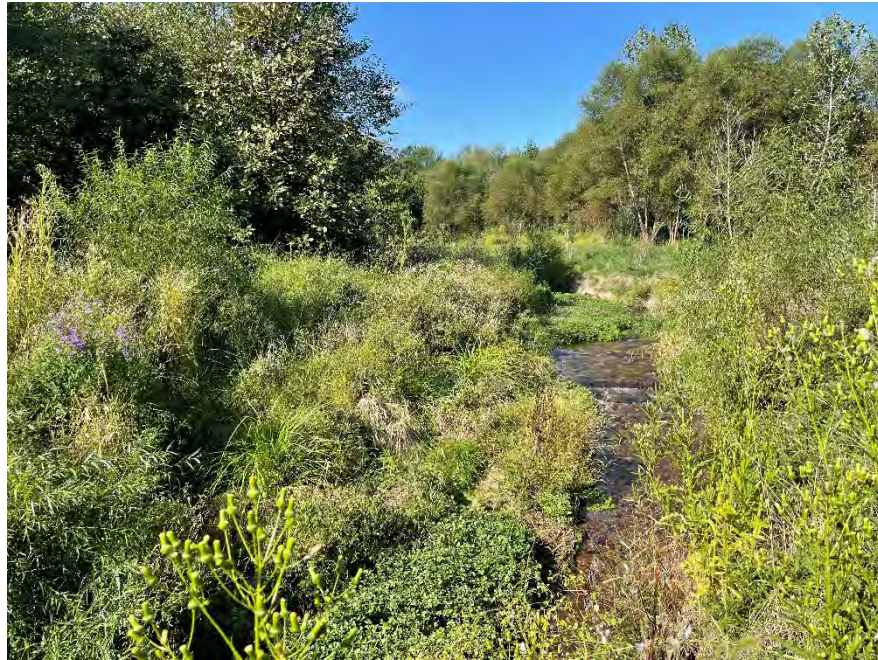
Comments:
View of the well-established hydrophytic vegetation within the wetland enhancement area along Aquetong Creek featuring pussy willow (*Salix discolor*).

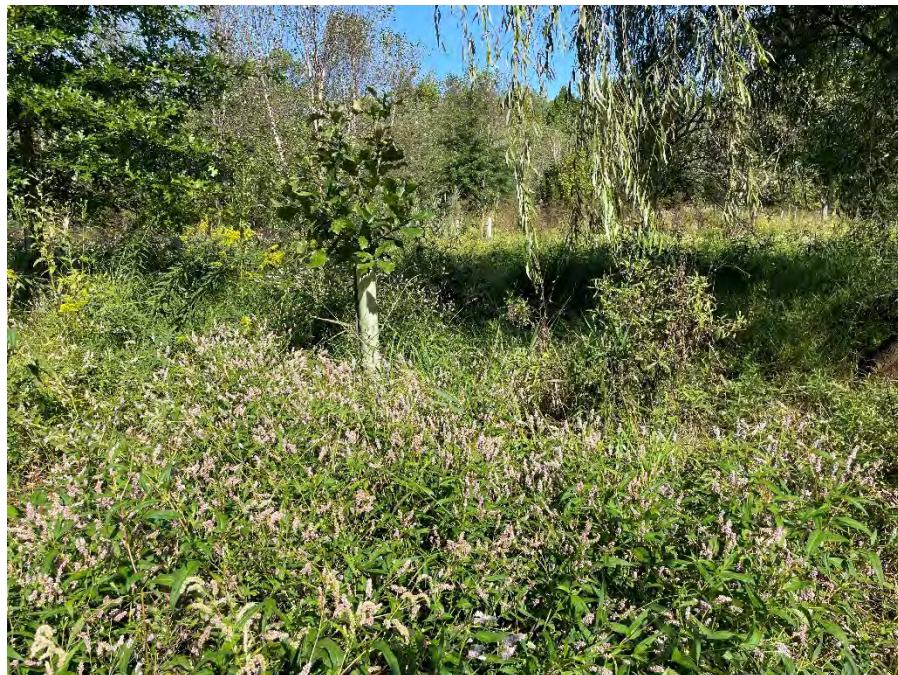
Client: Solebury Township**Site Name:** Aquetong Spring Park Restoration Project**Project Number:** 0388.011**Site Location:** Solebury Township, PA**Photograph ID:** 7**Date:** Sept. 15, 2022**Location:**
See photo location map.**Direction:**
West**Comments:**
View of the diverse plant community within the wetland creation and enhancement areas along the banks of Aquetong Creek.

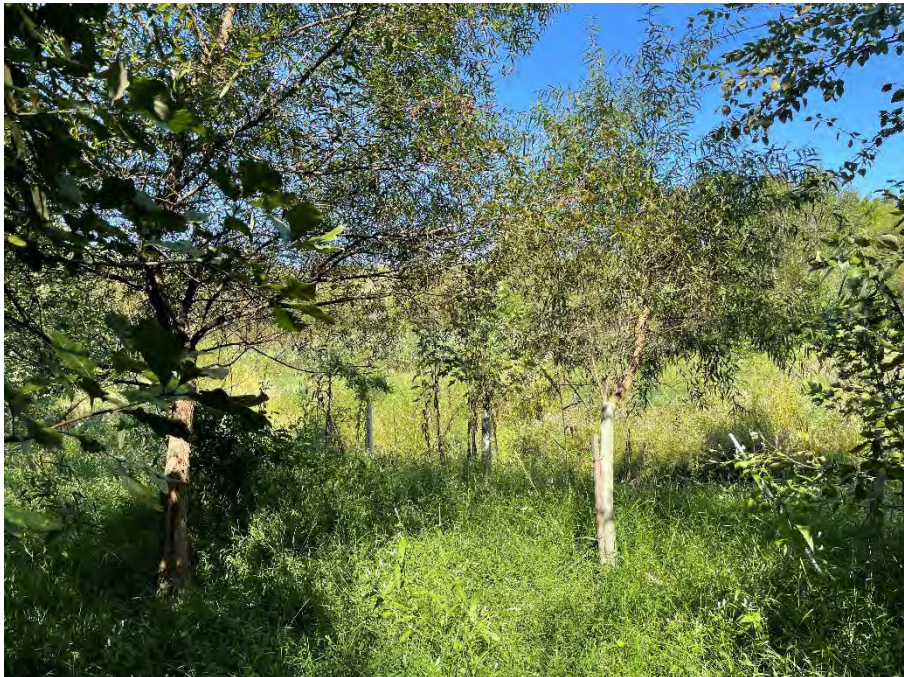
Date: Sept. 15, 2022	
Location: See photo location map.	
Direction: Northwest	
Comments: View of the well-established black willow live stakes and American sycamore (background) within the wetland enhancement area in the eastern portion of the Site.	
Photograph ID: 10

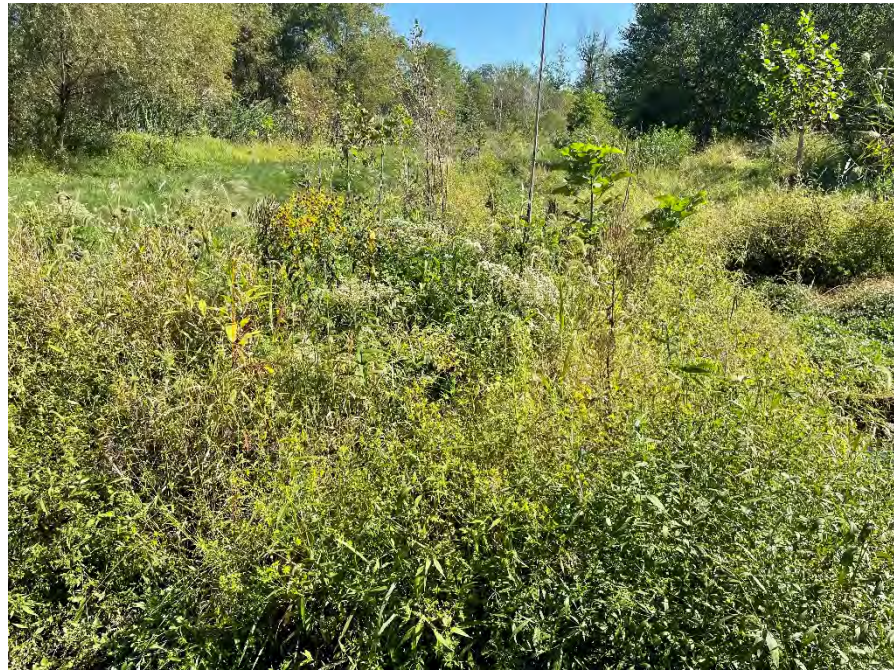
Comments:
Closeup view of a pin oak within a robust herbaceous community in the wetland enhancement area.

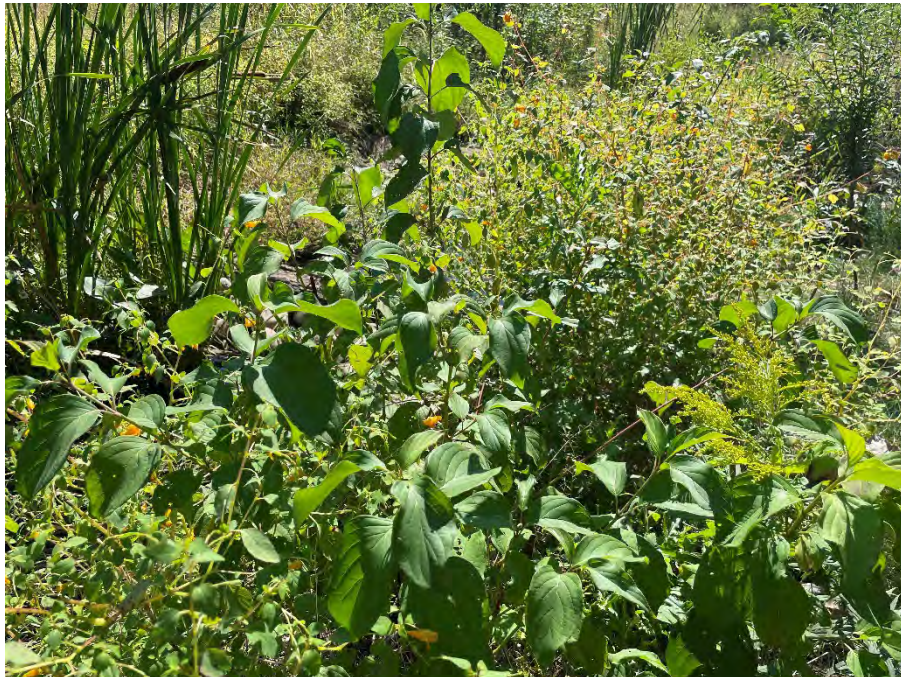
Client: Solebury Township**Site Name:** Aquetong Spring Park Restoration Project**Project Number:** 0388.011**Site Location:** Solebury Township, PA**Photograph ID:** 13**Date:** Sept. 15, 2022**Location:**
See photo location map.**Direction:**
Northeast**Comments:**
General view of the diverse and well-established herbaceous layer within the wetland creation area along Aquetong Creek.

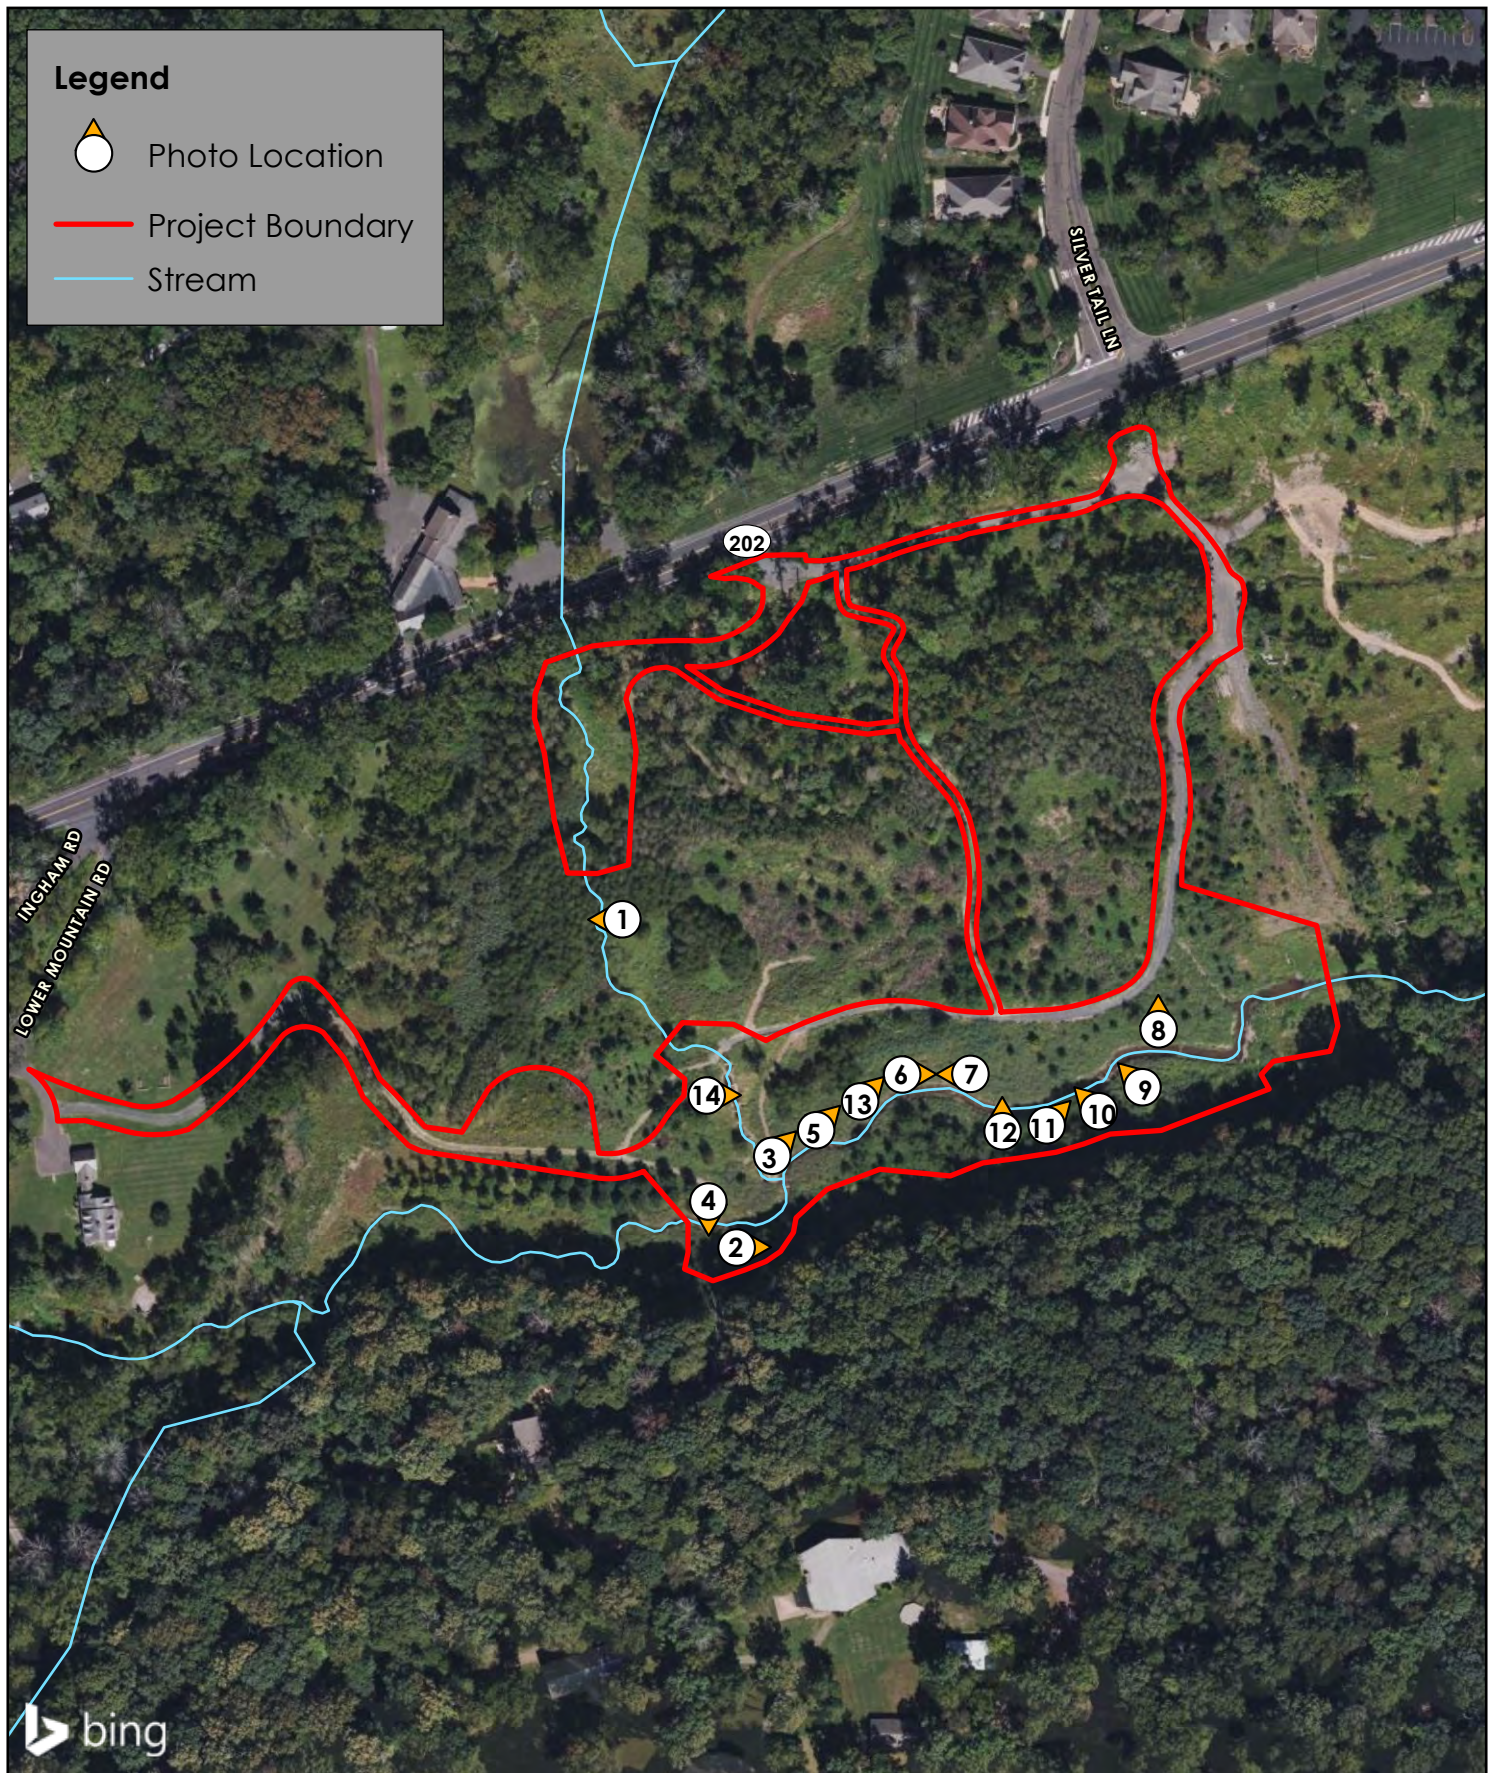
**Photograph ID:** 14**Date:** Sept. 15, 2022**Location:**
See photo location map.**Direction:**
East**Comments:**
Closeup view of a healthy silky dogwood (*Cornus amomum*) planting, jewelweed, and broadleaf cattail (*Typha latifolia*) along the bank of the tributary to Aquetong Creek.

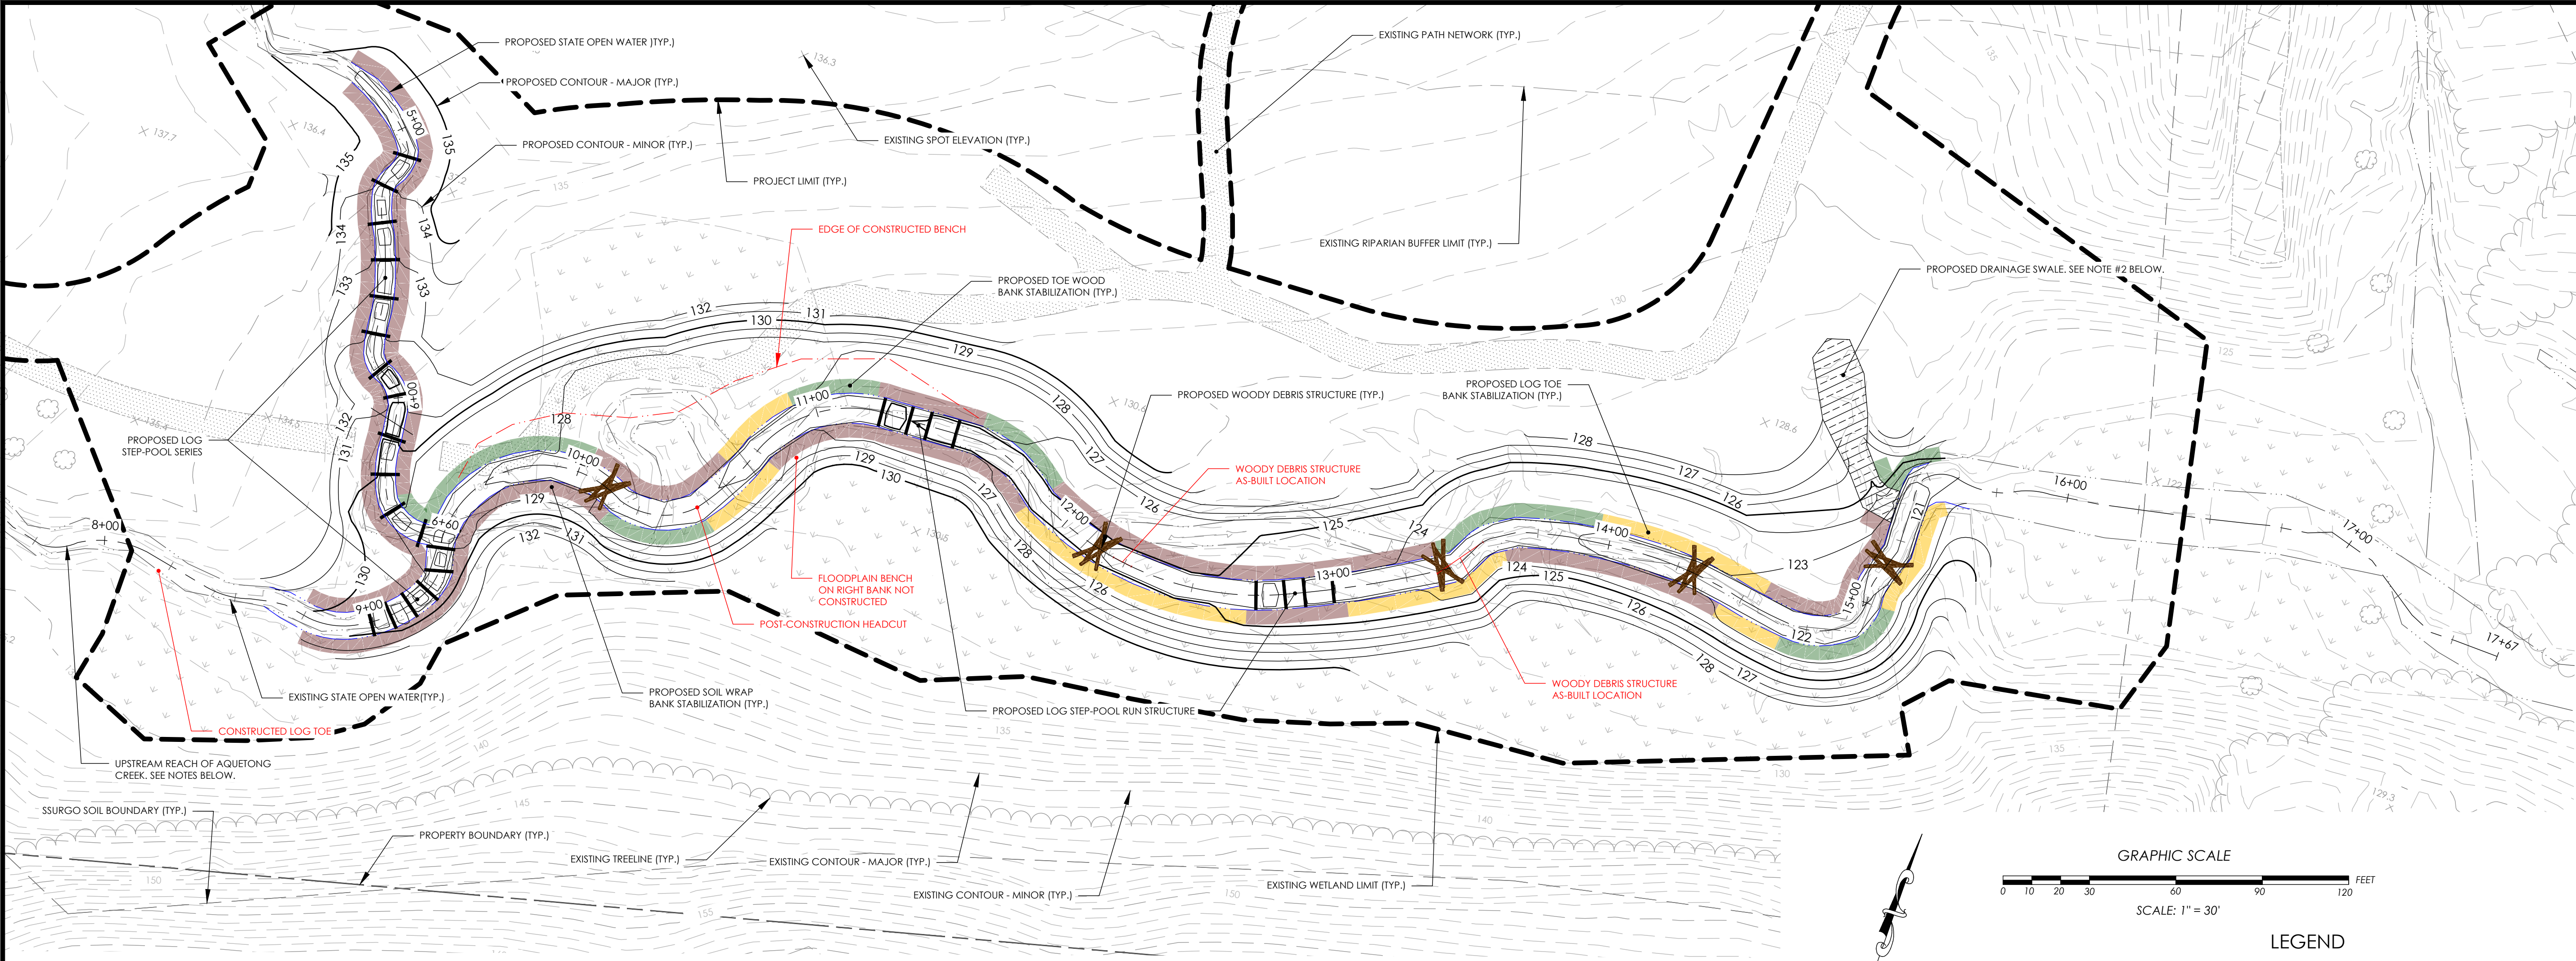
A PROPOSED PLAN VIEW - MAIN CHANNEL - DOWNSTREAM
1" = 30'

- NOTES:
- ACTIVE EROSION IS OCCURRING THROUGHOUT THE REACH OF AQUETONG CREEK UPSTREAM OF STATION 08+75, HOWEVER NO TREATMENT OR ACTIVE RESTORATION IS CURRENTLY PROPOSED. IF TREATMENT IS NEEDED IN THE FUTURE, IT SHALL BE COMPLETED UNDER SEPARATE COVER.
 - THE DRAINAGE SWALE SHALL BE STABILIZED USING STEP POOLS CONSTRUCTED FROM EXCESS LOGS AND ROCKS. THESE STEP POOLS SHALL BE FIELD FIT BASED ON THE FIELD CONDITIONS AT THE TIME OF CONSTRUCTION AND AS DIRECTED BY ONSITE ENGINEER. THE STEP POOLS SHALL BE CONSTRUCTED IN ACCORDANCE WITH DETAIL A ON SHEET 7 OF 15.
 - THE TWO CULVERTS UNDER ROUTE 202 DRAINING INTO THE 202 STORMWATER TRIBUTARY SHALL BE STABILIZED UNDER A SEPARATE CONTRACT.

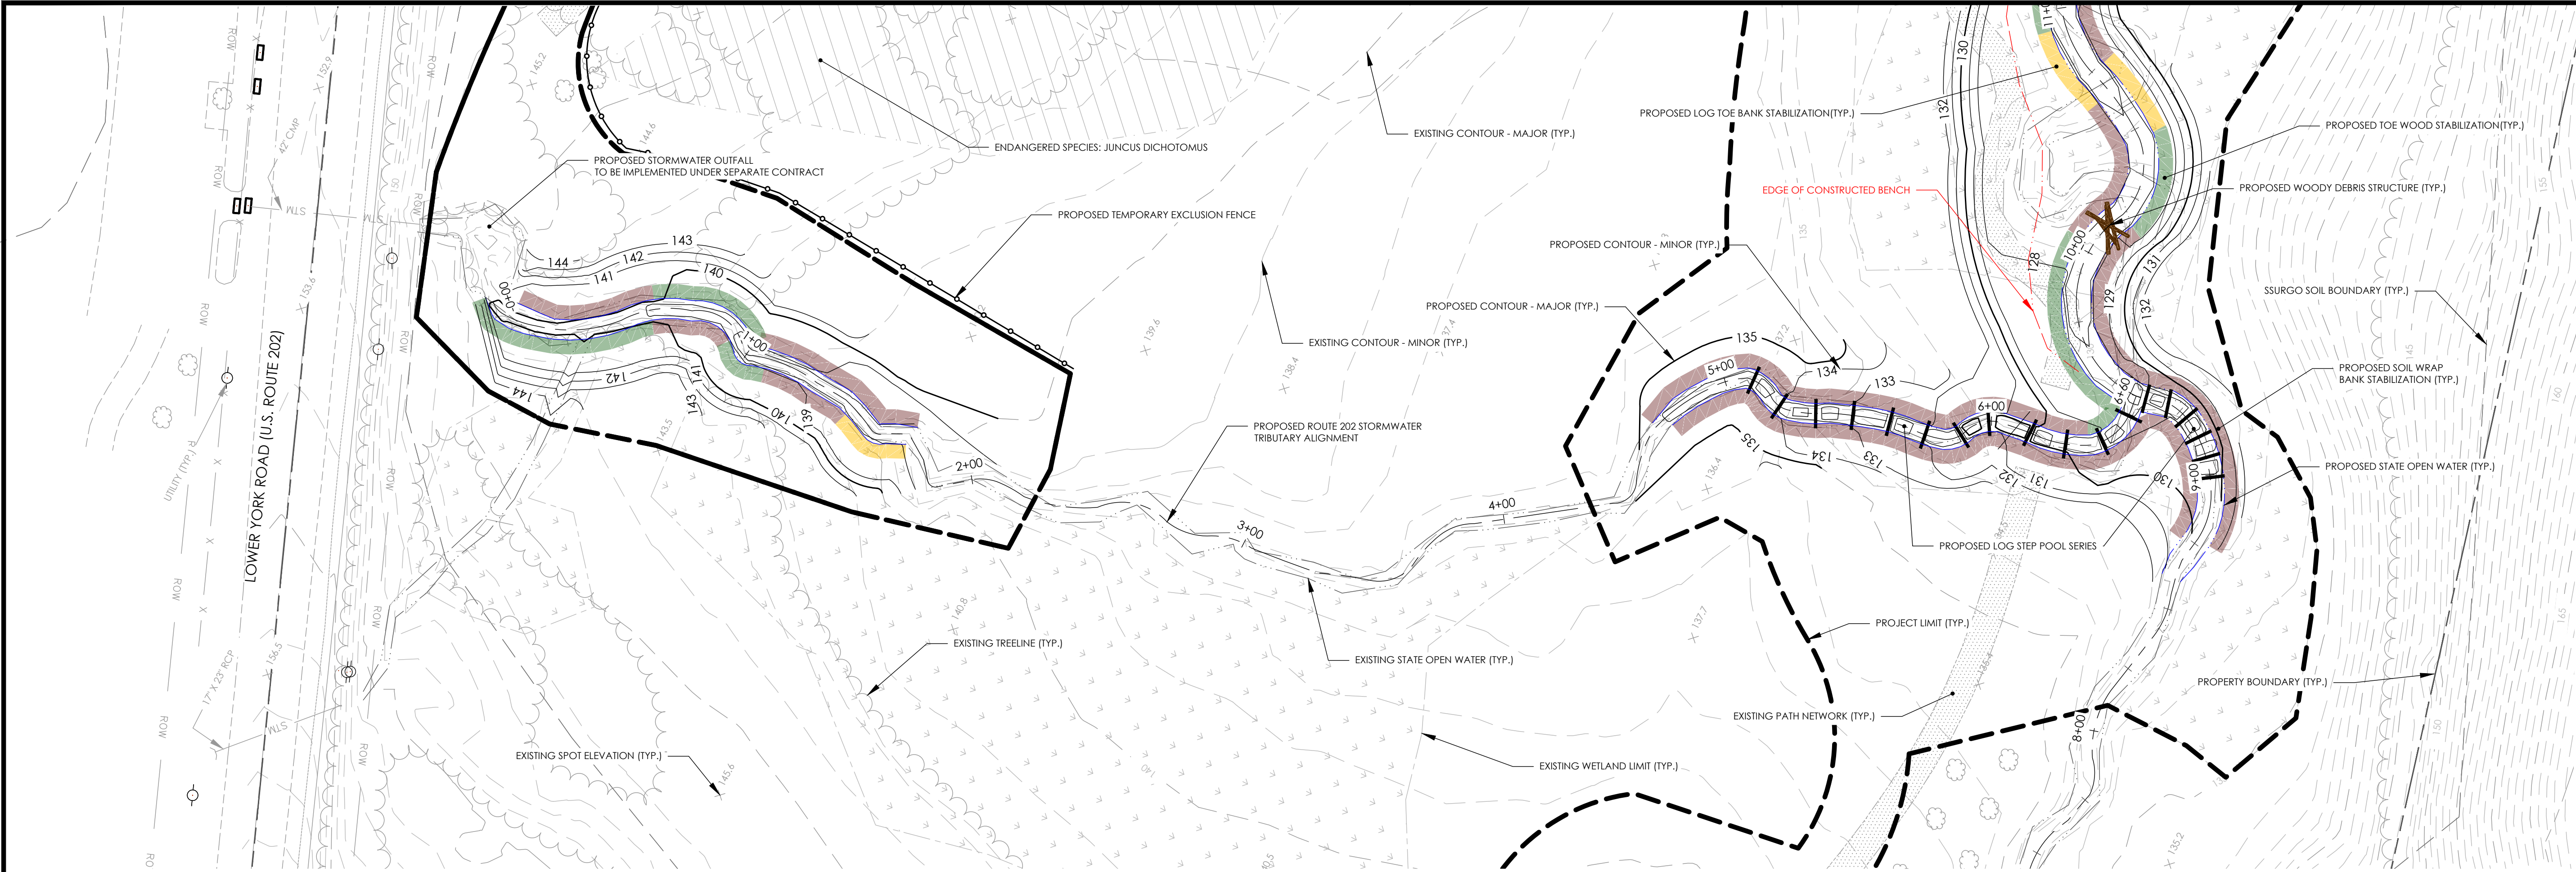
A PROPOSED PLANVIEW - STORMWATER TRIBUTARY
1" = 30'

1. ACTIVE EROSION IS OCCURRING THROUGHOUT THE REACH OF AQUETONG CREEK UPSTREAM OF STATION 08+75, HOWEVER NO TREATMENT OR ACTIVE RESTORATION IS CURRENTLY PROPOSED. IF TREATMENT IS NEEDED IN THE FUTURE, IT SHALL BE COMPLETED UNDER SEPARATE COVER.
2. THE DRAINAGE SWALE SHALL BE STABILIZED USING STEP POOLS CONSTRUCTED FROM EXCESS LOGS AND ROCKS. THESE STEP POOLS SHALL BE FIELD FIT BASED ON THE FIELD CONDITIONS AT THE TIME OF CONSTRUCTION AND AS DIRECTED BY ONSITE ENGINEER. THE STEP POOLS SHALL BE CONSTRUCTED IN ACCORDANCE WITH DETAIL A ON SHEET 7 OF 15.
3. THE TWO CULVERTS UNDER ROUTE 202 DRAINING INTO THE 202 STORMWATER TRIBUTARY SHALL BE STABILIZED UNDER A SEPARATE CONTRACT.

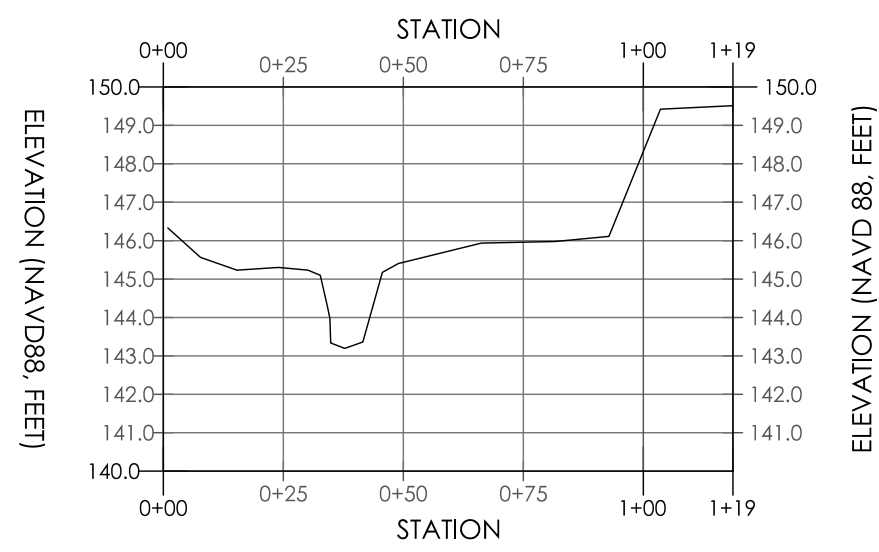
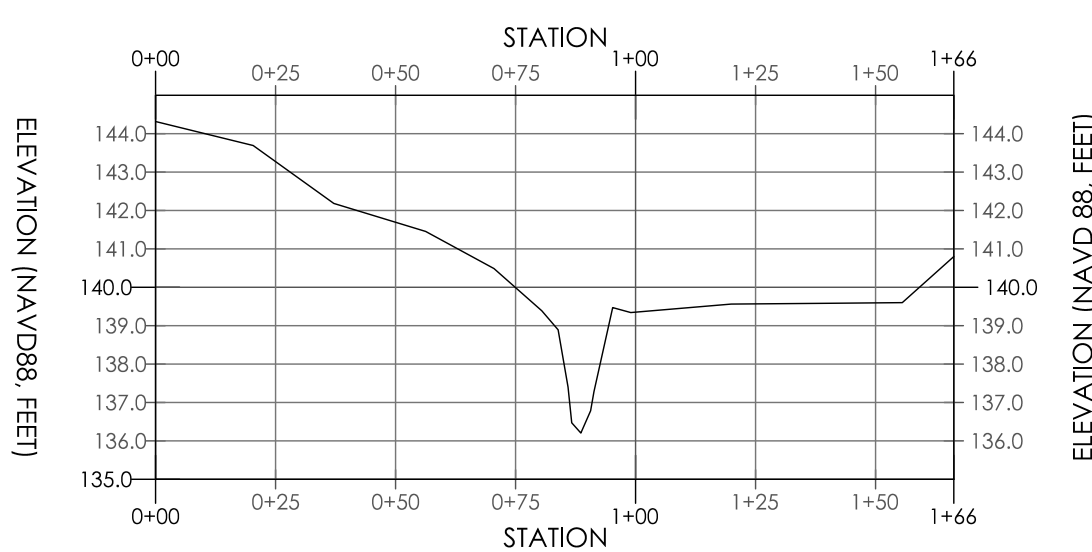
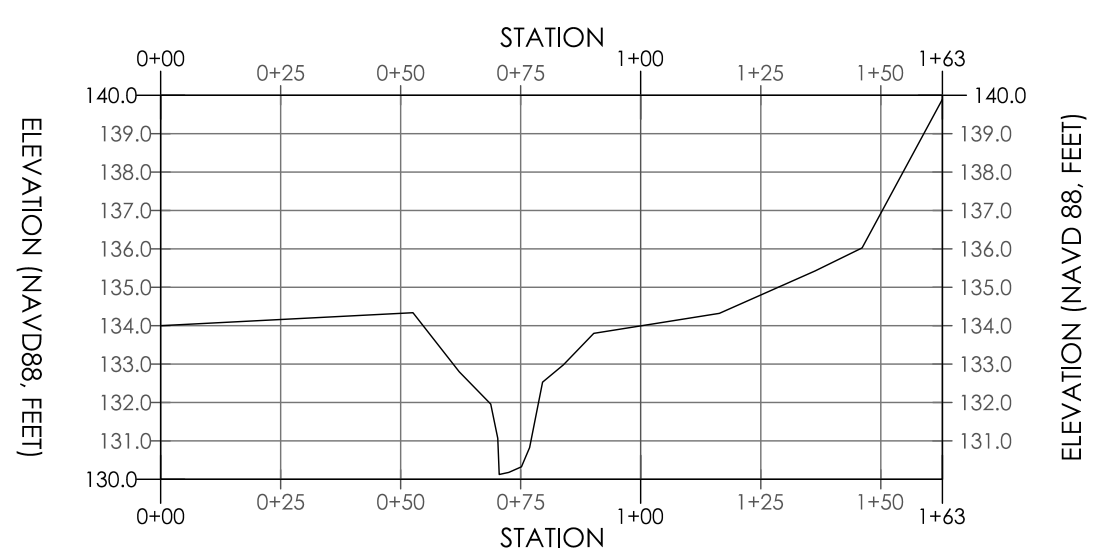
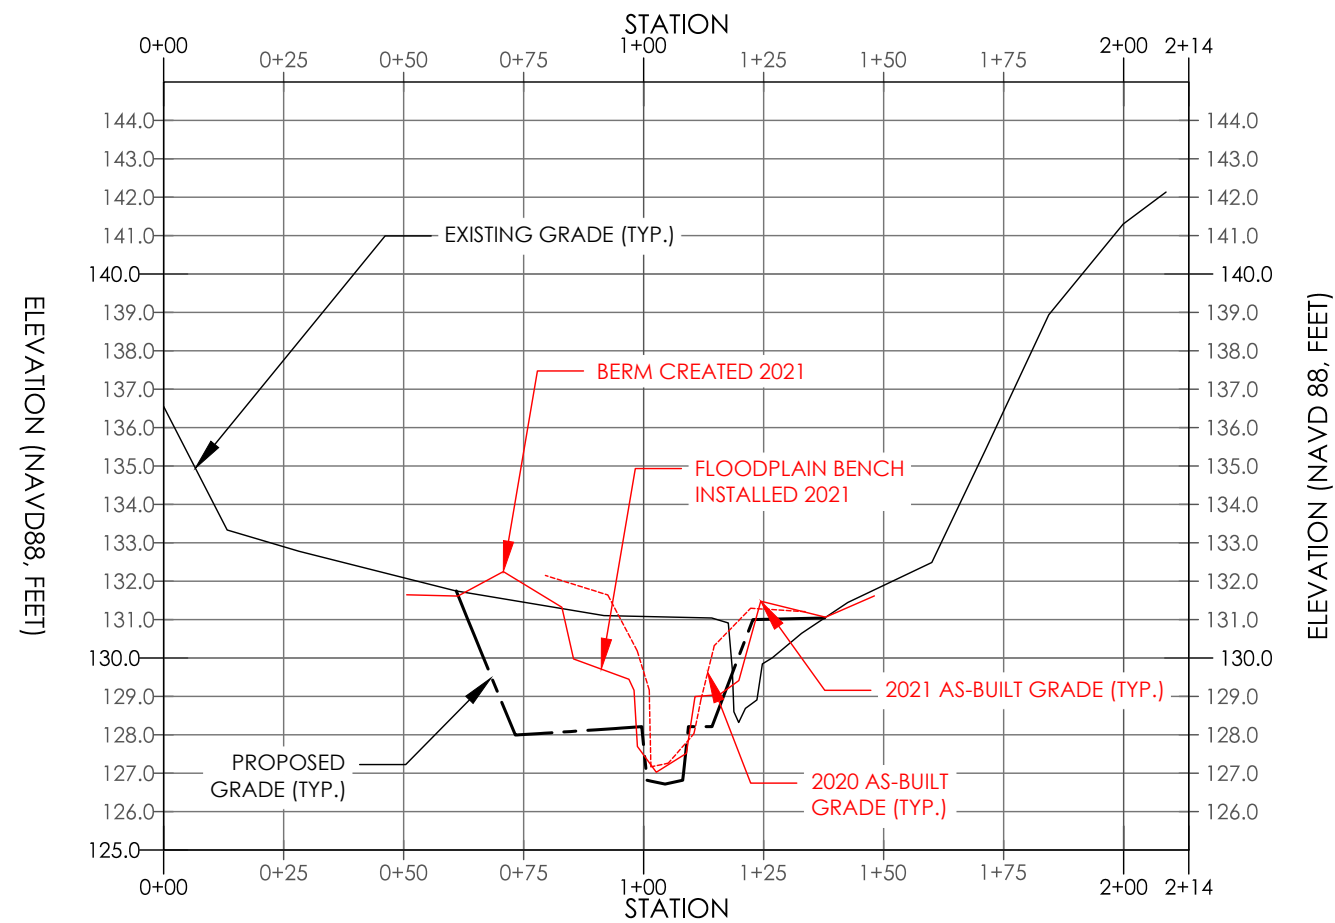
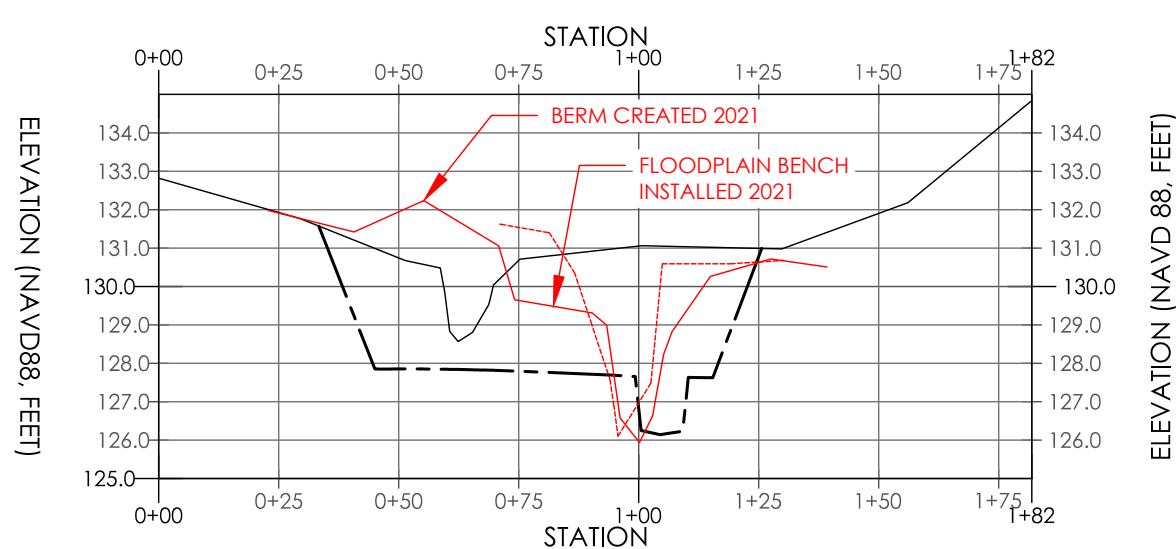
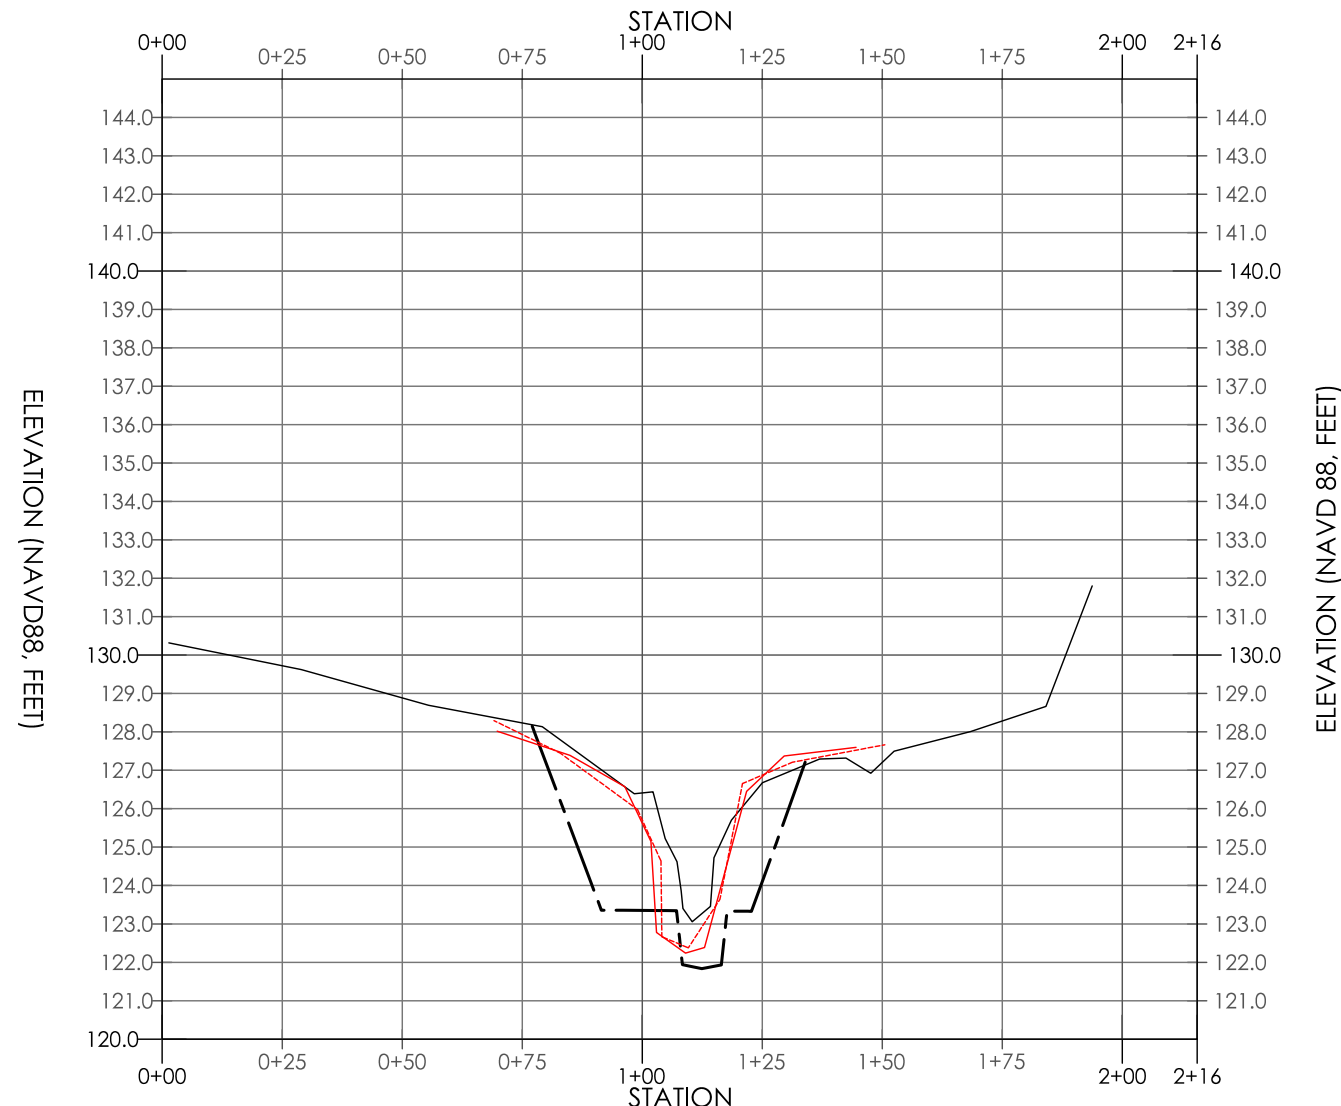
A MAIN CHANNEL CROSS SECTION A (MC XS-A)
HORIZONTAL SCALE: 1" = 40'
VERTICAL SCALE: 1" = 5' (VERT. EXAG. = 8X)

B MAIN CHANNEL CROSS SECTION B (MC XS-B)
HORIZONTAL SCALE: 1" = 40'
VERTICAL SCALE: 1" = 5' (VERT. EXAG. = 8X)

C MAIN CHANNEL CROSS SECTION C (MC XS-C)
HORIZONTAL SCALE: 1" = 40'
VERTICAL SCALE: 1" = 5' (VERT. EXAG. = 8X)

D MAIN CHANNEL CROSS SECTION D (MC XS-D)
HORIZONTAL SCALE: 1" = 40'
VERTICAL SCALE: 1" = 5' (VERT. EXAG. = 8X)

E MAIN CHANNEL CROSS SECTION E (MC XS-E)
HORIZONTAL SCALE: 1" = 40'
VERTICAL SCALE: 1" = 5' (VERT. EXAG. = 8X)

F MAIN CHANNEL CROSS SECTION F (MC XS-F)
HORIZONTAL SCALE: 1" = 40'
VERTICAL SCALE: 1" = 5' (VERT. EXAG. = 8X)

- NOTES:
- ALL CROSS SECTIONS ARE DEPICTED FROM LEFT BANK TO RIGHT BANK, LOOKING DOWNSTREAM.
 - CROSS SECTION LOCATIONS CAN BE FOUND ON PAGE 3 OF 15.

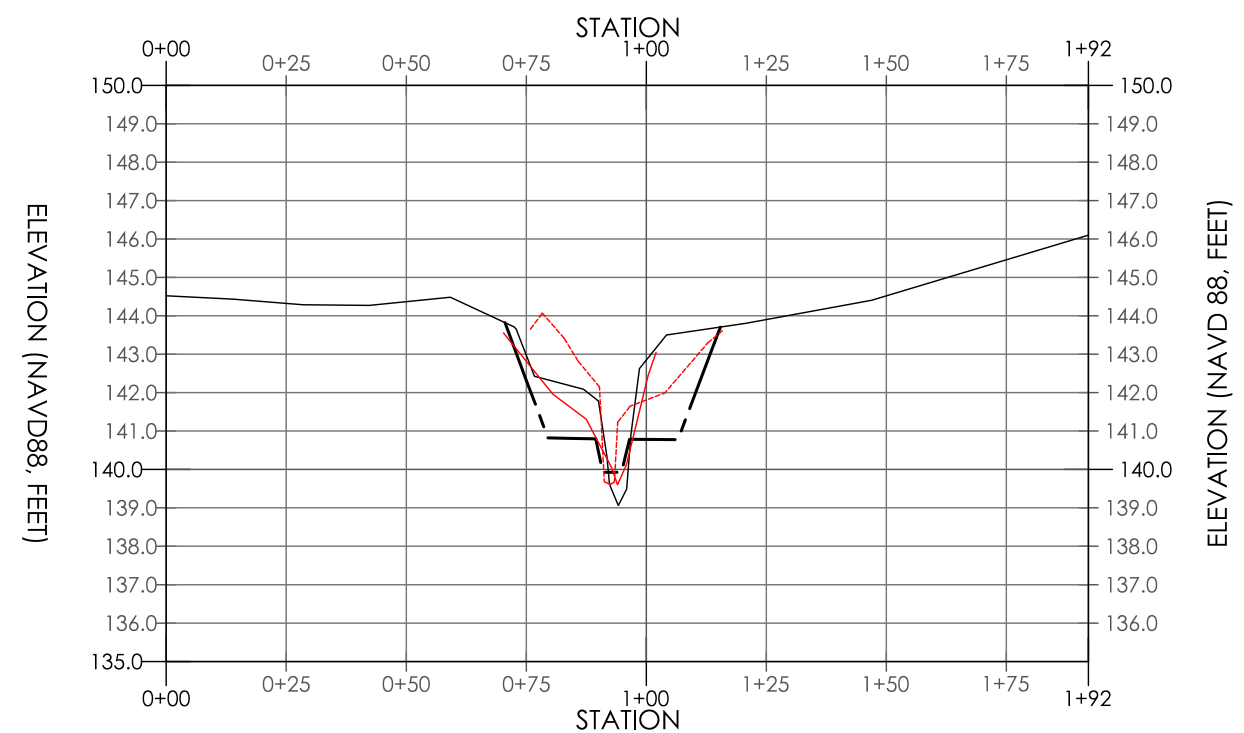
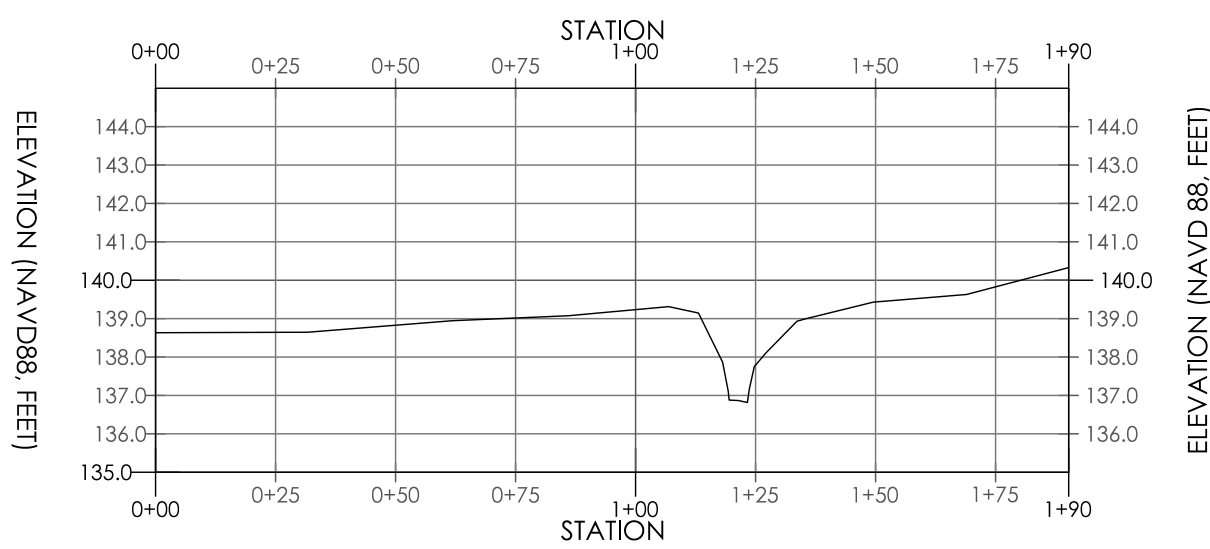
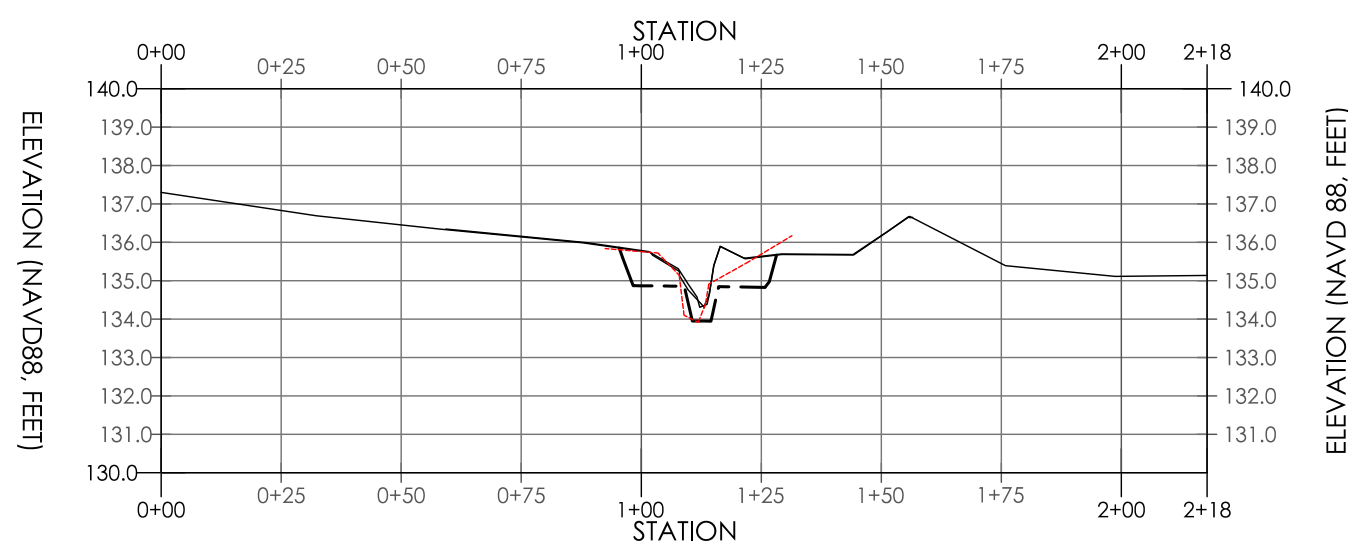
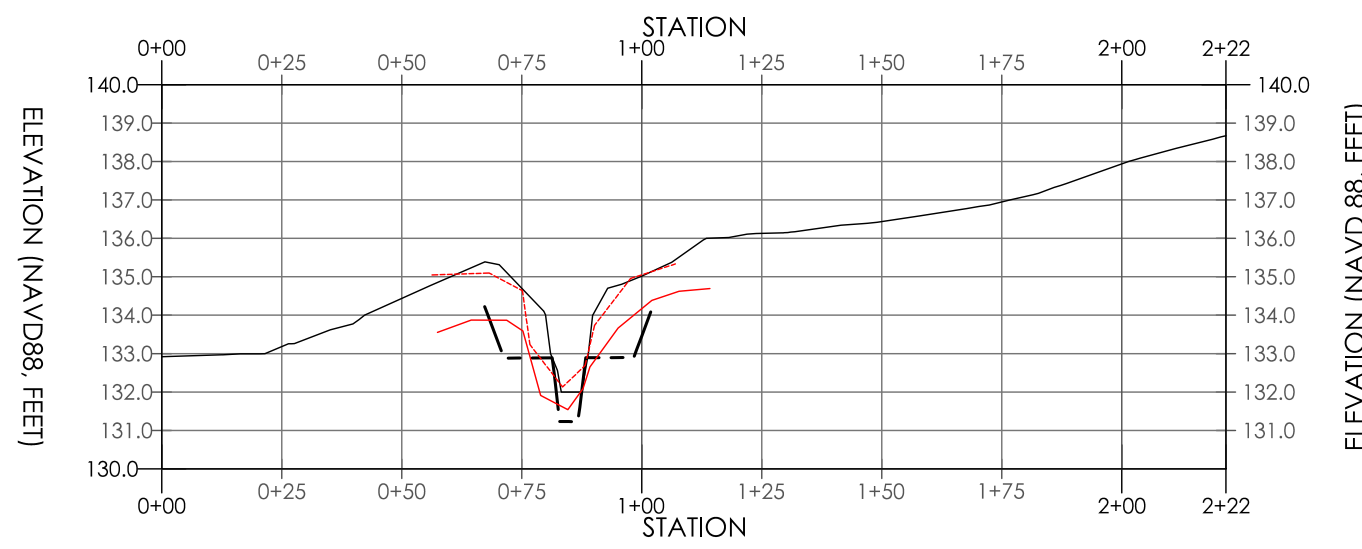
G STORWATER TRIBUTARY CROSS SECTION A (ST XC-A)
HORIZONTAL SCALE: 1" = 40'
VERTICAL SCALE: 1" = 5' (VERT. EXAG. = 8X)

H STORWATER TRIBUTARY CROSS SECTION B (ST XC-B)
HORIZONTAL SCALE: 1" = 40'
VERTICAL SCALE: 1" = 5' (VERT. EXAG. = 8X)

I STORWATER TRIBUTARY CROSS SECTION C (ST XC-C)
HORIZONTAL SCALE: 1" = 40'
VERTICAL SCALE: 1" = 5' (VERT. EXAG. = 8X)

J STORWATER TRIBUTARY CROSS SECTION D (ST XC-D)
HORIZONTAL SCALE: 1" = 40'
VERTICAL SCALE: 1" = 5' (VERT. EXAG. = 8X)
