Prepared for:

Solebury Township 3092 Sugan Road Solebury, Pennsylvania 18963

Uhl, Baron, Rana, & Associates, Inc. 243 North Union Street Suite 240 P.O. Box 347 Lambertville, New Jersey 08530

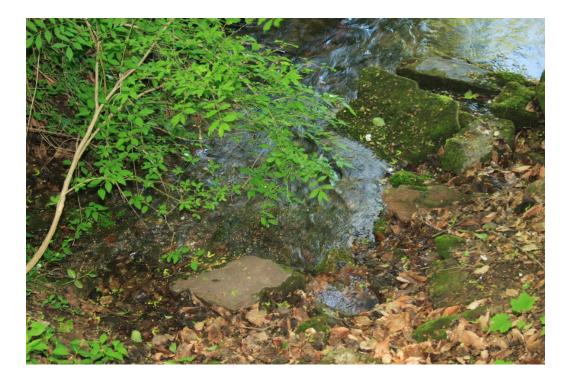
Photo 1: Ingham Spring Outlet

Ingham Spring (**Figure 1 and Photo 1**) is located in Solebury Township just east of the intersection of Route 202 (Lower York Road) and Lower Mountain Road. The spring is located slightly south of Route 202, between Lower Mountain Road and Silver Tail Road. The spring is made up of a number of springs within a few feet of each other that discharge to a pond (**Photo 2**) and flow over an old dam structure to a creek (**Photo 3**). The spring discharge serves to fill Aquetong Lake a few hundred feet to the east of the spring. Aquetong Lake is approximately 15 acres in area and the outlet from this lake forms one of the two main tributaries of Aquetong Creek. The spring is bordered to the east by Deer Park Camp, which is mainly undeveloped forested land; to the northnorthwest by Route 202 and the residential developments Fox Run and Fox Run Estates; to the south by residential development along Heather Lane; and to the east by undeveloped land owned by the Commonwealth of Pennsylvania.

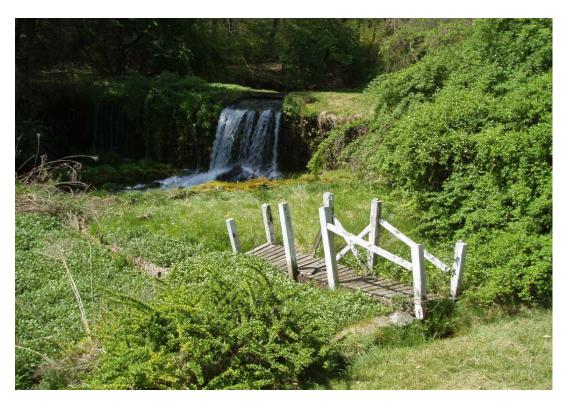
Photo 3: Dam (enclosing Ingham Spring Pond) and Waterfall

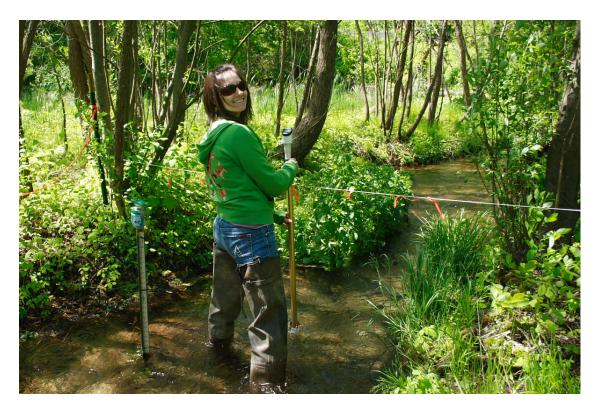
Photo 5: Ingham Spring Outlet Stream Flow Measurement Location and Staff Gauge

Spring flow measurements were obtained from a location in the outlet creek downgradient of Ingham Spring pond on a monthly basis from May 2007 to May 2008 (**Figure 1**). The stream flow measurements were initiated by measuring the width of the stream and then dividing the stream up into six 1-foot sections. A Global Flow Probe FB101-EP201 current meter was then used to measure the maximum and average velocity of the water flow in each 1-foot measurement section. The probe was held at each measurement location for approximately 40 seconds to account for surging. True velocity averaging was recorded by slowly moving the probe back and forth through the entire water column in a vertical line (from bottom to top) for approximately one minute. **Photo 5** shows a flow measurement in May of 2008 and **Photo 6** is a close up of the current meter measurement instrument.

The Ingham Spring flow rate, as measured at the outlet creek downgradient of the pond (Photo 5), ranged from a minimum of 2.7 million gallons per day (MGD) in January 2008 to a maximum of 5.4 MGD in May 2007; 1,875 gpm to 3,750 gpm. For the 12 month period from June 2007 to May 2008, the average spring discharge was 3.53 MGD (2,450 gpm). There was a decline in spring flow from May 2007 to October 2008 which is reflective of the natural decrease in groundwater recharge that occurs from the wetter spring months to the drier summer and early fall/winter seasons due to higher temperatures and increased rates of evapo-transpiration.

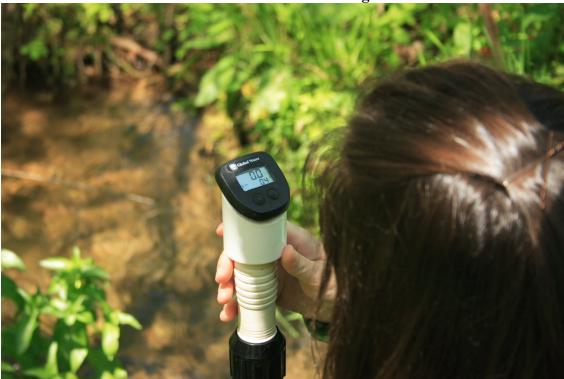
Photo 6: Flow Meter Screen Reading Maximum Velocity

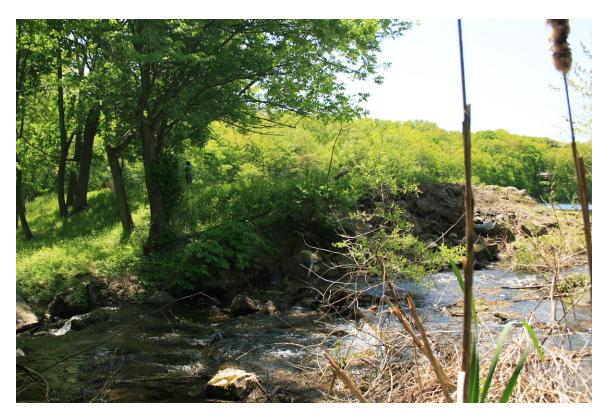
Photo 9: Aquetong Lake Earthen Dam and Lake Outlet to Aquetong Creek

Ingham Spring has an approximate surface elevation of 167.25 ft, amsl. The spring flows into Aquetong Lake, formed by an earthen dam approximately 500 feet in length. The lake outflow joins the northern tributary of Aquetong Creek, and flows northeast through Solebury Township and into the Borough of New Hope, to its confluence with the Delaware River.
